# **Fluvial Geomorphic Assessment and River Corridor Planning in the Wood-Pawcatuck Watershed, RI and CT**

Prepared for  
Wood-Pawcatuck Watershed Association  
Hope Valley, RI

Prepared by  
John Field  
Field Geology Services  
Farmington, ME

March 2016

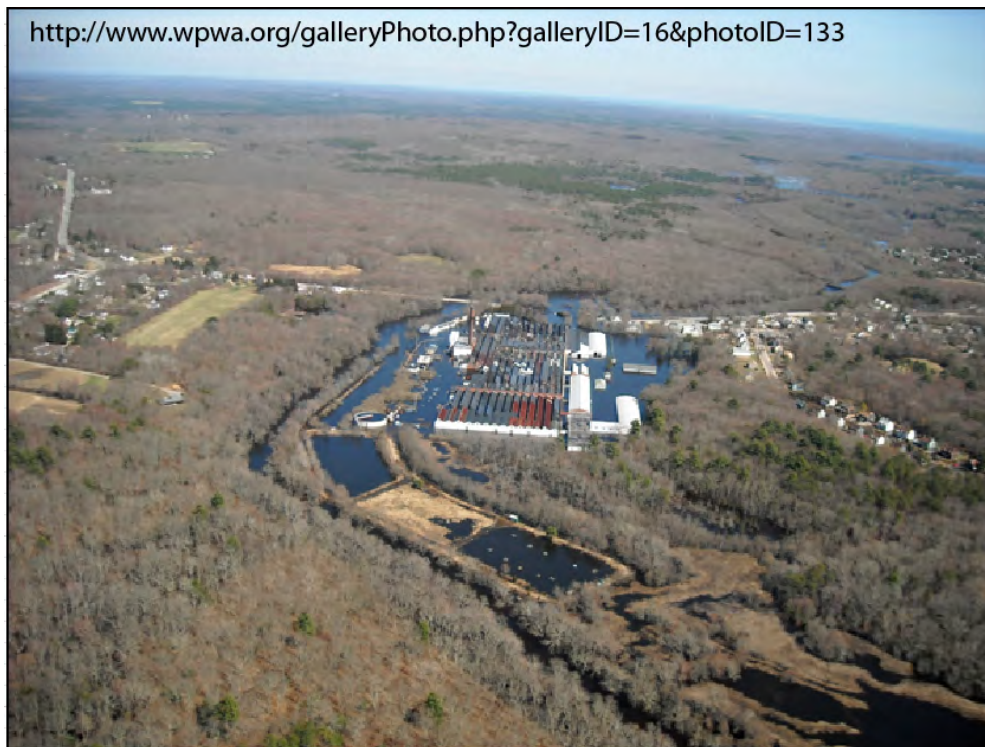
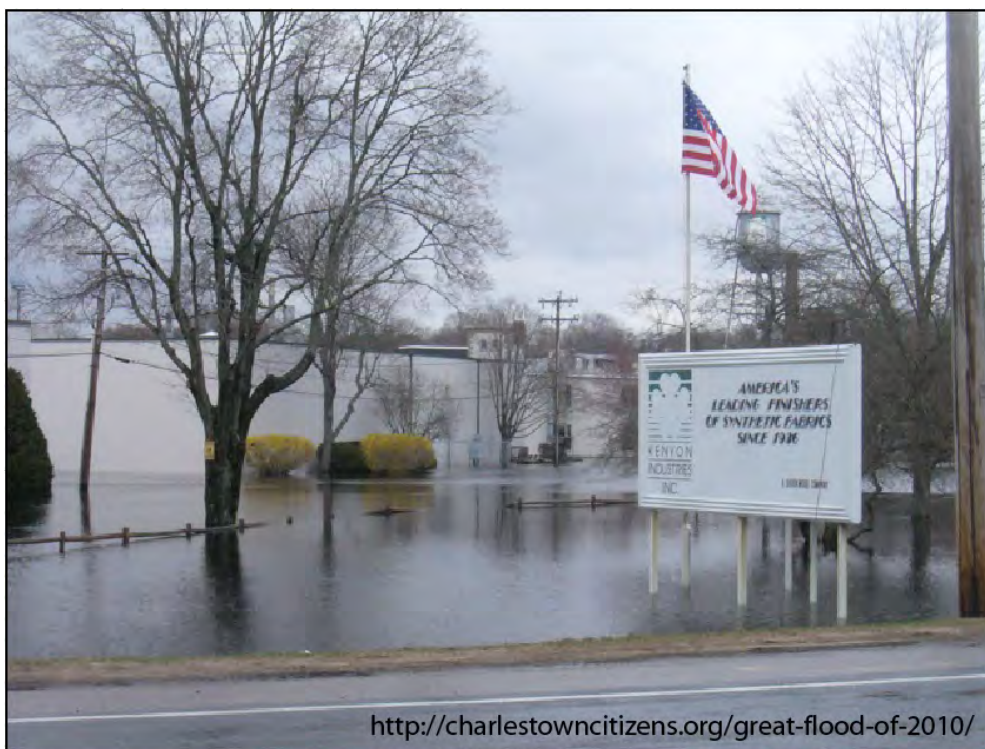
Figure 3. a) Aerial view of flooding at Bradford Dye Association plant looking upstream on April 1, 2010 and b) photo of flooding at Kenyon Industries complex on March 31, 2010.

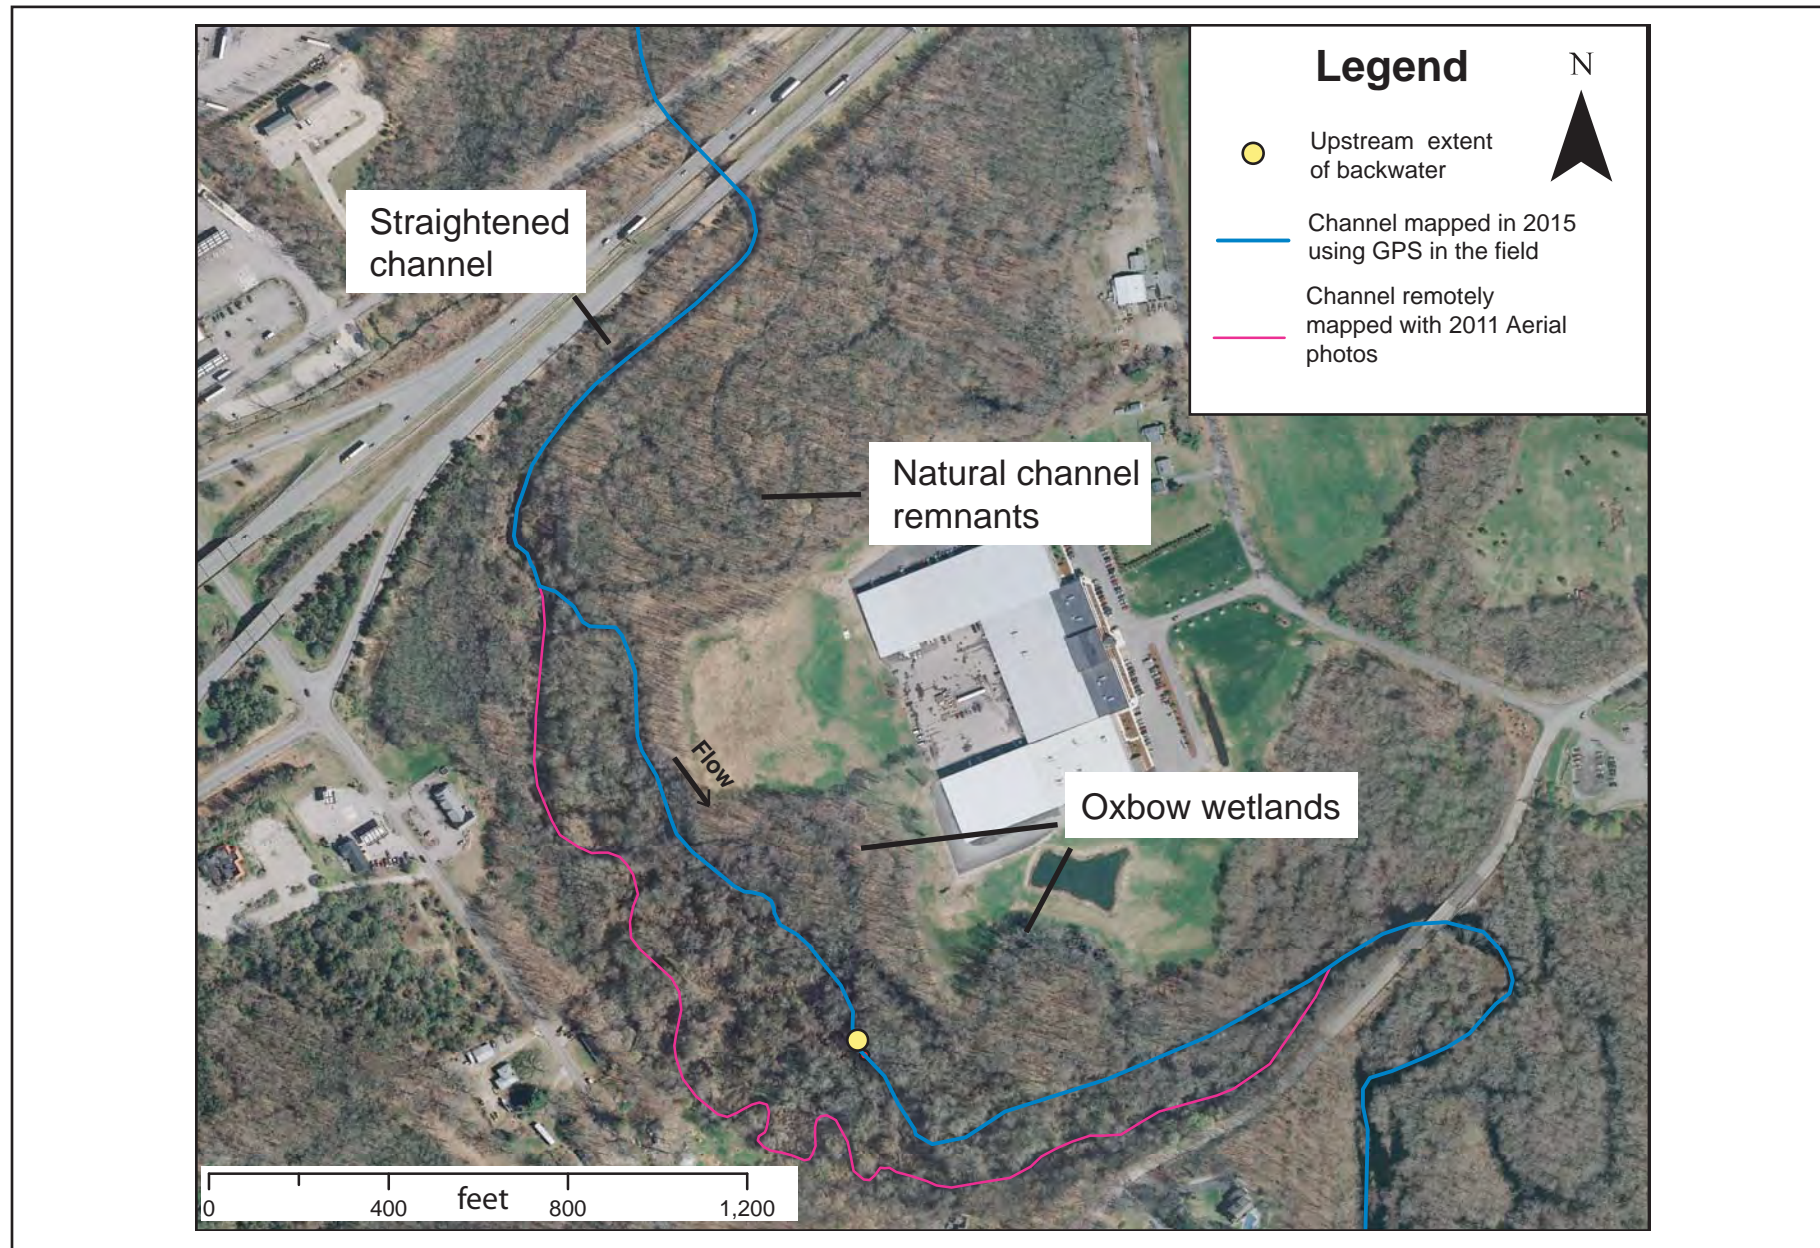
Figure 4. GAS-4 near Clarks Falls, CT overlaying 2011 6 inch orthoimagery. This reach is upstream of an impoundment, and a poorly aligned bridge. The backwater effects have caused a recent avulsion, and there is evidence of older avulsions. The recent avulsion shortened the stream, and began at the end of straightened channel.

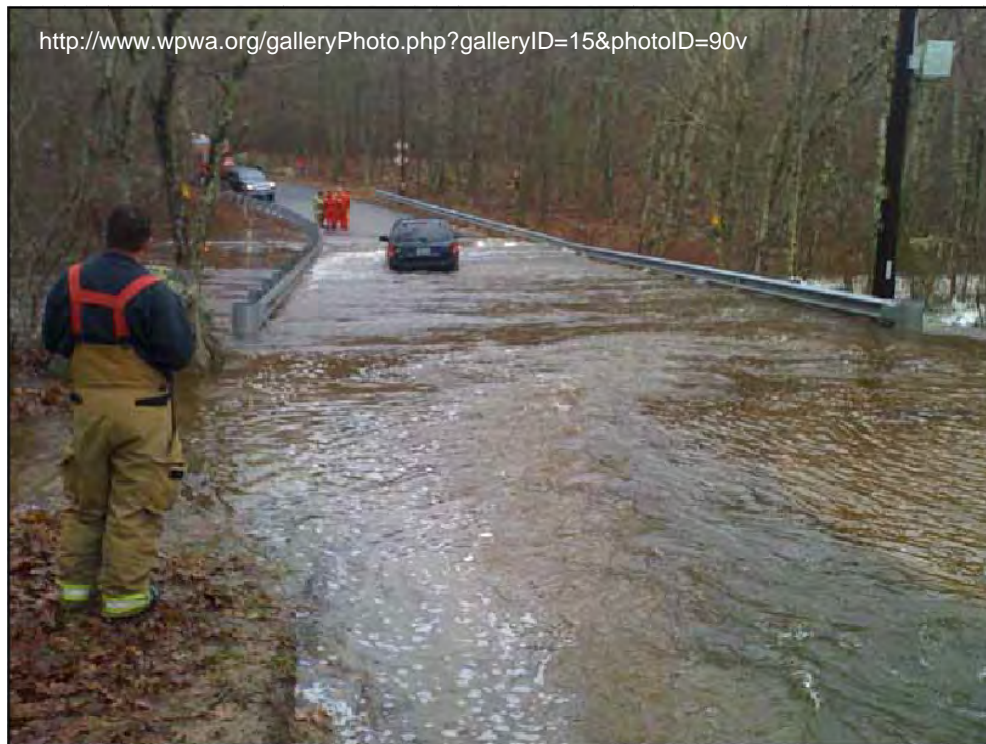
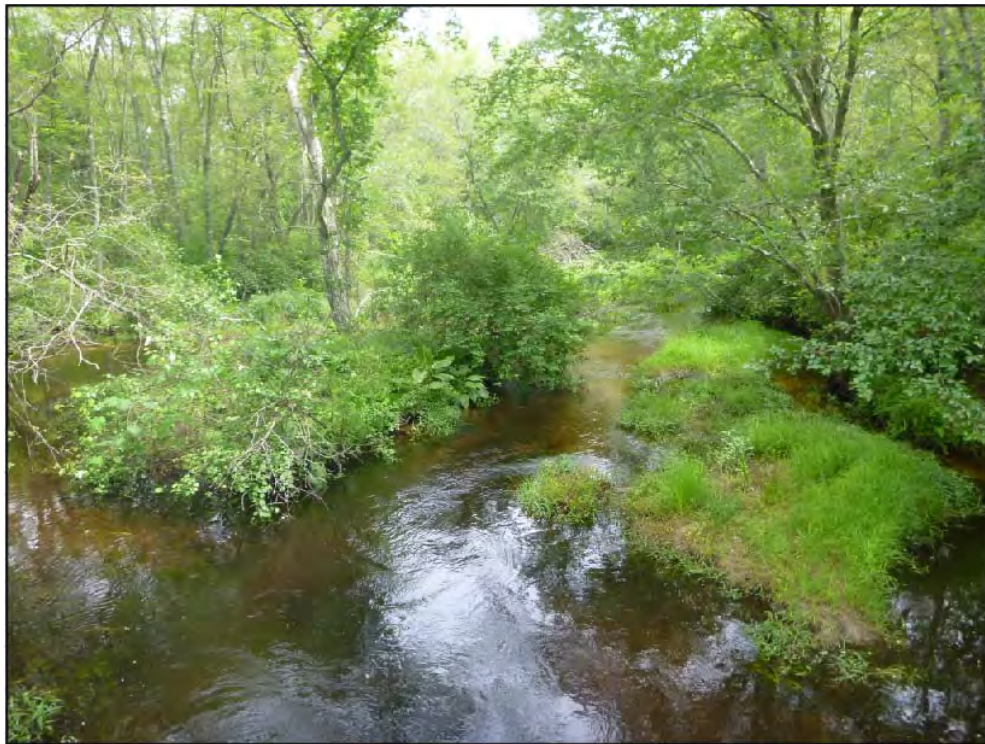
Figure 5. a) Photo of culvert at Hillsdale Road and Beaver River in Richmond RI taken on March 31, 2010 and b) view upstream from Liberty Road on QUS-11 showing backwatering impacts on channel morphology.

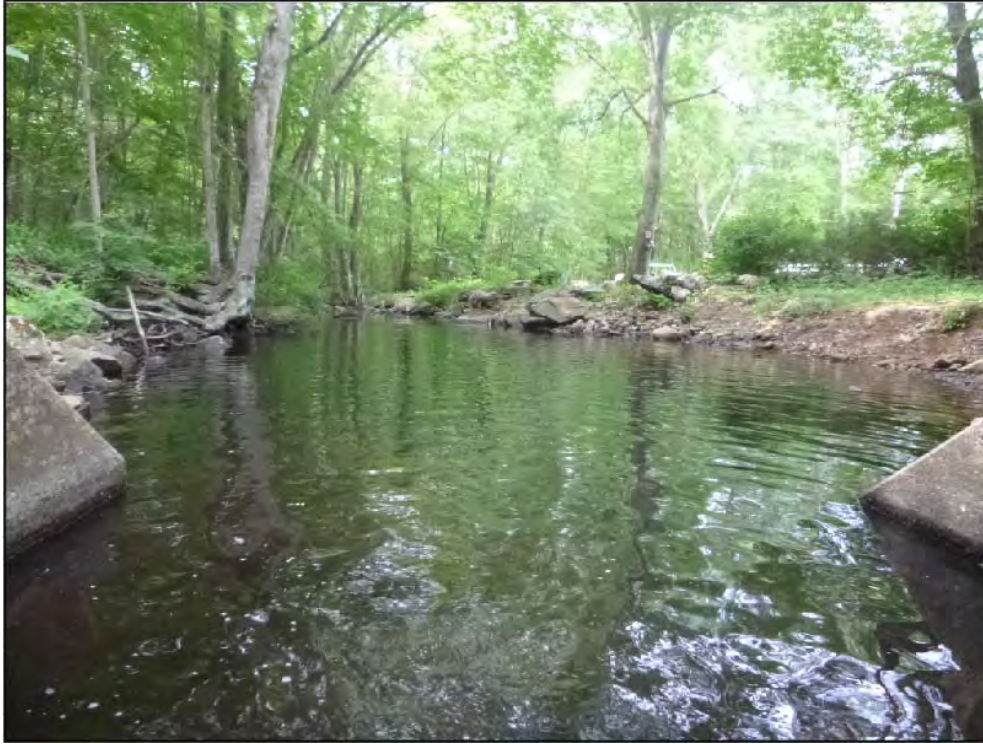
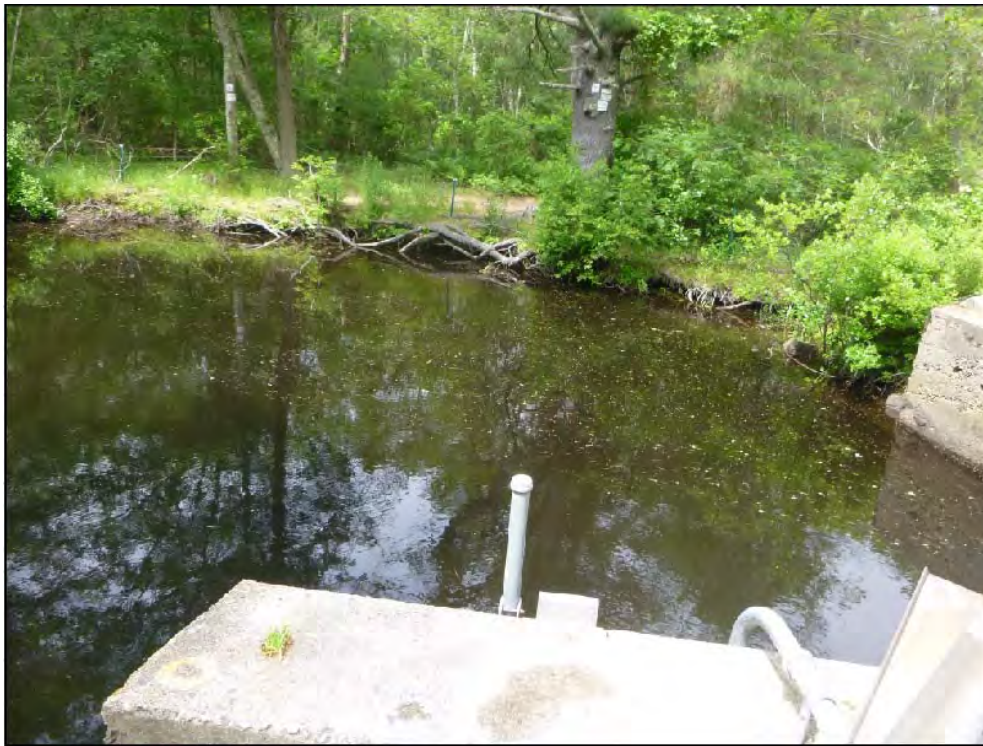
Figure 6. Scour of bed and banks downstream of a) Puttker Road on GAS-8 and b) Mail Road on QUS-11.

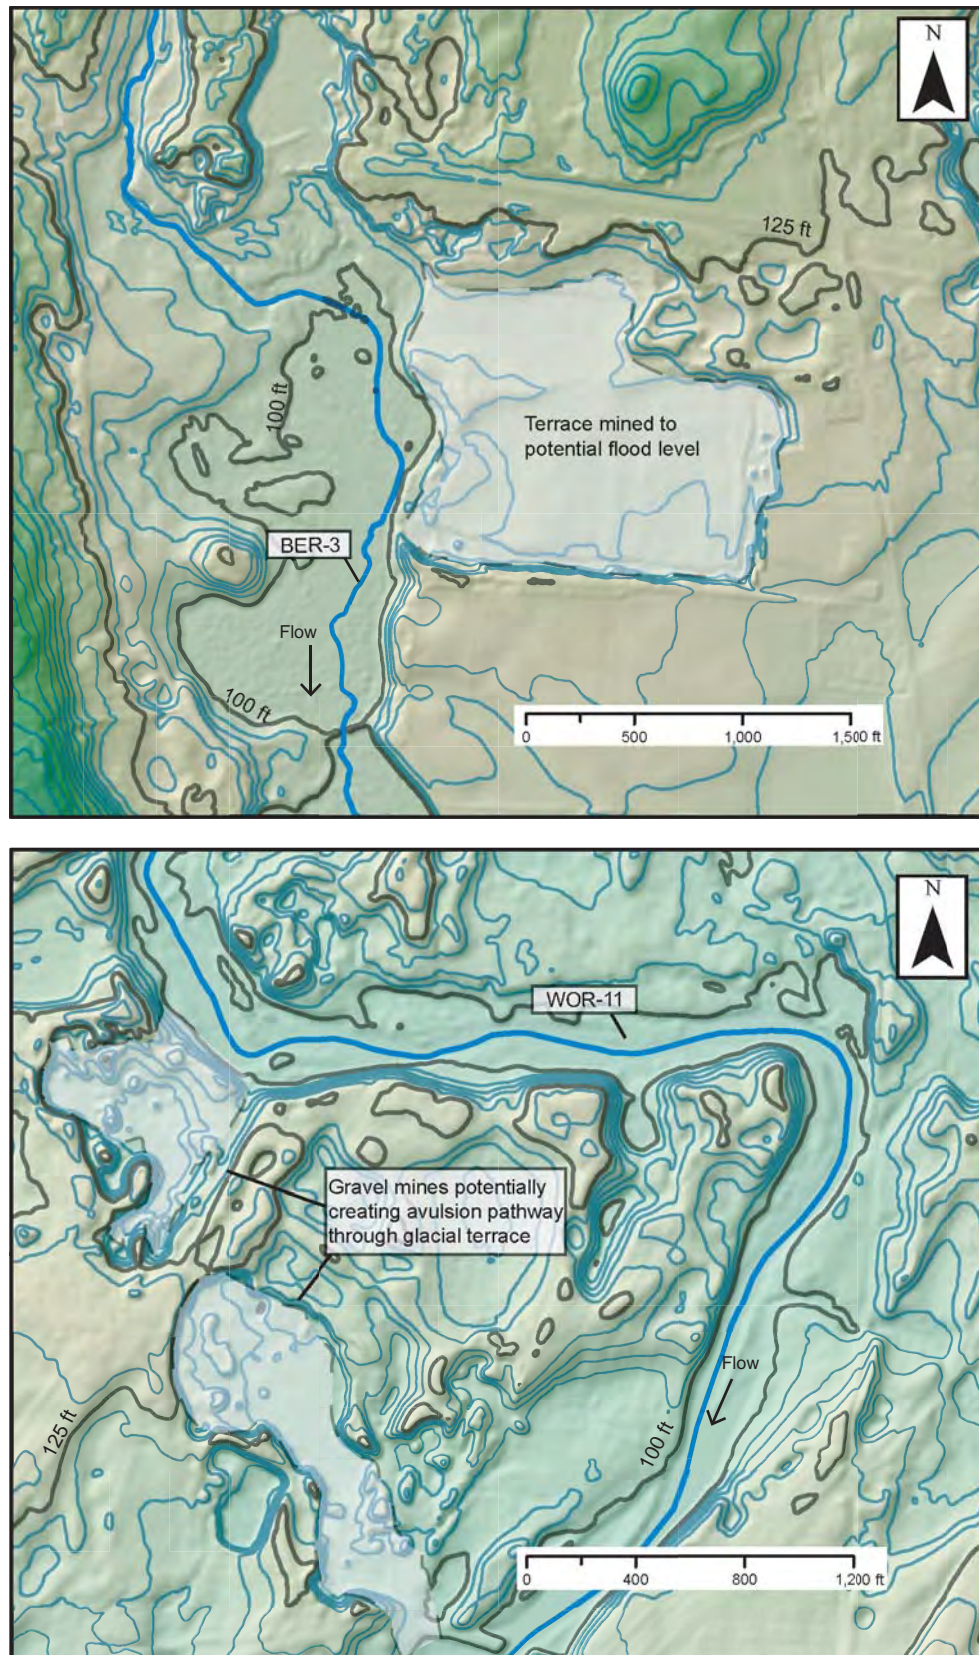
Figure 8. LiDAR shaded relief maps with 5-foot contours from 2011 RI 1-meter resolution dataset. Maps show two examples of gravel mining potentially effecting river corridor and geomorphic processes.

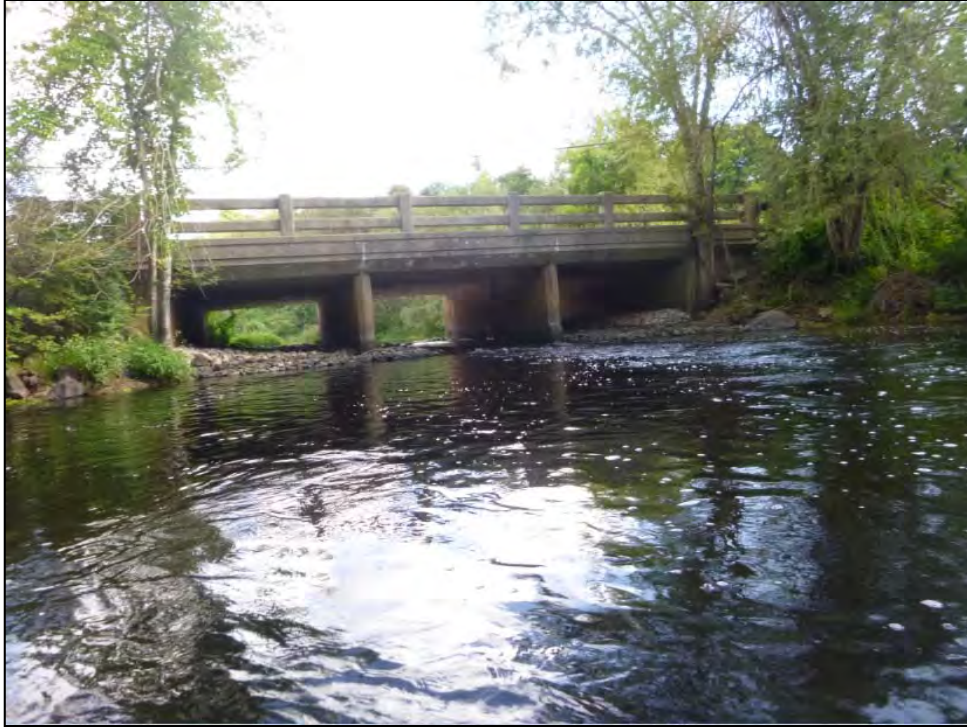
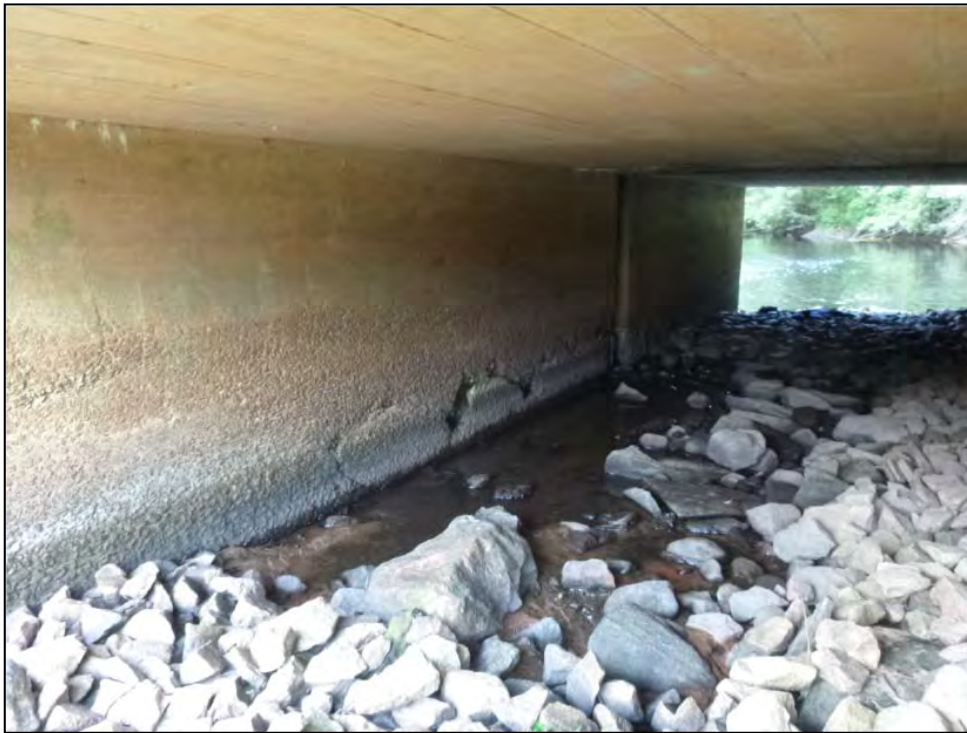
Figure 10. a) Downstream view of Old Shannock Road Bridge in PAR-23 and b) closeup of riprap placed on bed and scour of bridge pier in right bank cell.

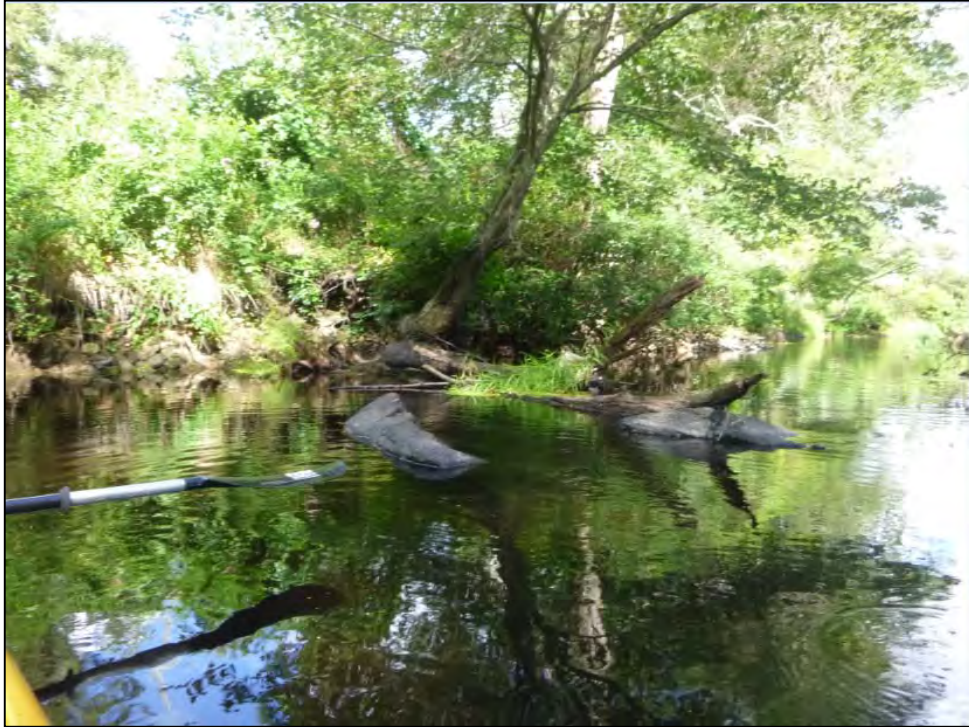
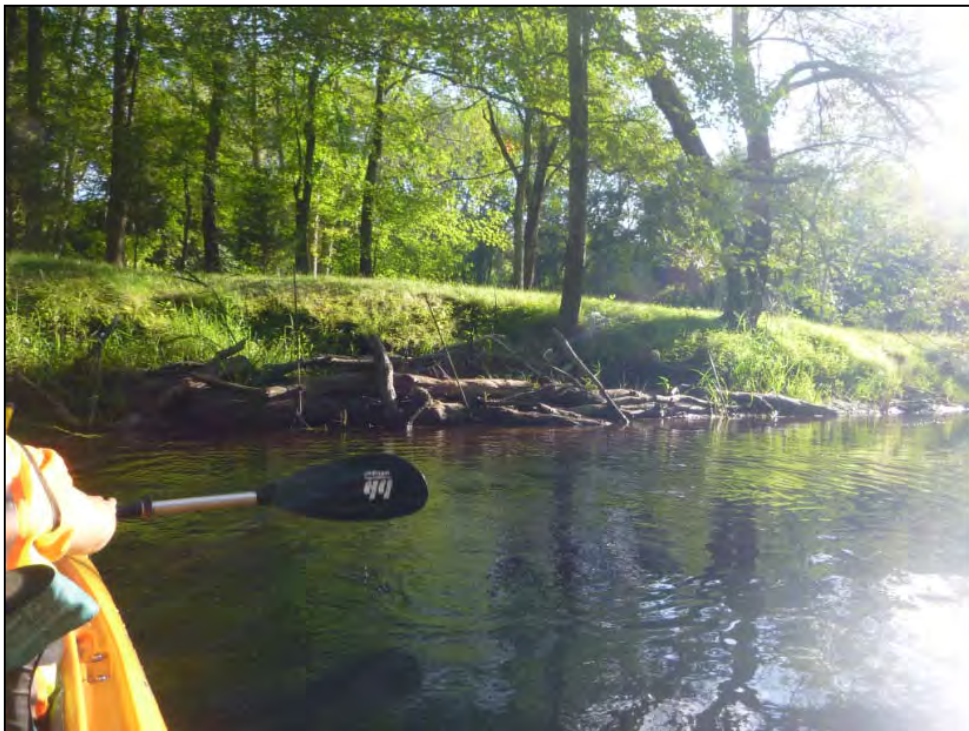
Figure 11. Previous bank restoration efforts in PAR-23 include a) boulder supported marginal log jam structure and b) toe wood revetment. Views looking downstream.

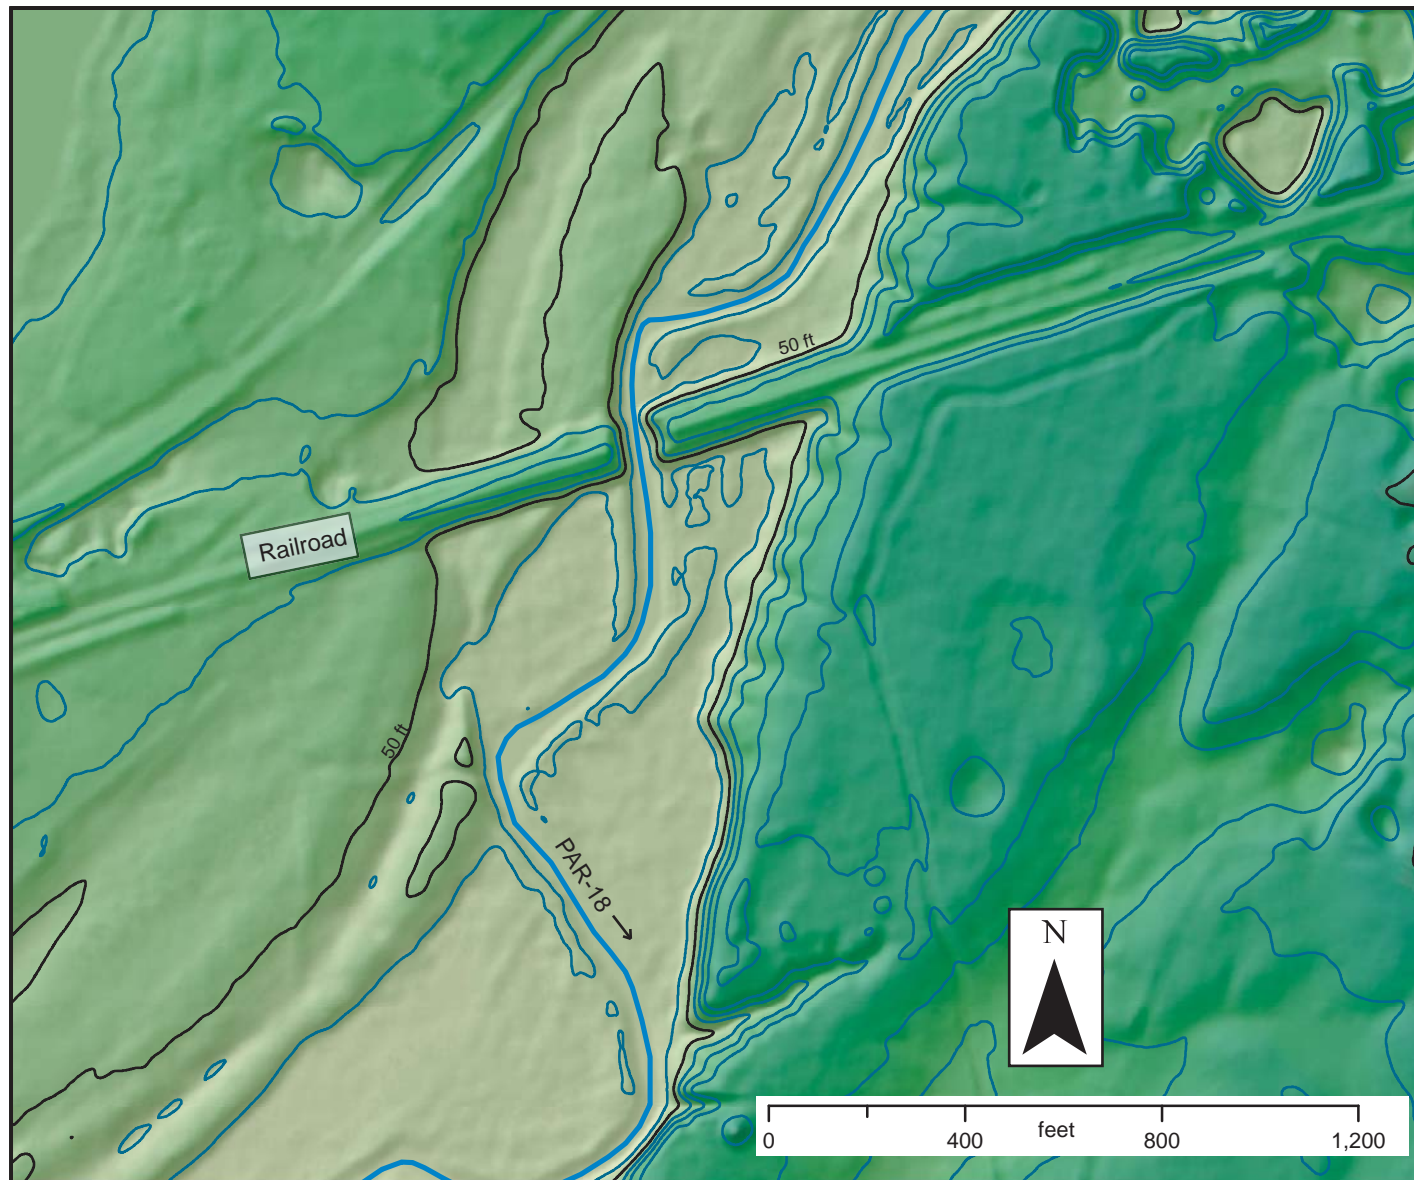
Figure 12. LiDAR shaded relief map of valley-constricting railroad fill in PAR-18. One-meter LiDAR is from 2011 RI statewide LiDAR dataset. Contours are in 5 ft intervals.

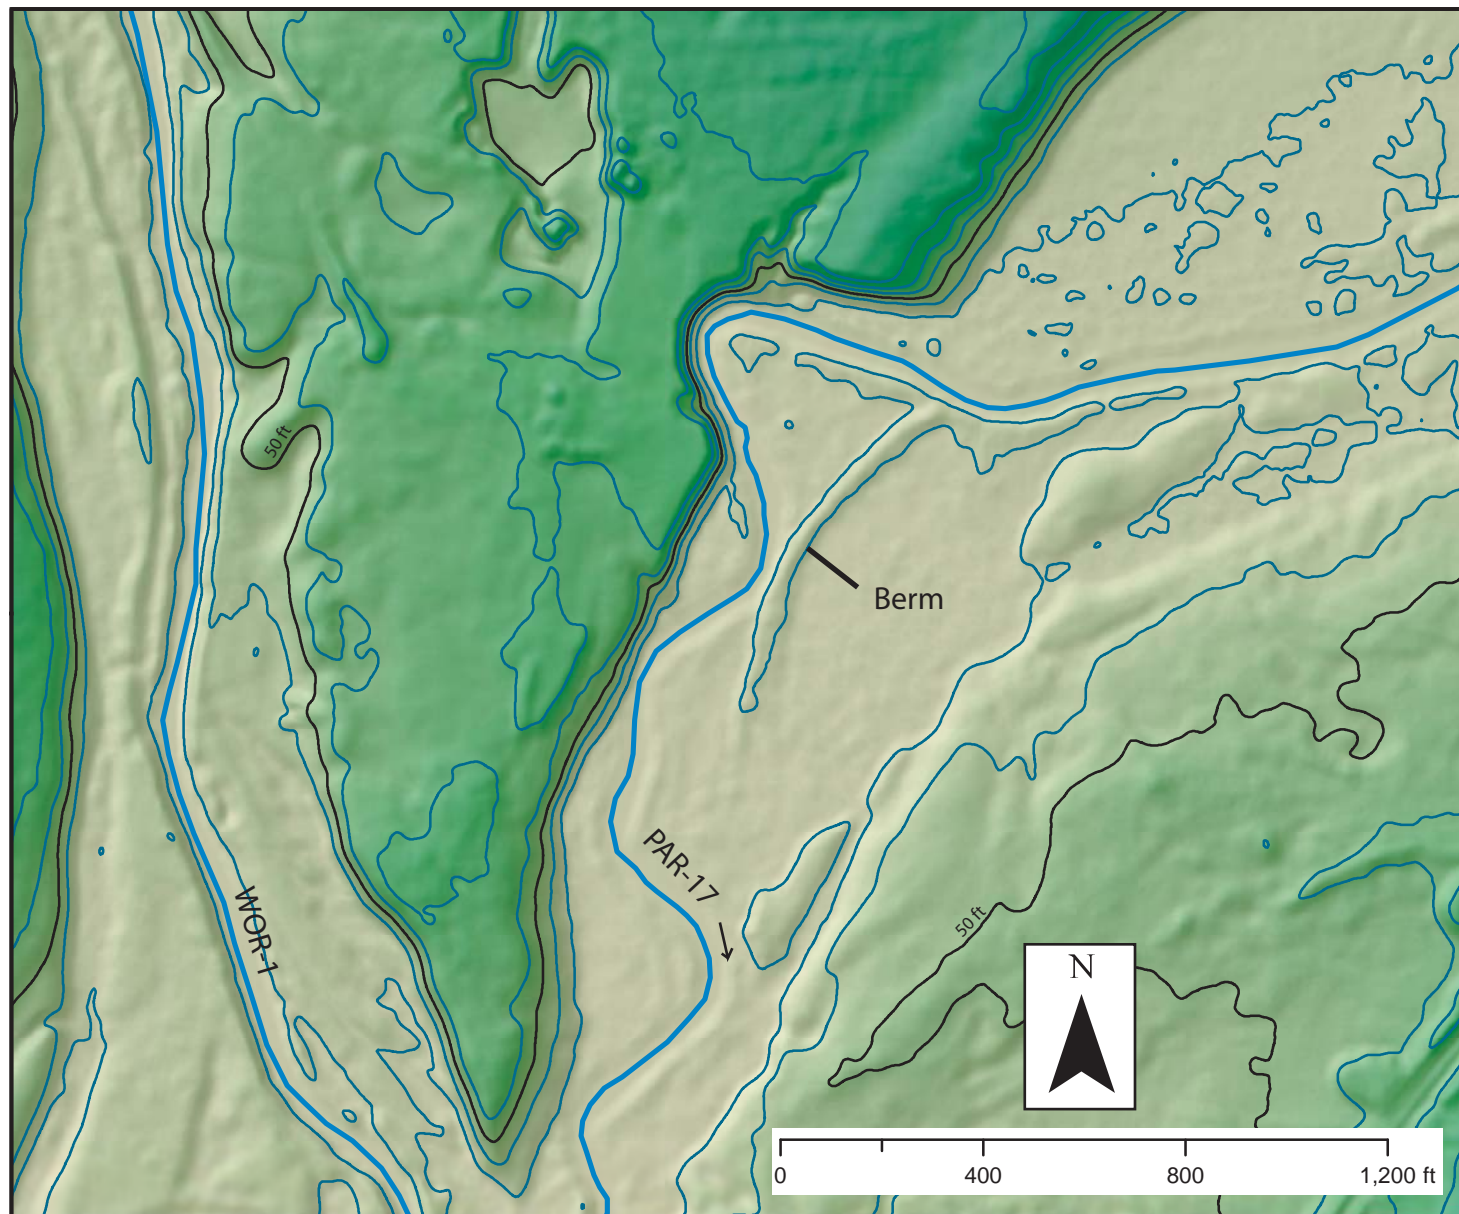
Figure 13a. LiDAR shaded relief map of of PAR-17 showing berm that runs along the left bank.

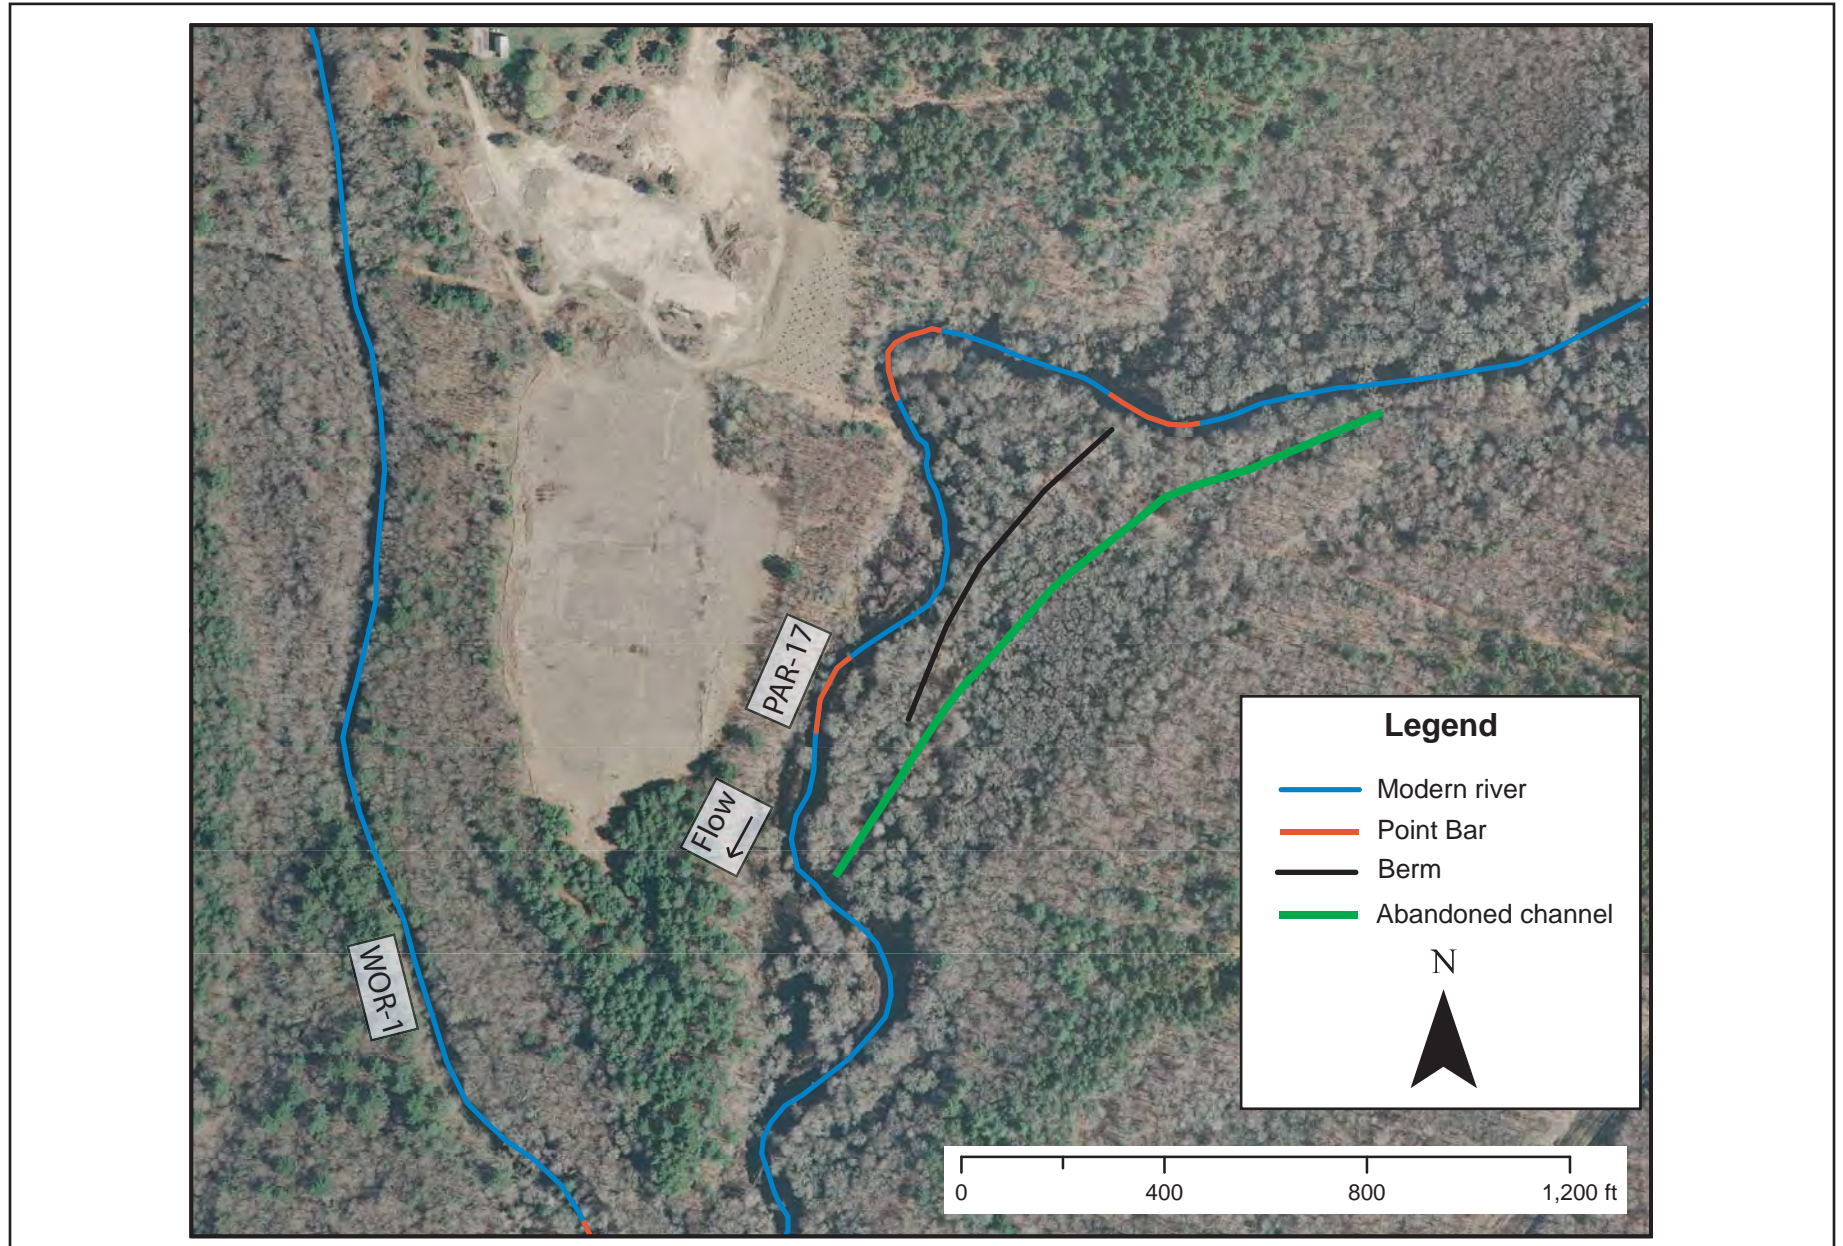
Figure 13b. Orthoimagery from 2012 showing PAR-17 with old berm, abandoned straightened channel, and point bars on modern river driving meander reformation.

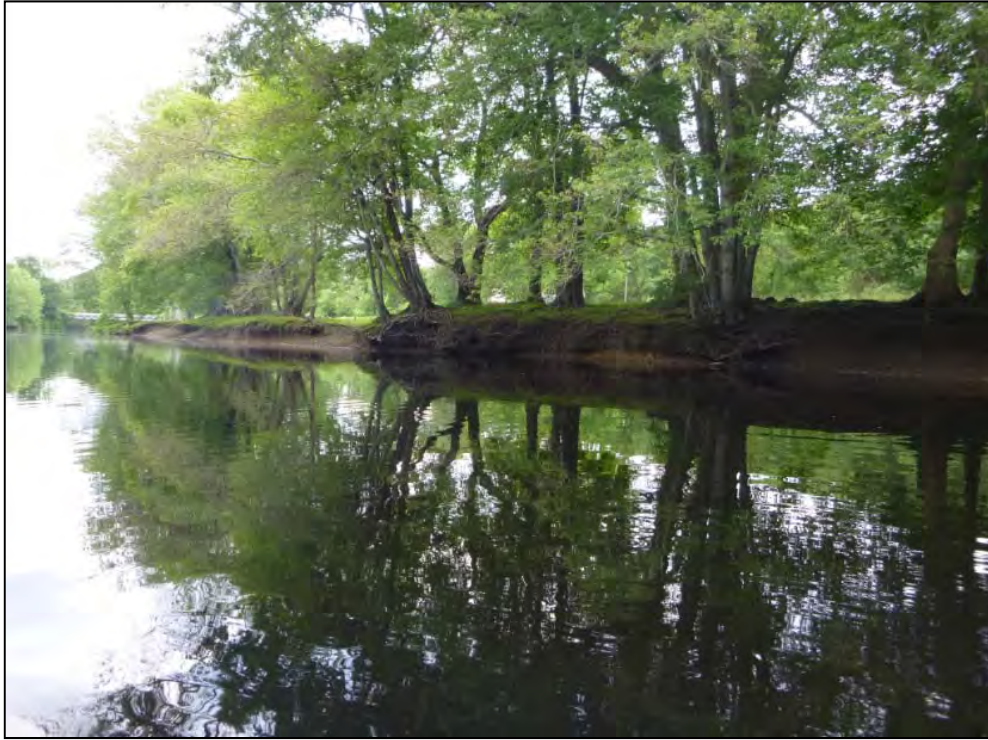
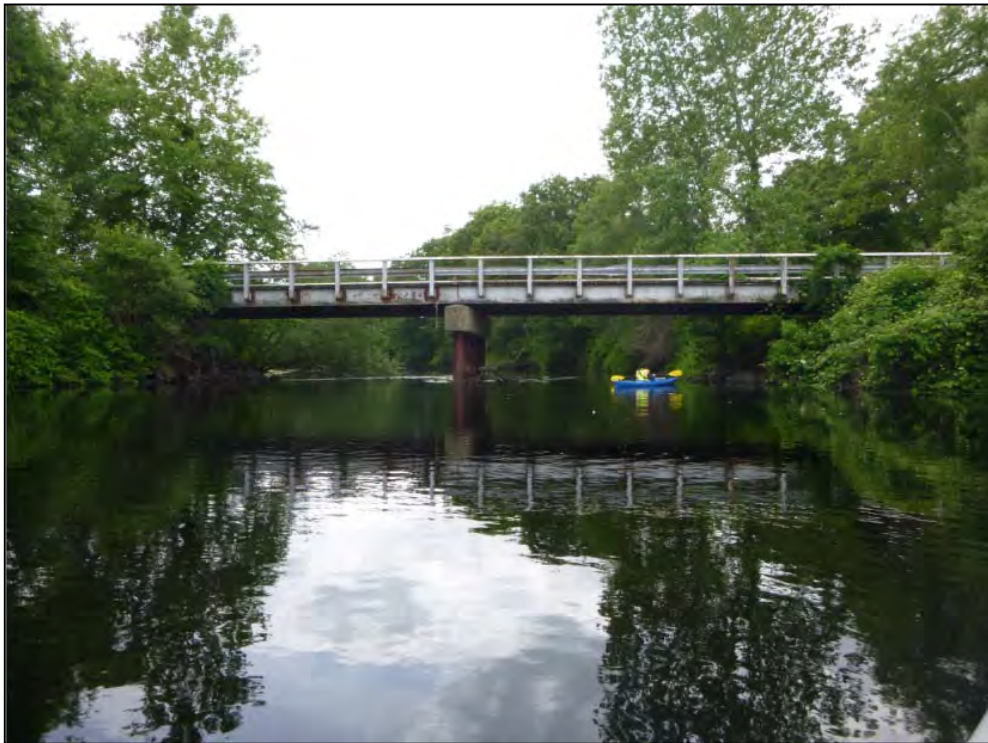
Figure 14. a) Scour on the inside of a meander bend upstream of Boom Bridge in PAR-6 and b) severe damage to Boom Bridge pier.

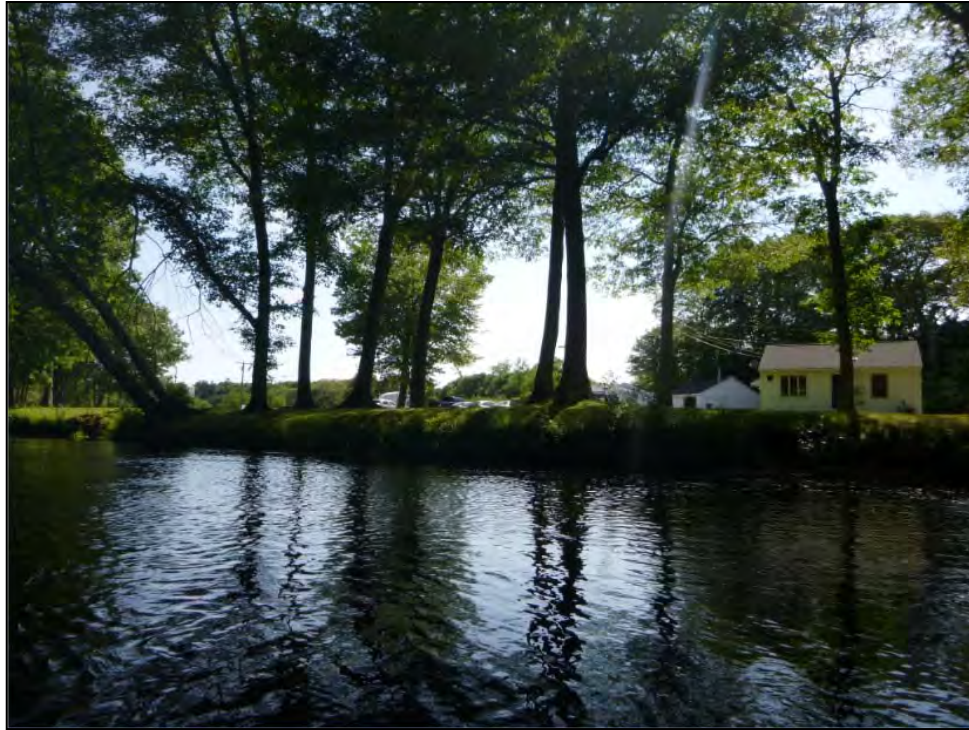
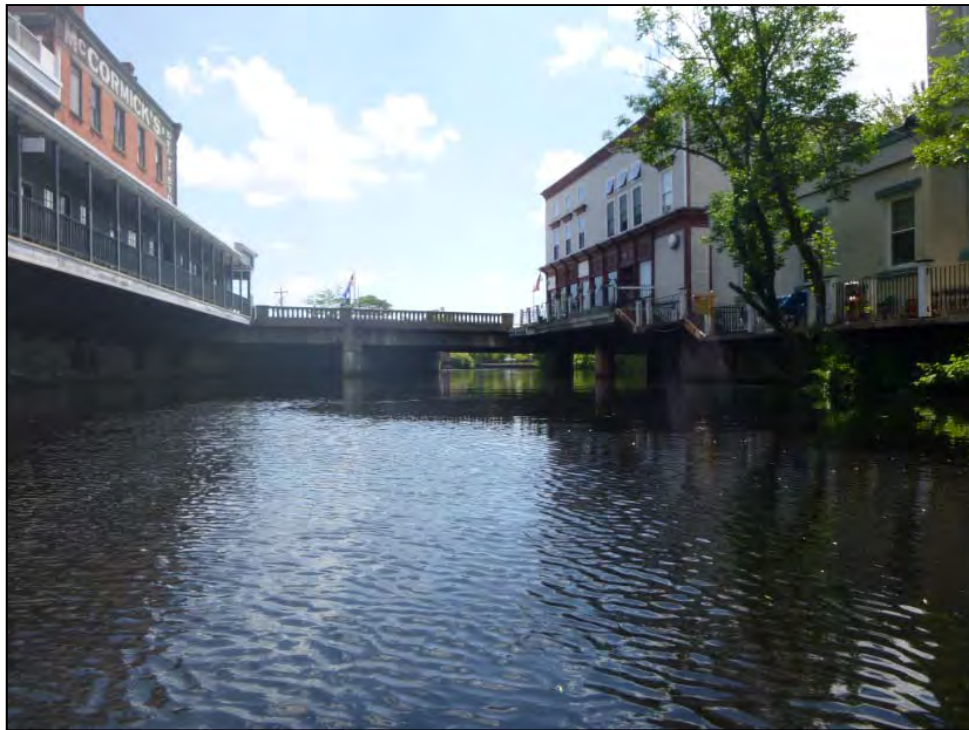
Figure 15. a) Insufficient riparian vegetation in PAR-3 and b) downstream view of lower PAR-1 where downtown Westerly completely encroaches on the channel.

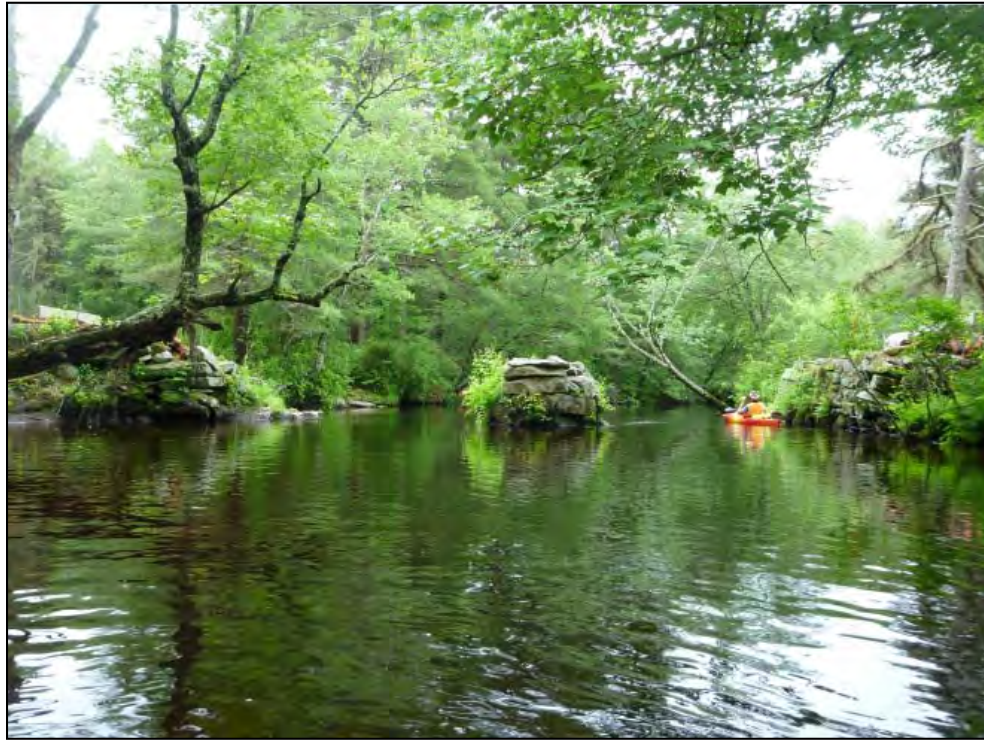
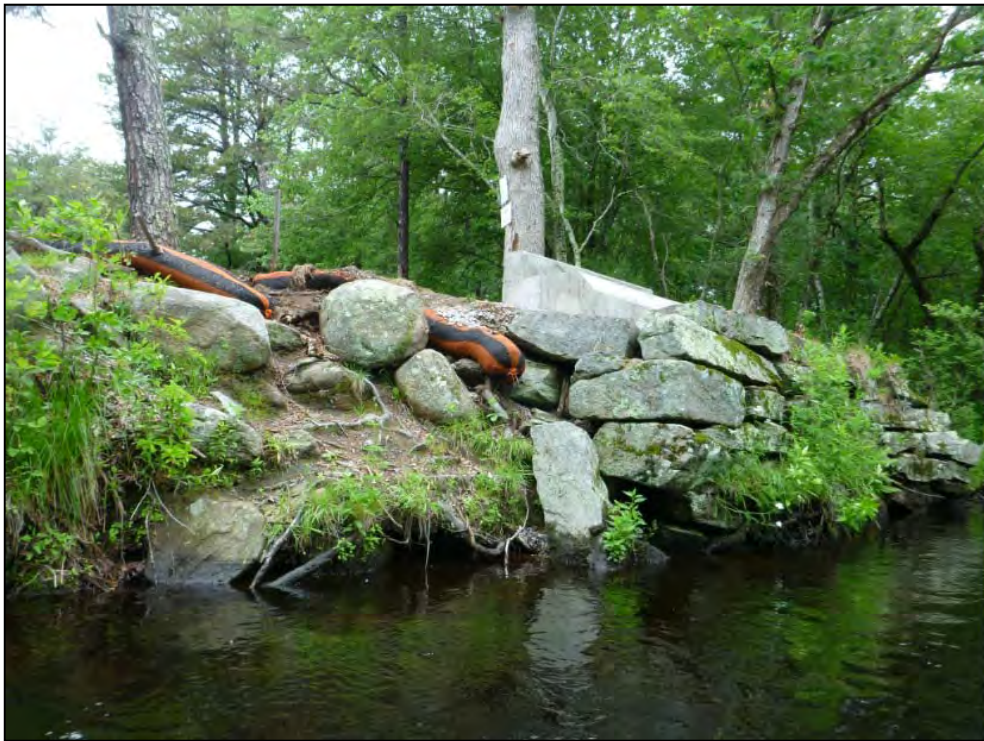
Figure 16. a): Downstream view of old abutments constricting channel in WOR-16 and b) right bank view of bank erosion due to abutments.
