# **Fluvial Geomorphic Assessment and River Corridor Planning in the Wood-Pawcatuck Watershed, RI and CT**

Prepared for  
Wood-Pawcatuck Watershed Association  
Hope Valley, RI

Prepared by  
John Field  
Field Geology Services  
Farmington, ME

March 2016

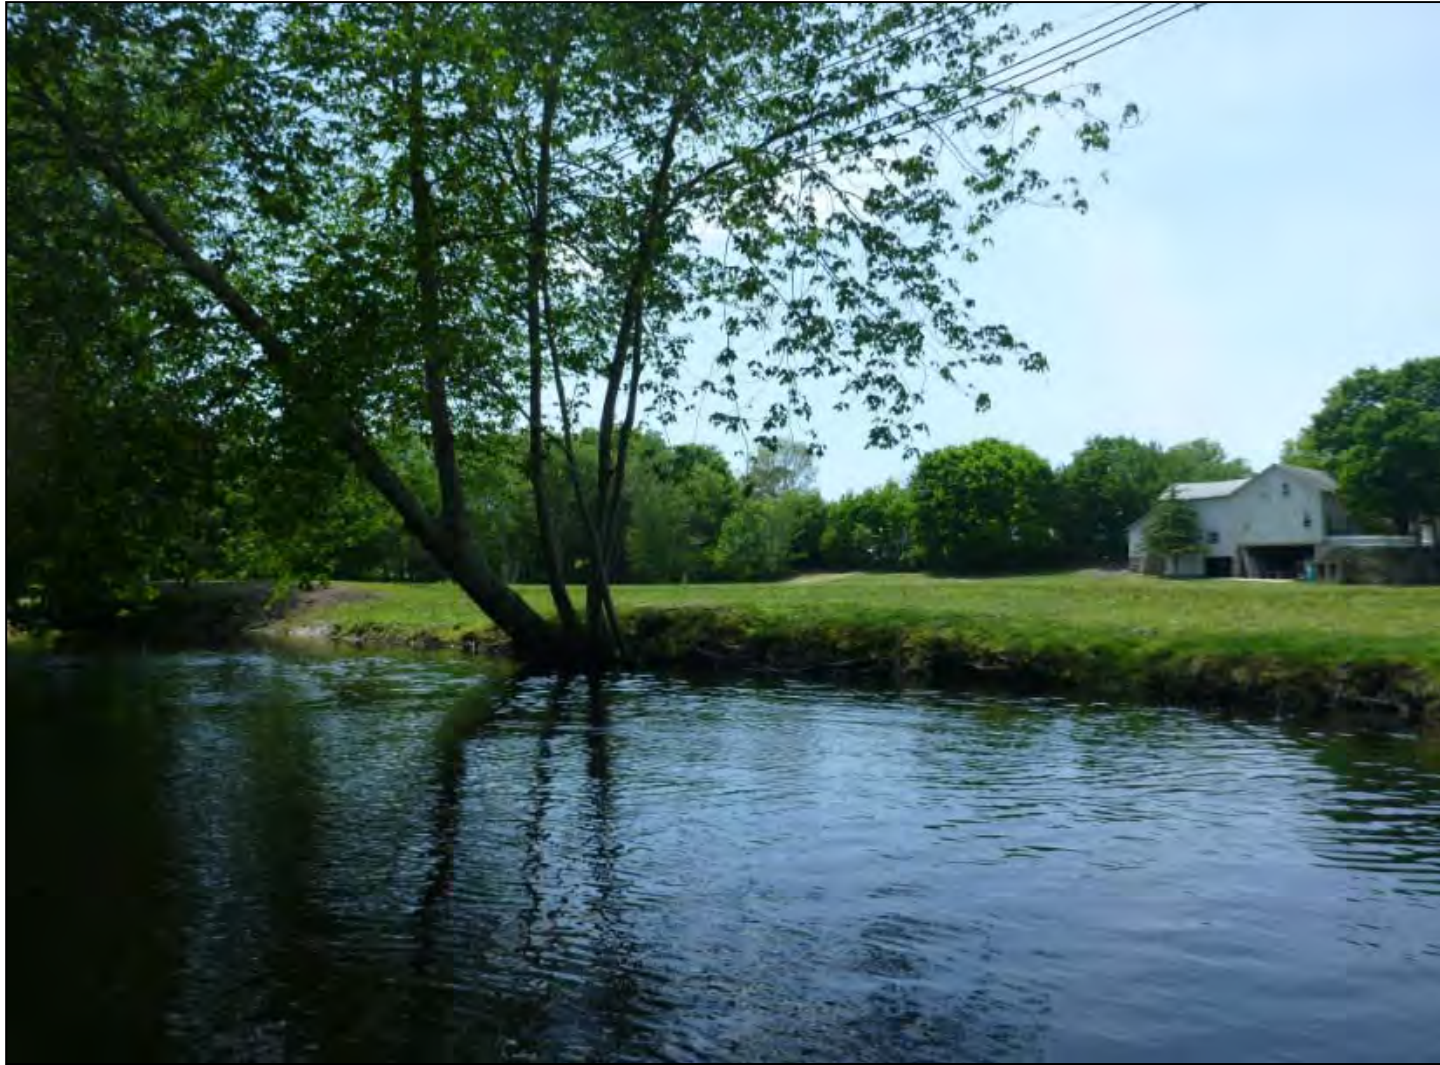
Figure 17. Right bank view of insufficient vegetation on bank in WOR-9.

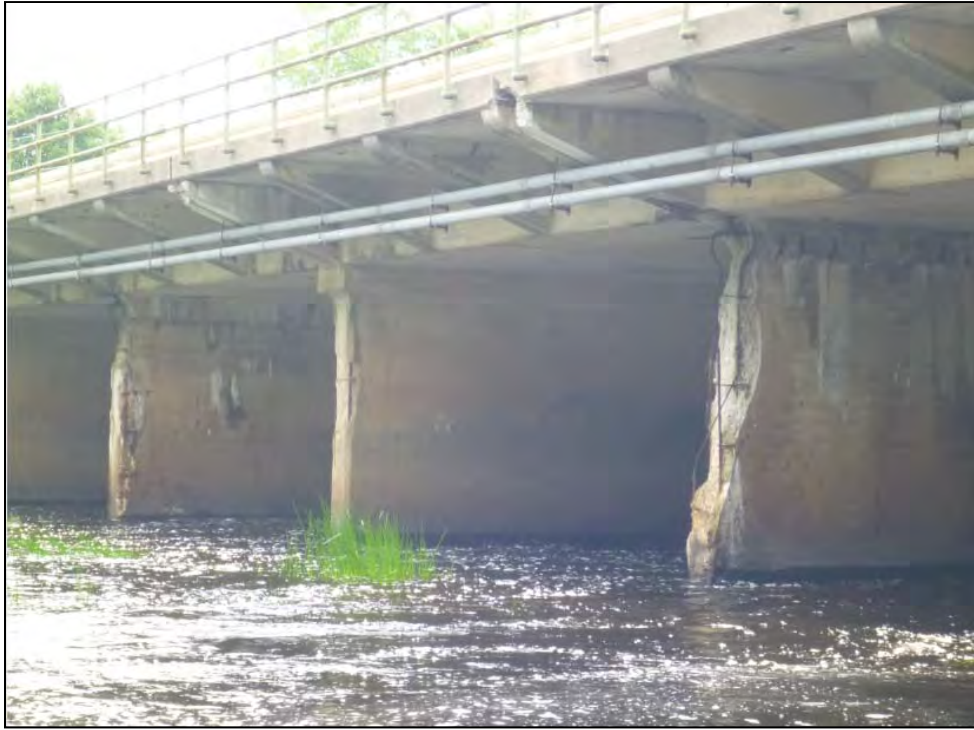
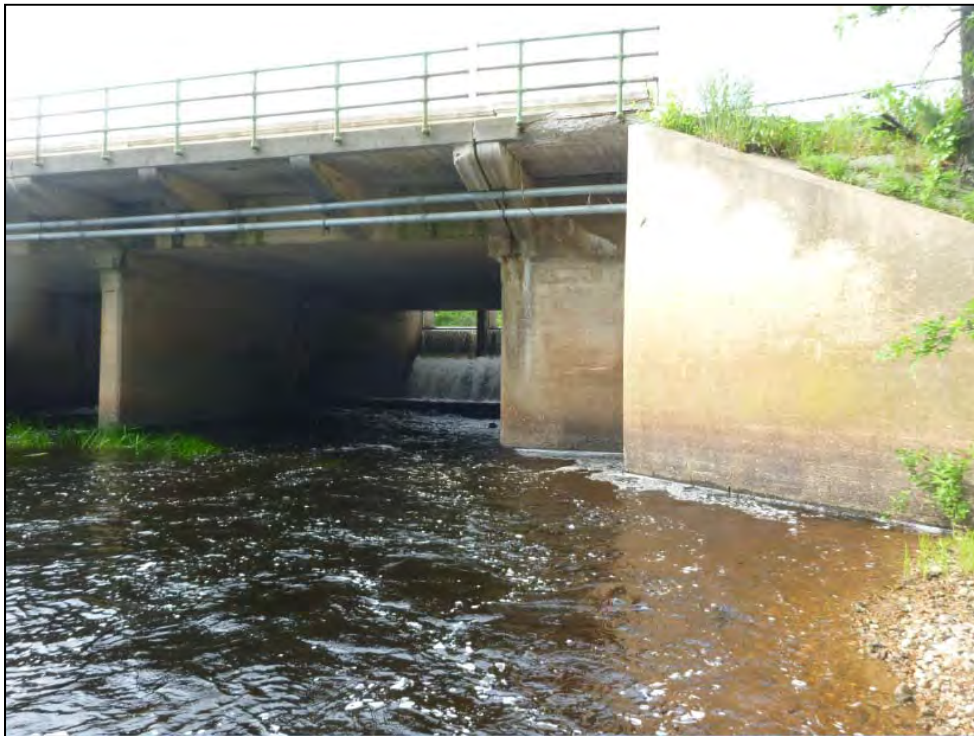
Figure 18. Route 91 Bridge and Alton Dam in WOR-1 showing a) right bank view of pier scour and b) dam underneath bridge.

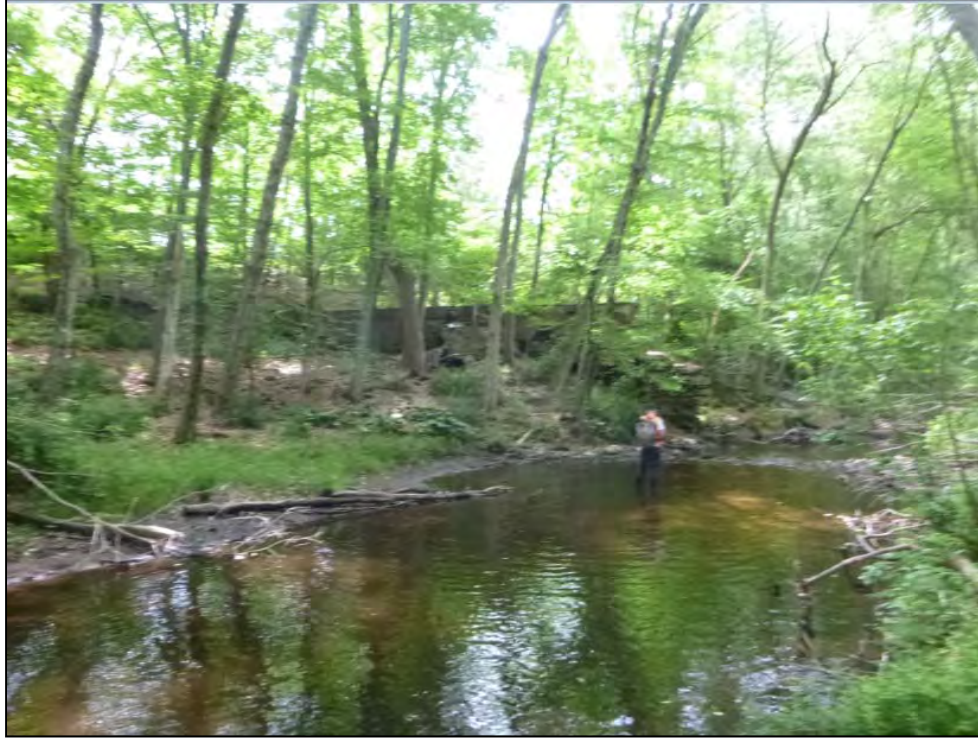
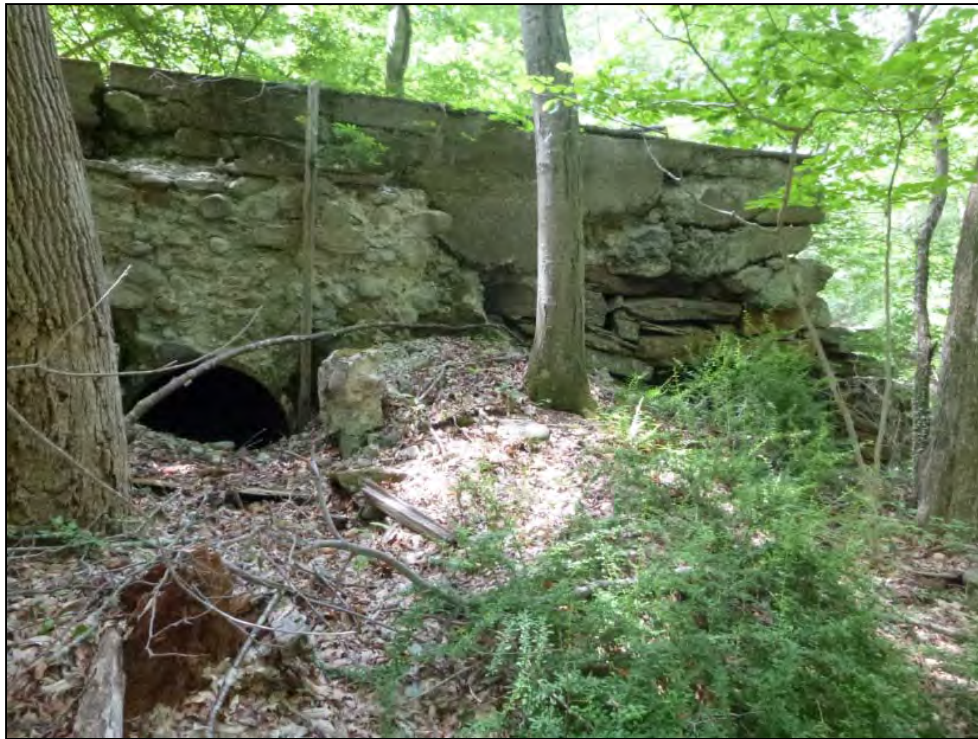
Figure 19. Old dam structure on left bank of GAS-8 showing a) downstream view of structure and b) close up of mill race intake.

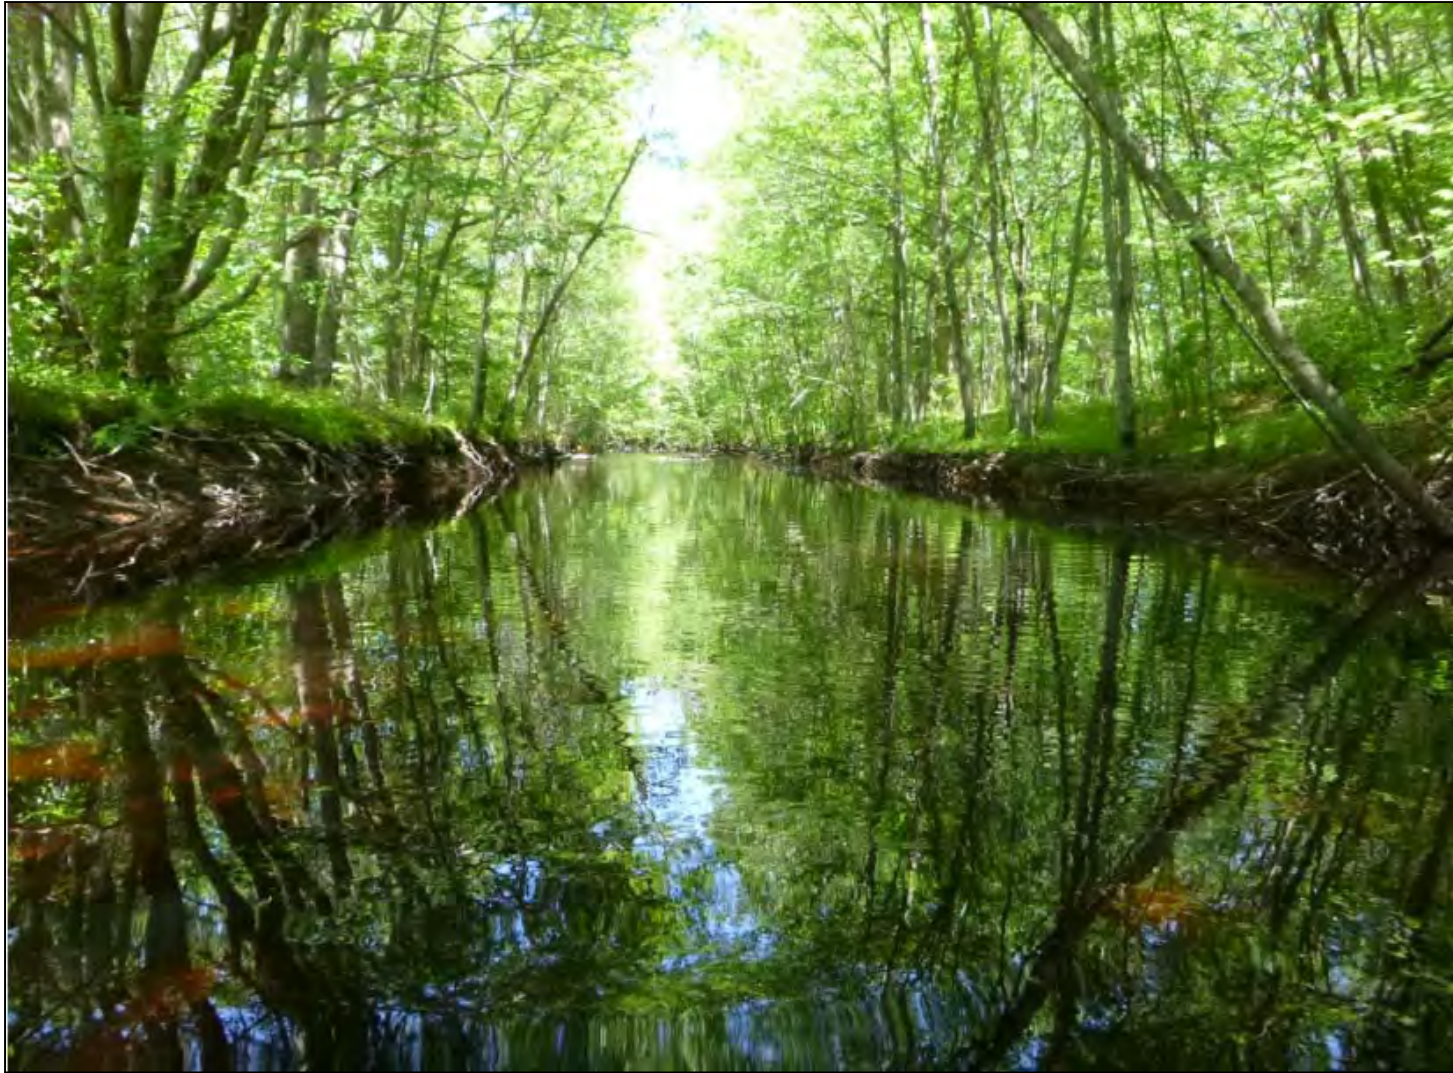
Figure 20. Upstream view of artificially straightened channel in GAS-4.

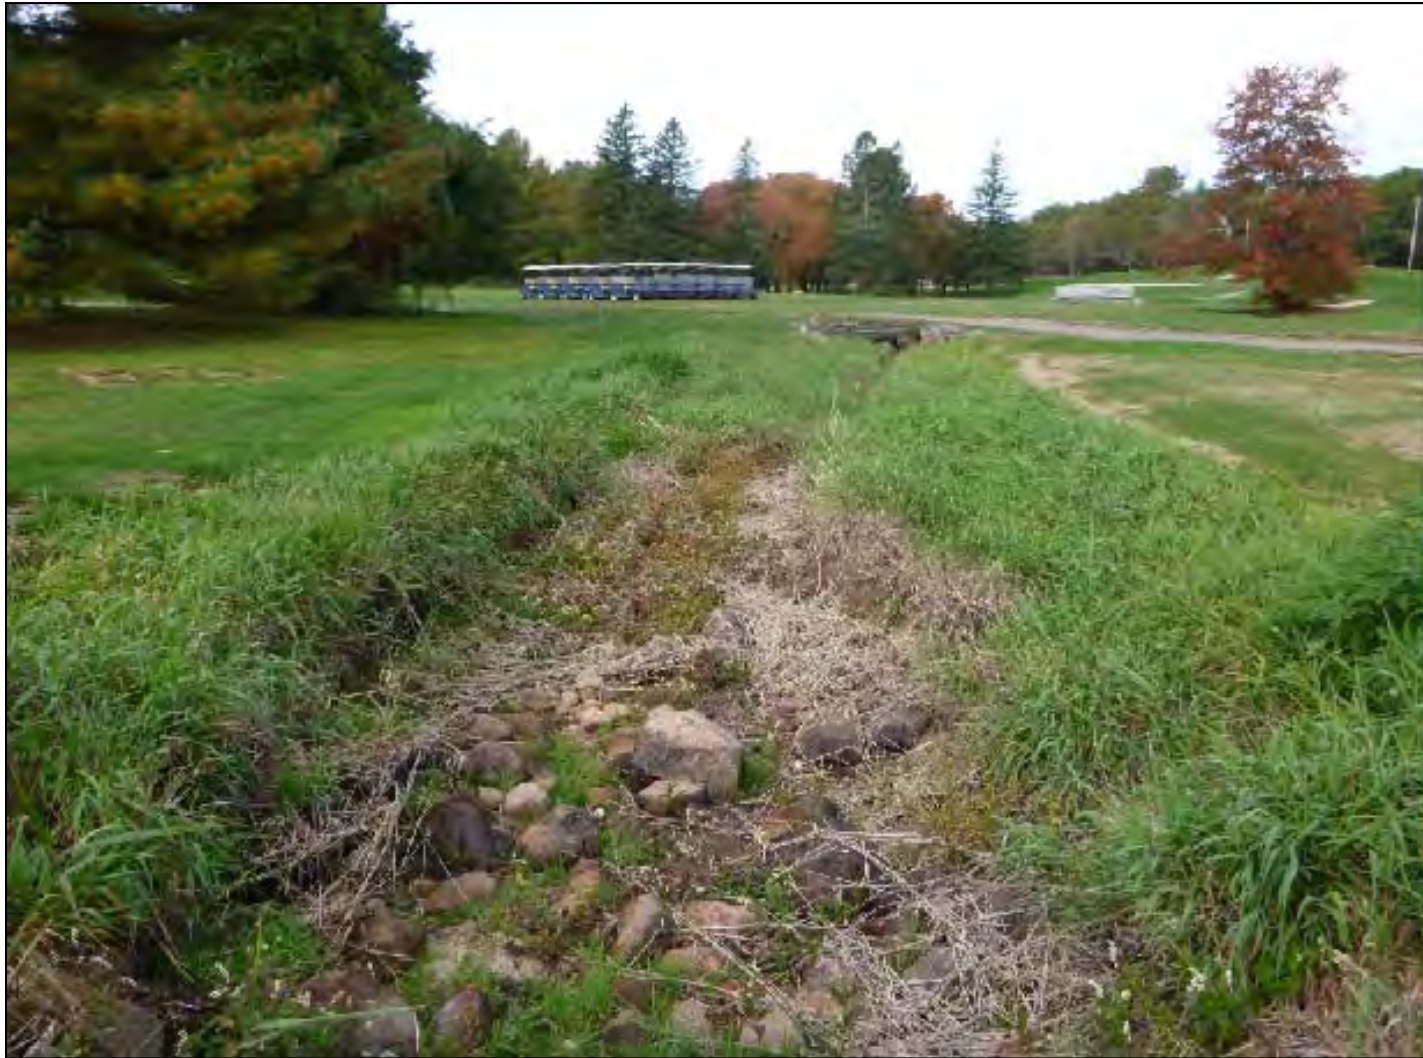
Figure 21. Absence of riparian vegetation and poorly formed channel on golf course in MEB-8b.

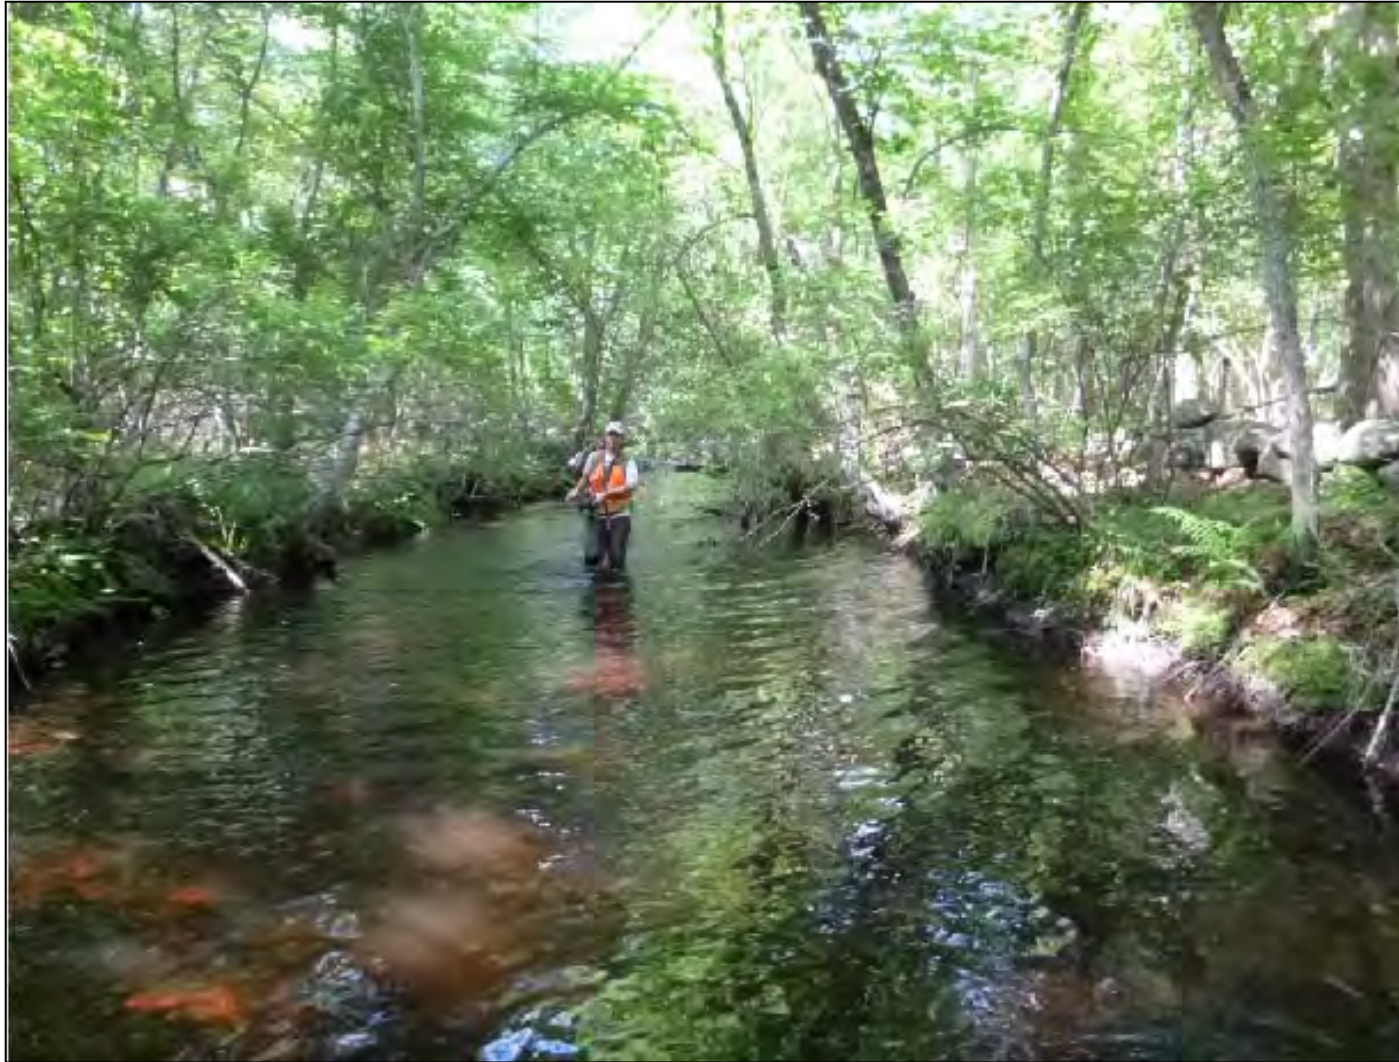
Figure 22. Upstream view of straightened channel with an old berm on the right bank of BER-6a.

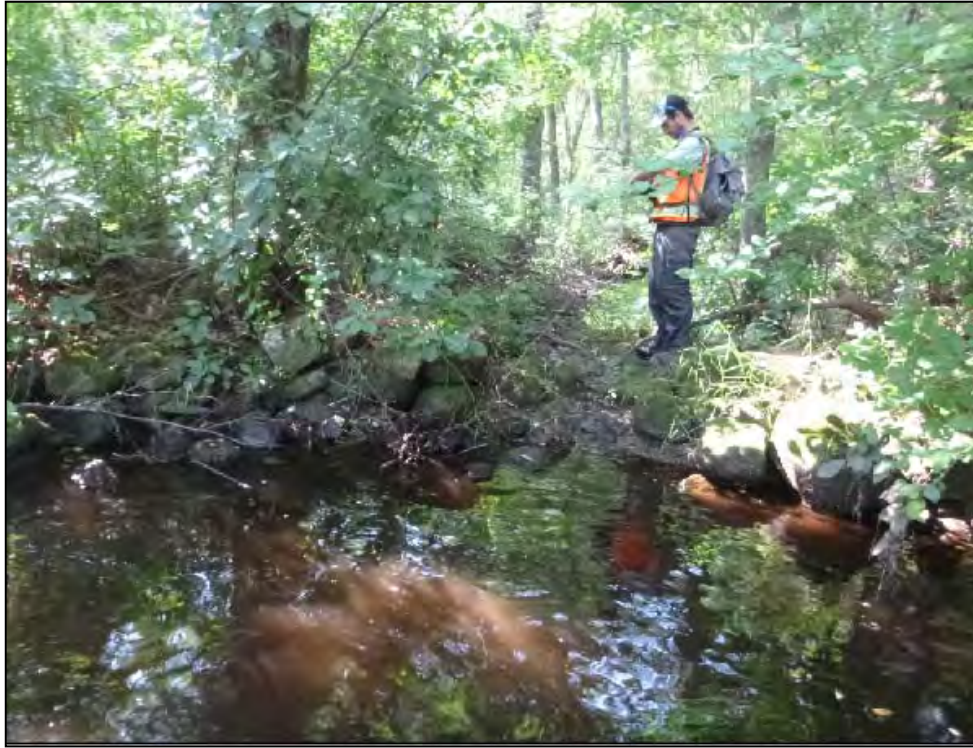
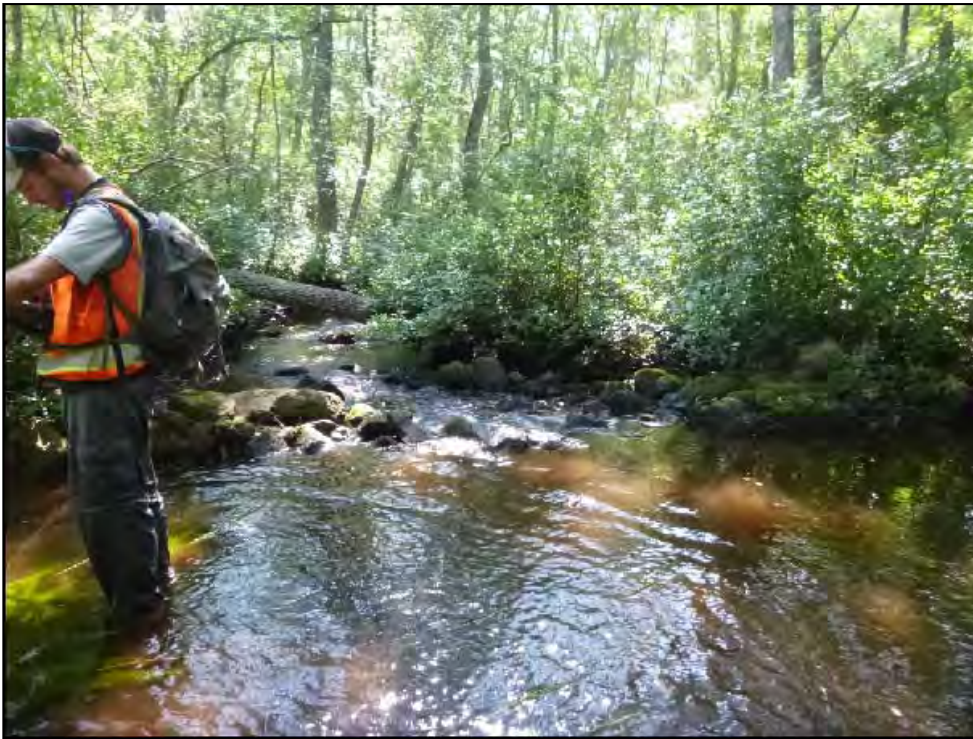
Figure 23. BER-3b showing a) old mill race channel that is now a flood chute and b) downstream view of modern stream flowing over old mill dam structure.

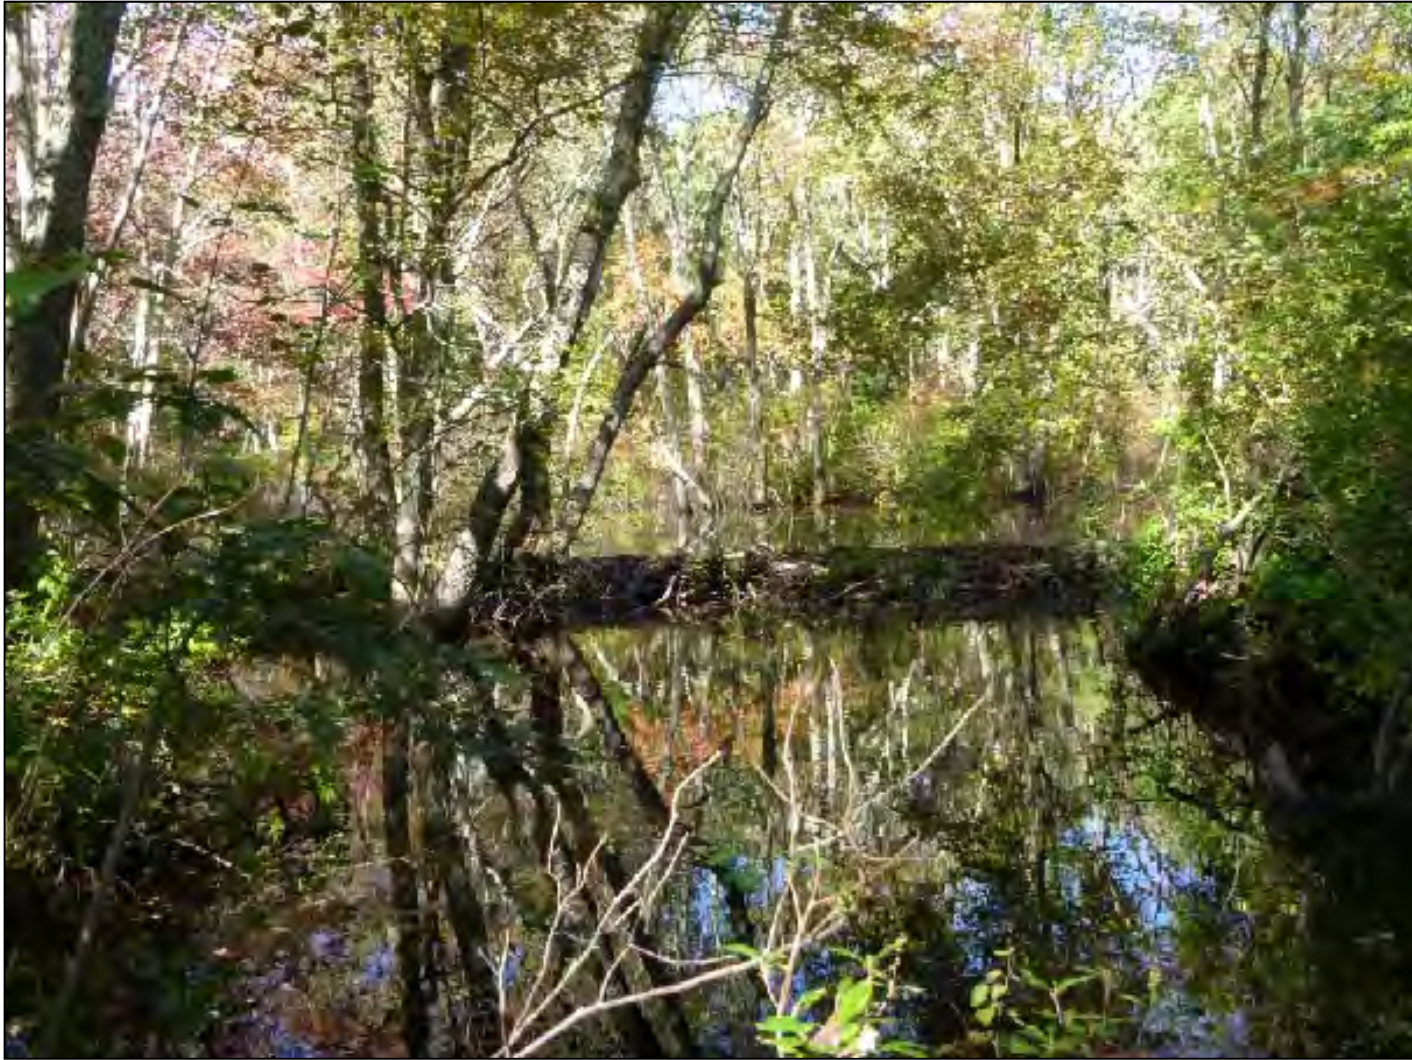
Figure 24. Active beaver dam in BER-2.

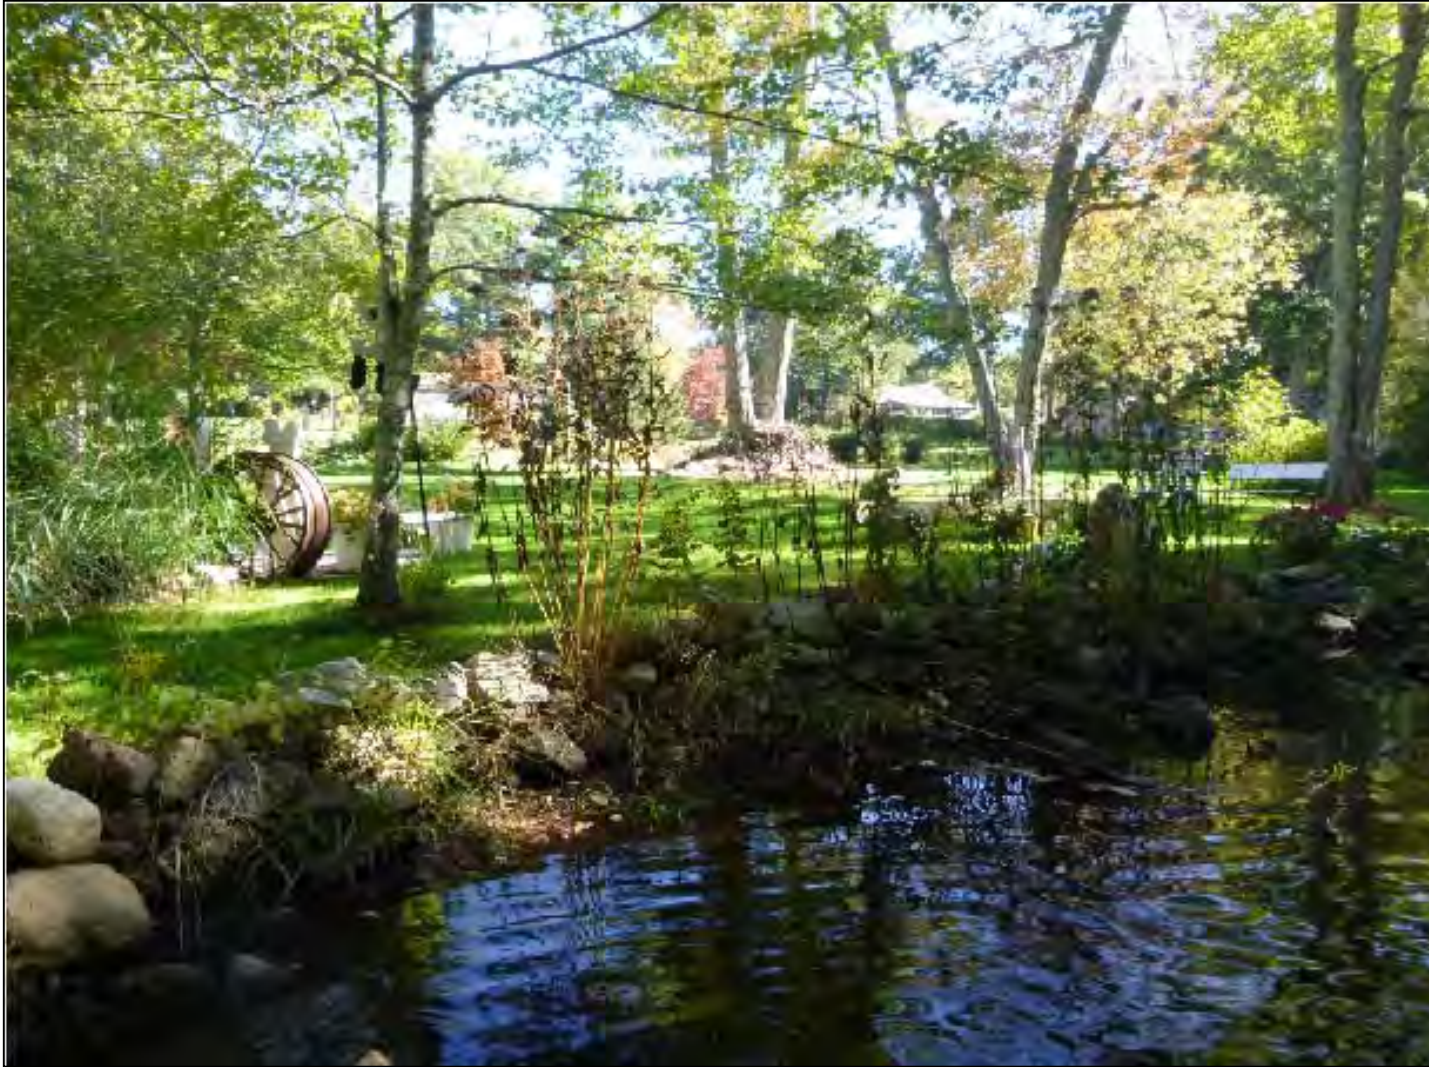
Figure 25. Bank armor on bank with insufficient riparian vegetation on the left bank of CHIP-10.

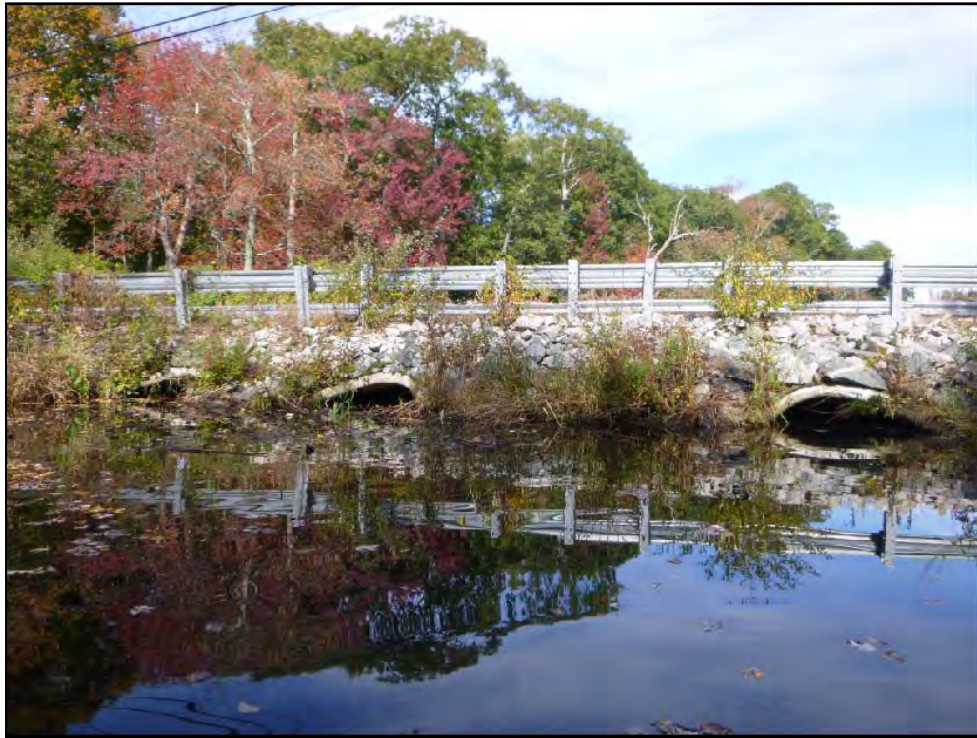
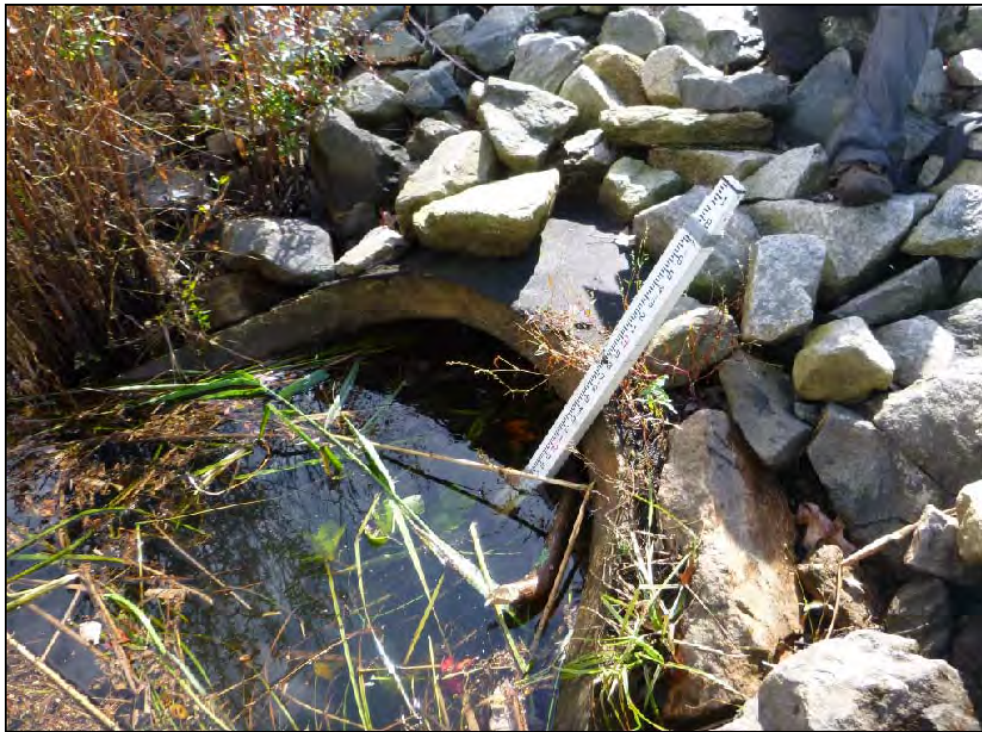
Figure 26. Undersized culvert at Yawgoo Valley Road in CHIP-8 showing a) upstream view of entire crossing and b) close up of beaver dam clogging culvert inlet.

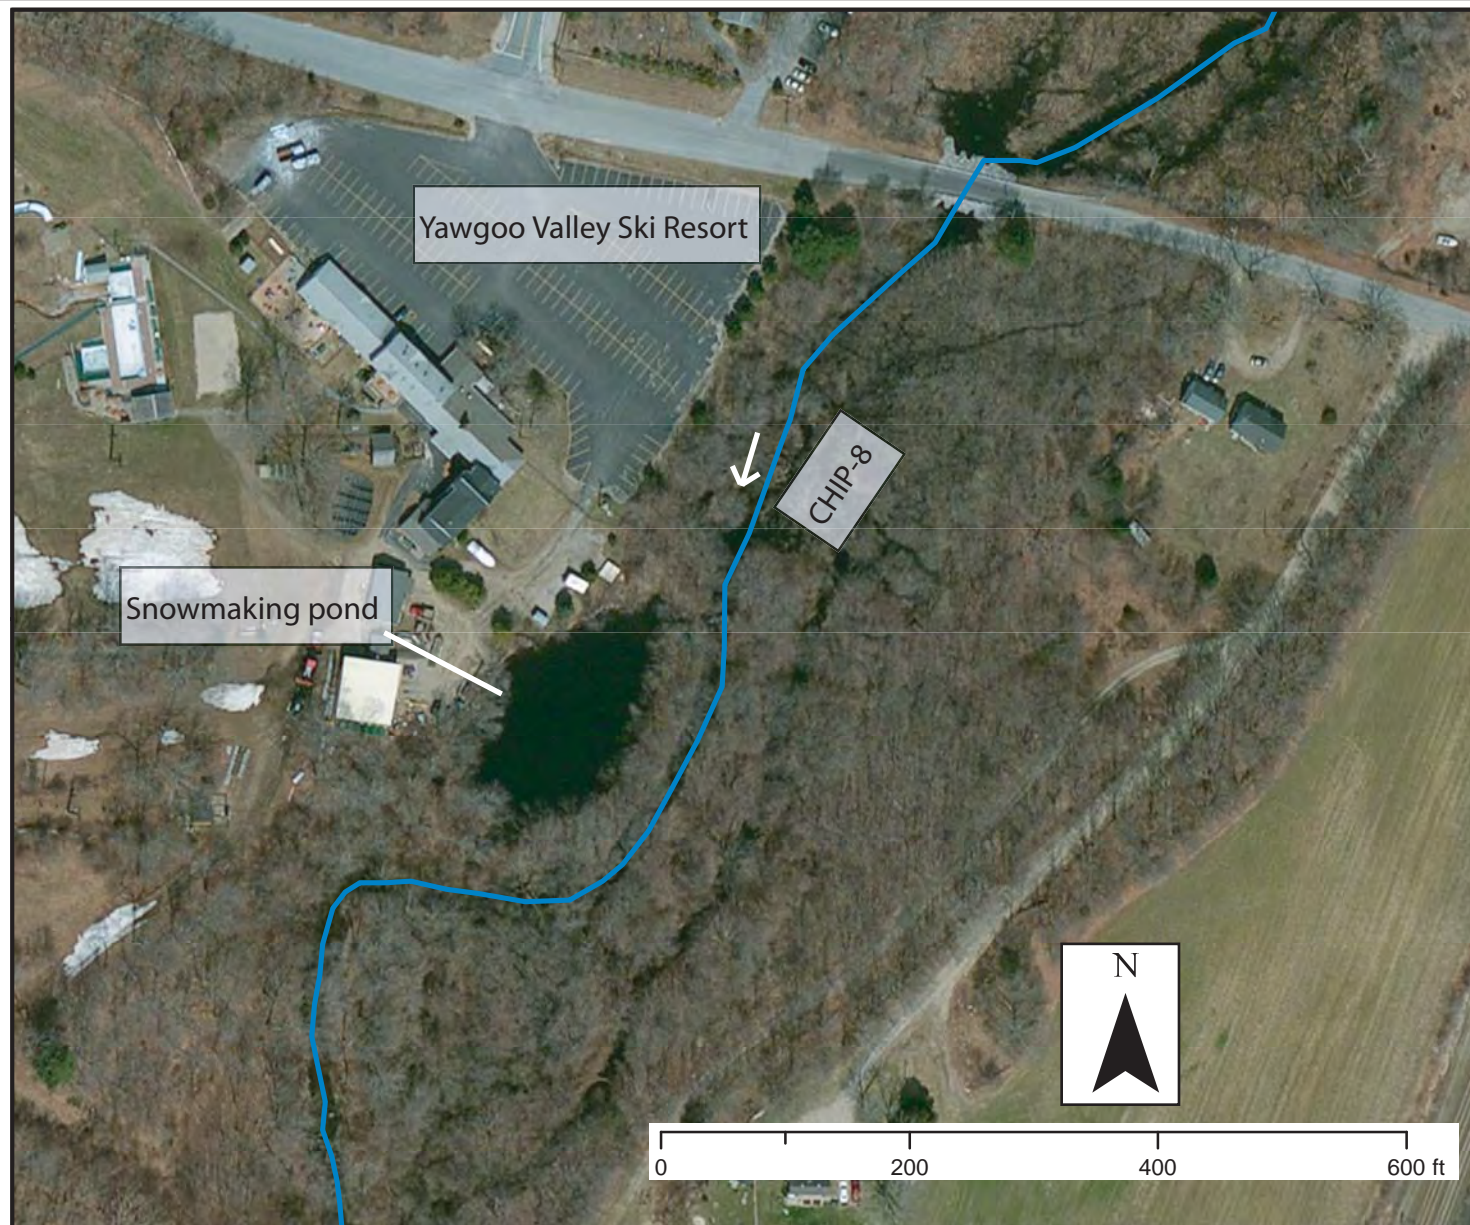
Figure 27. Aerial photograph showing a snowmaking pond that could potentially be an avulsion pathway in a dynamic section of CHIP-8.
