PAR21B - Upper Pawcatuck River

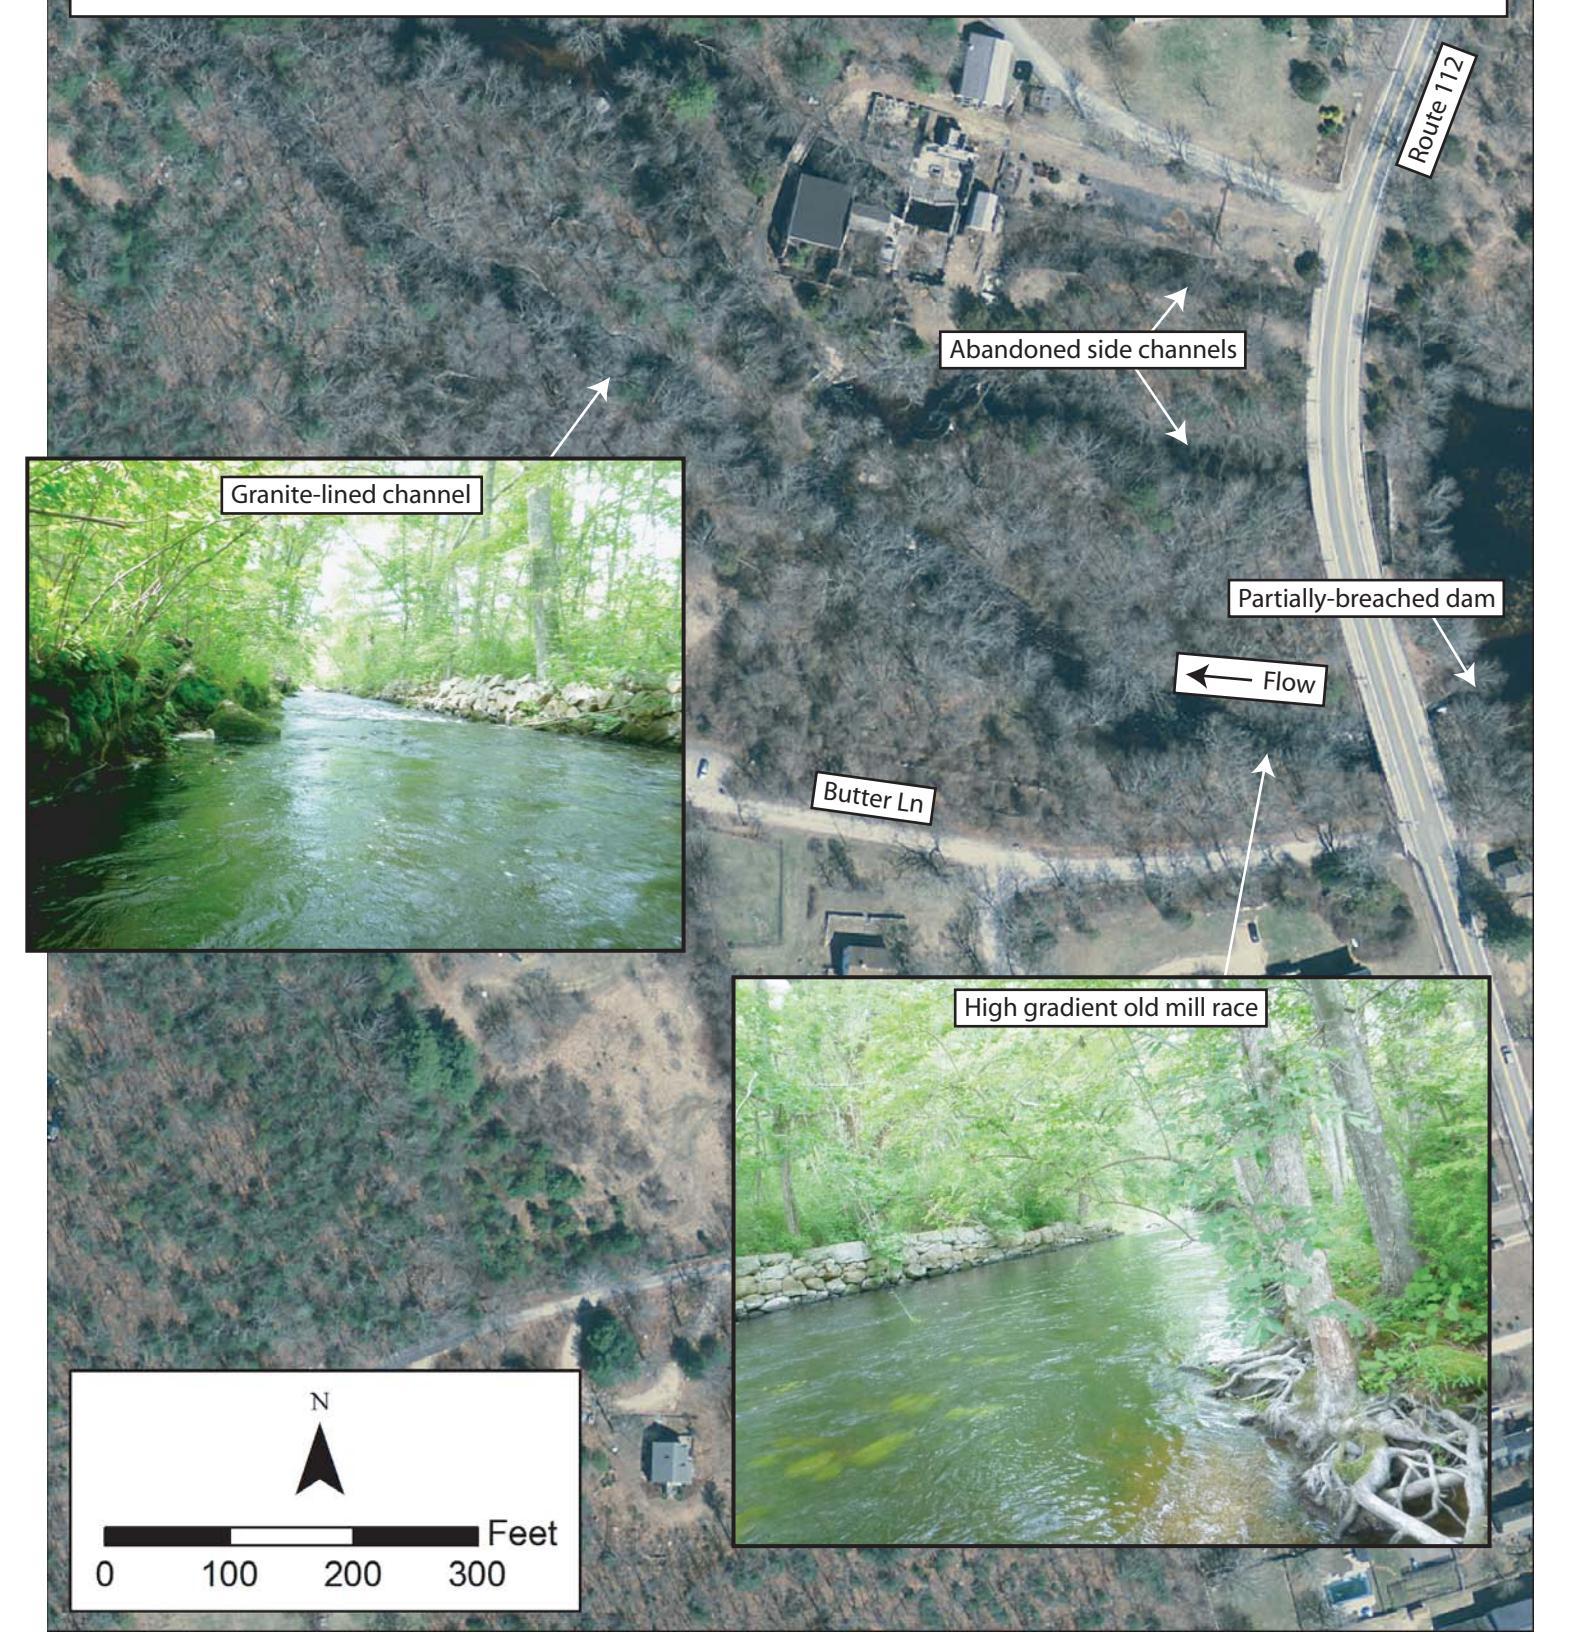
Pawcatuck River occupies steep straight mill race channel in village of Carolina. Channel banks are built of granite blocks which confine the channel and cut off side channel access. Upstream, the impoundment is maintained by a partially breached dam, which only allows water to flow down the left mill race channel leaving the others largely dry. Propose breaching granite bank / berm (removing floodplain obstruction) and potentially using some of the blocks in the construction of instream structures. Given the gradient any wood added to the stream will require anchoring to minimize mobility.

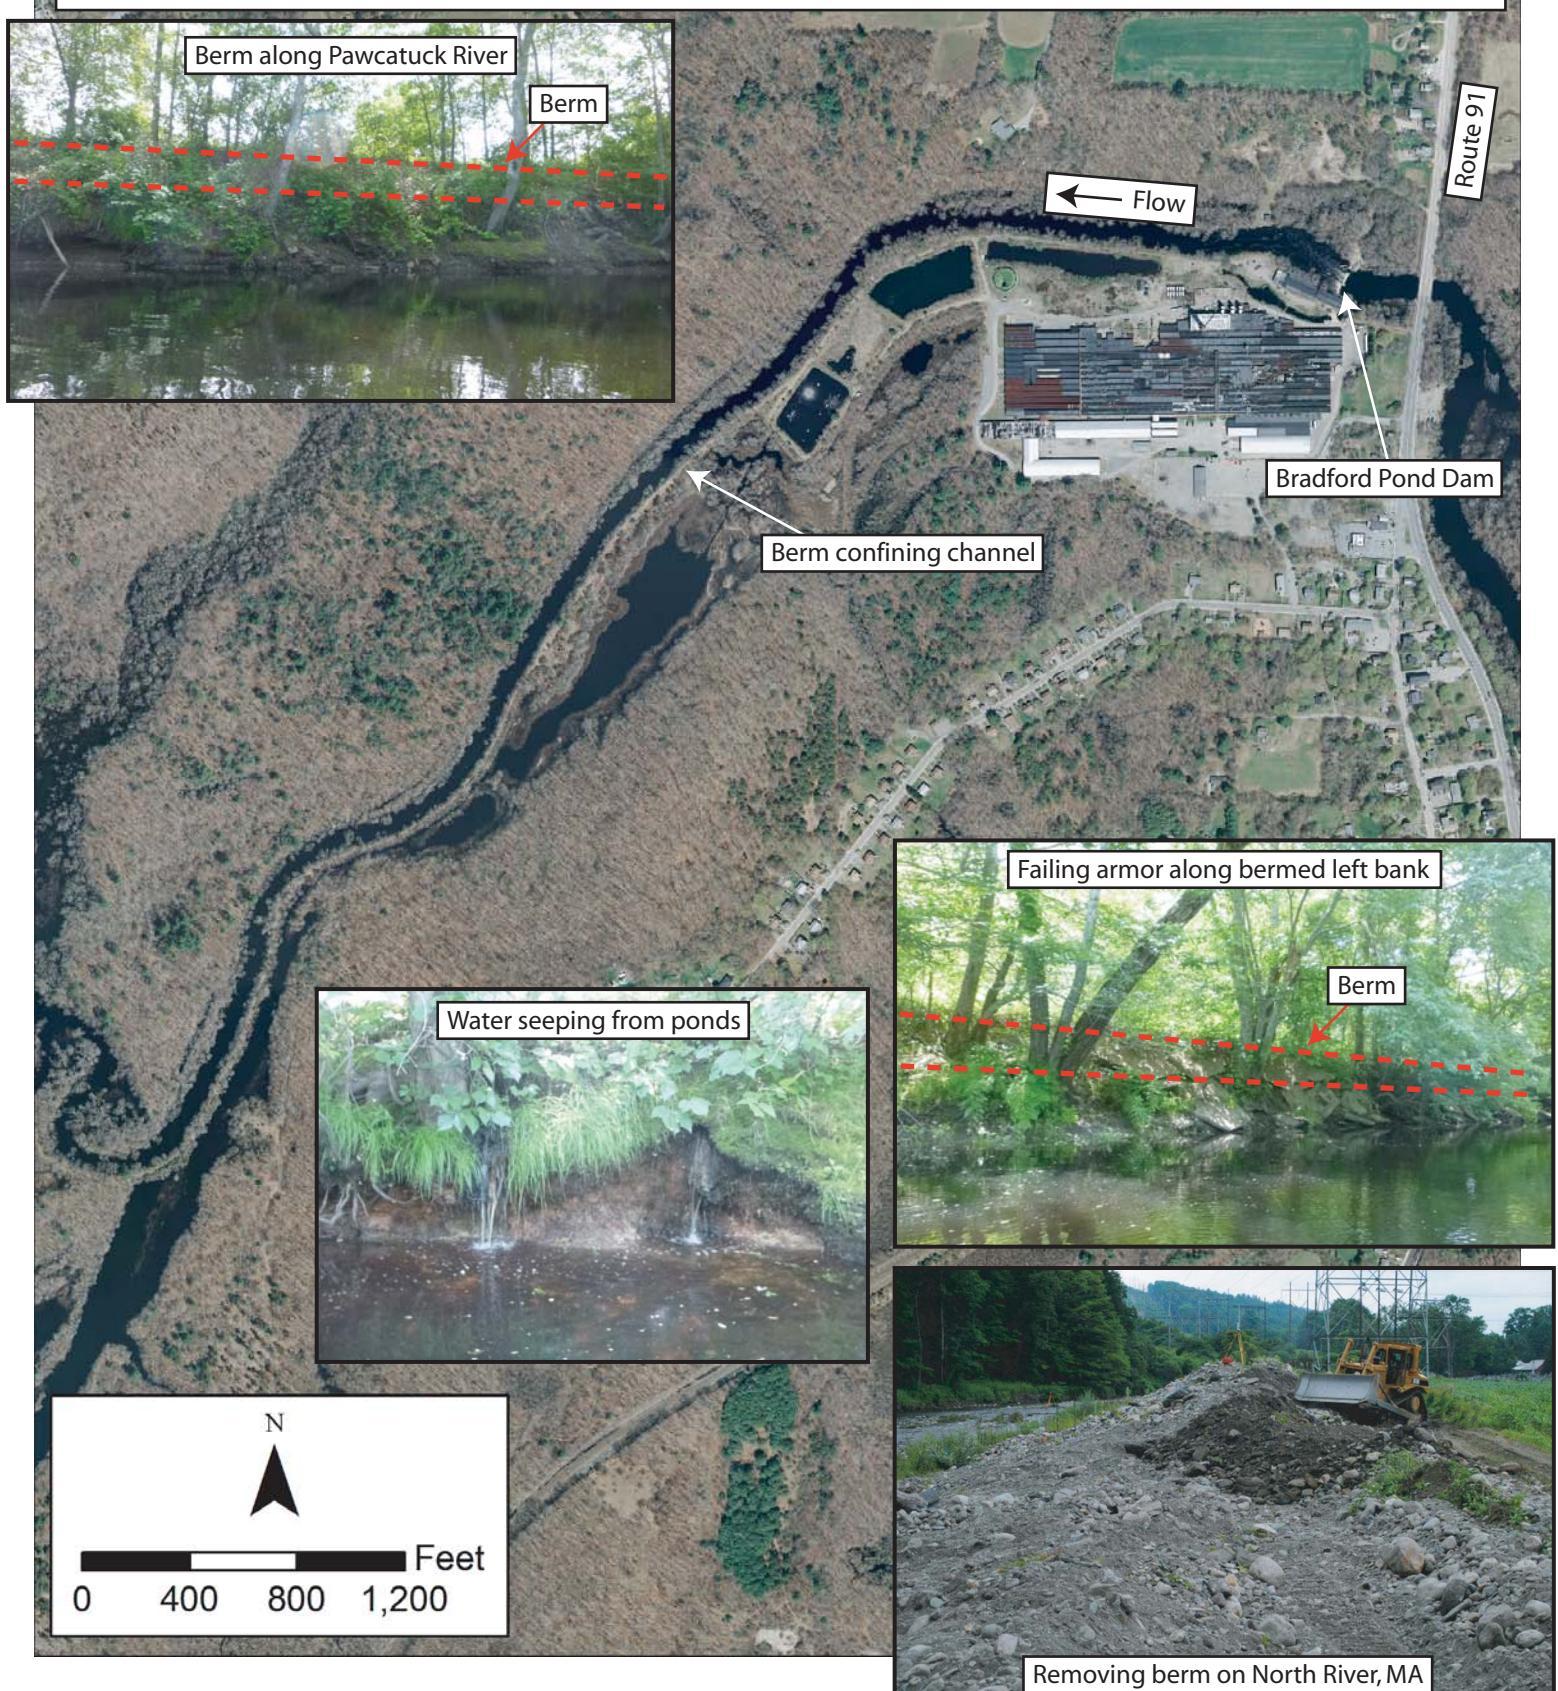
PAR12 - Middle Pawcatuck River

Downstream of the Bradford Pond Dam, the Pawcatuck River is channelized and confined by a berm along the left bank that continues the entire length of the reach. Behind the berm a series of man-made ponds contribute water to the river through bank seeps and outflow pipes. Propose berm breaching and/or removal to allow floodplain access, reducing flood and fluvial erosion hazards in the reach and downstream while increasing bank stability and creating sediment storage opportunities.

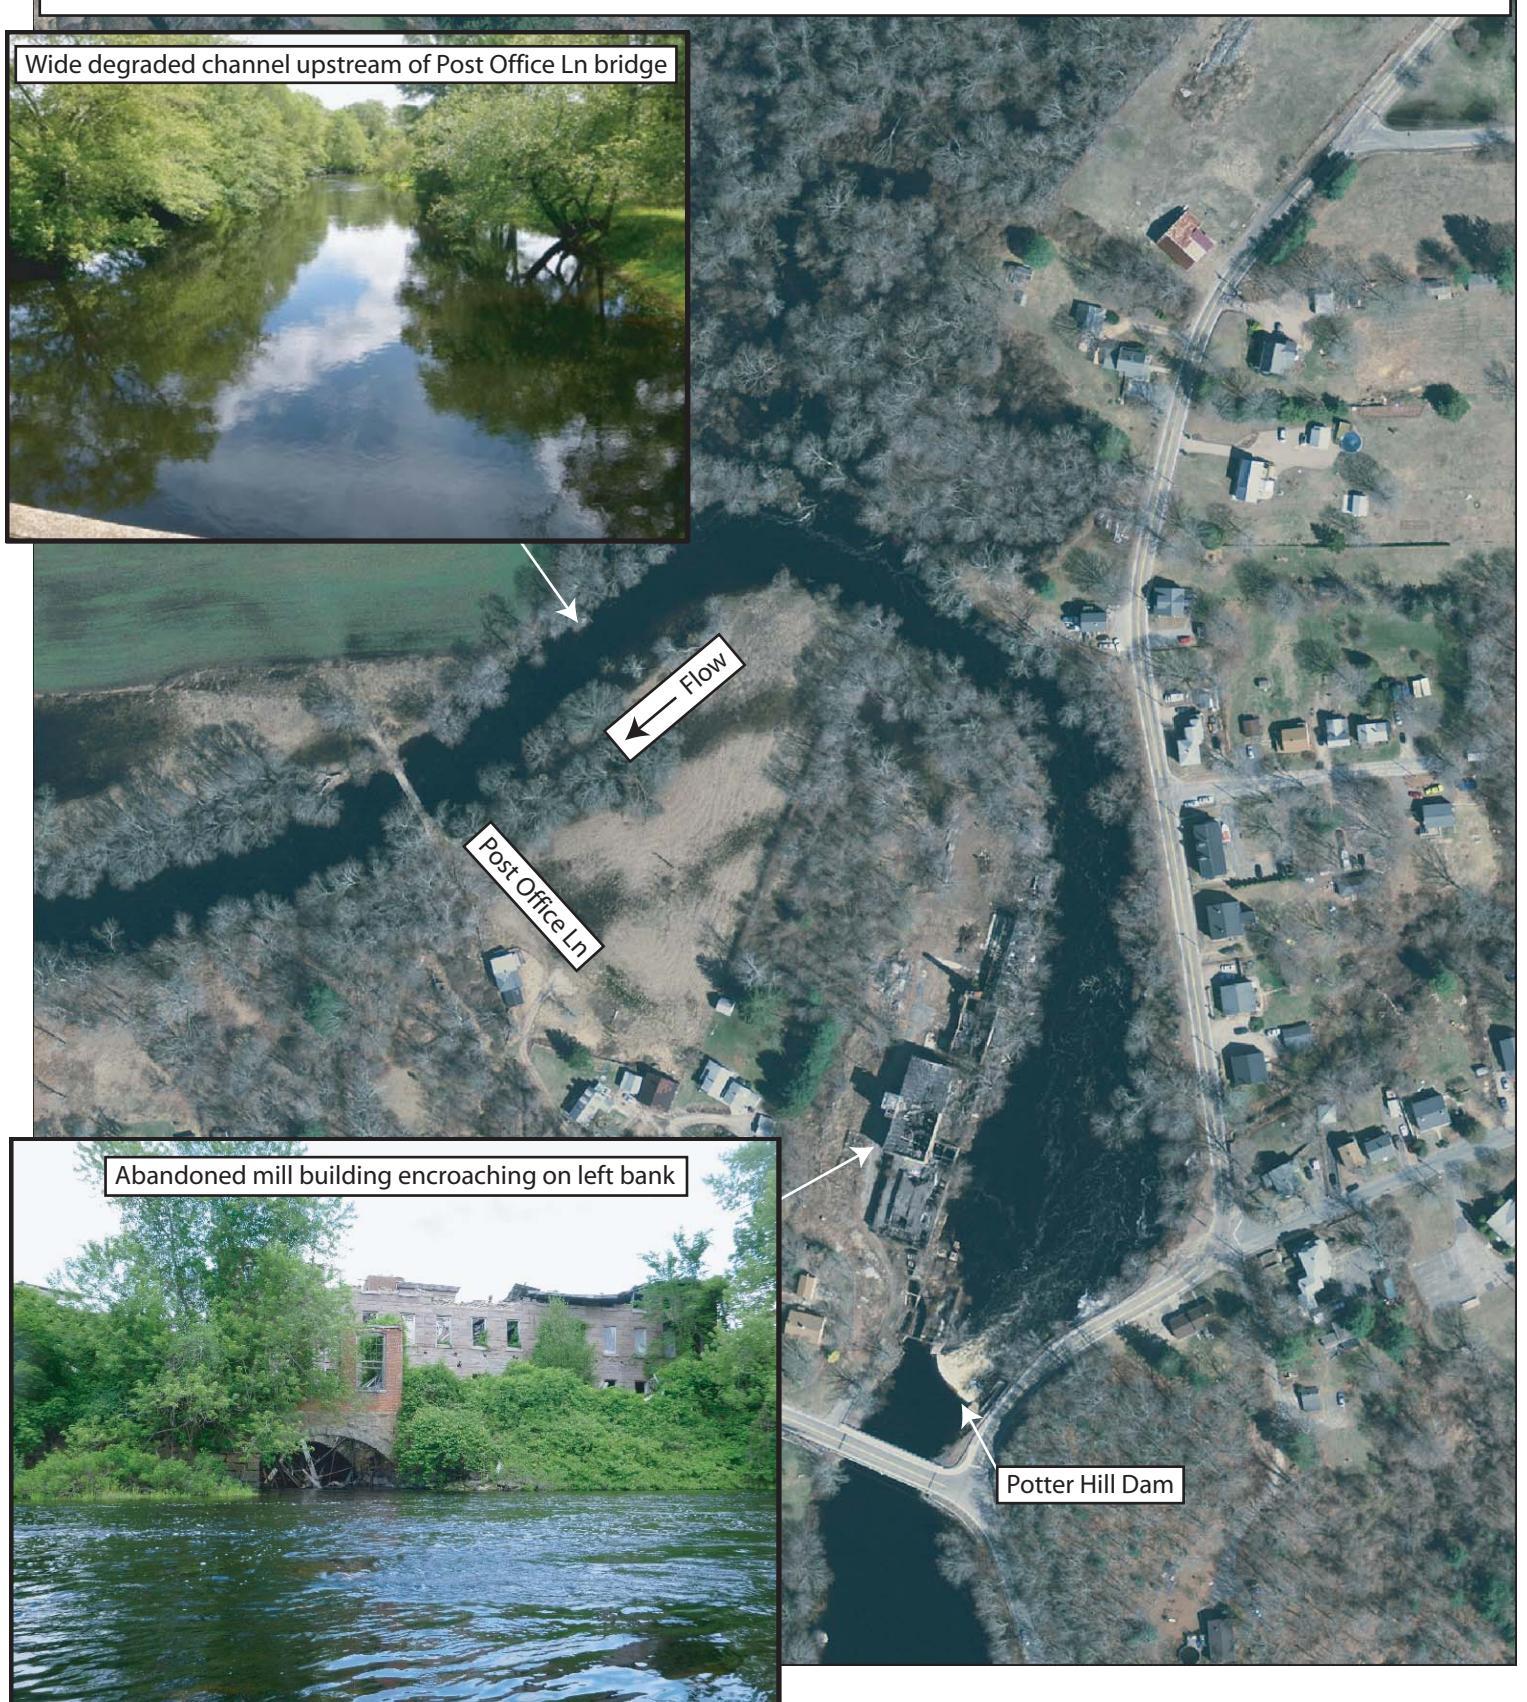
PAR07 and 06 - Lower Pawcatuck River

Downstream of Potter Hill Dam in Ashaway, a wide shallow channel with degraded habitat and impaired geomorphic function, could benefit from instream structures designed to narrow the channel, sort and store sediment, and provide cover for aquatic organisms. A large abandoned mill building encroaching along the left bank could be removed as part of a project to establish a passive recreation area. This site also contains the discontinued Post Office Lane bridge and is adjacent to high quality habitat in the lower Ashaway River.

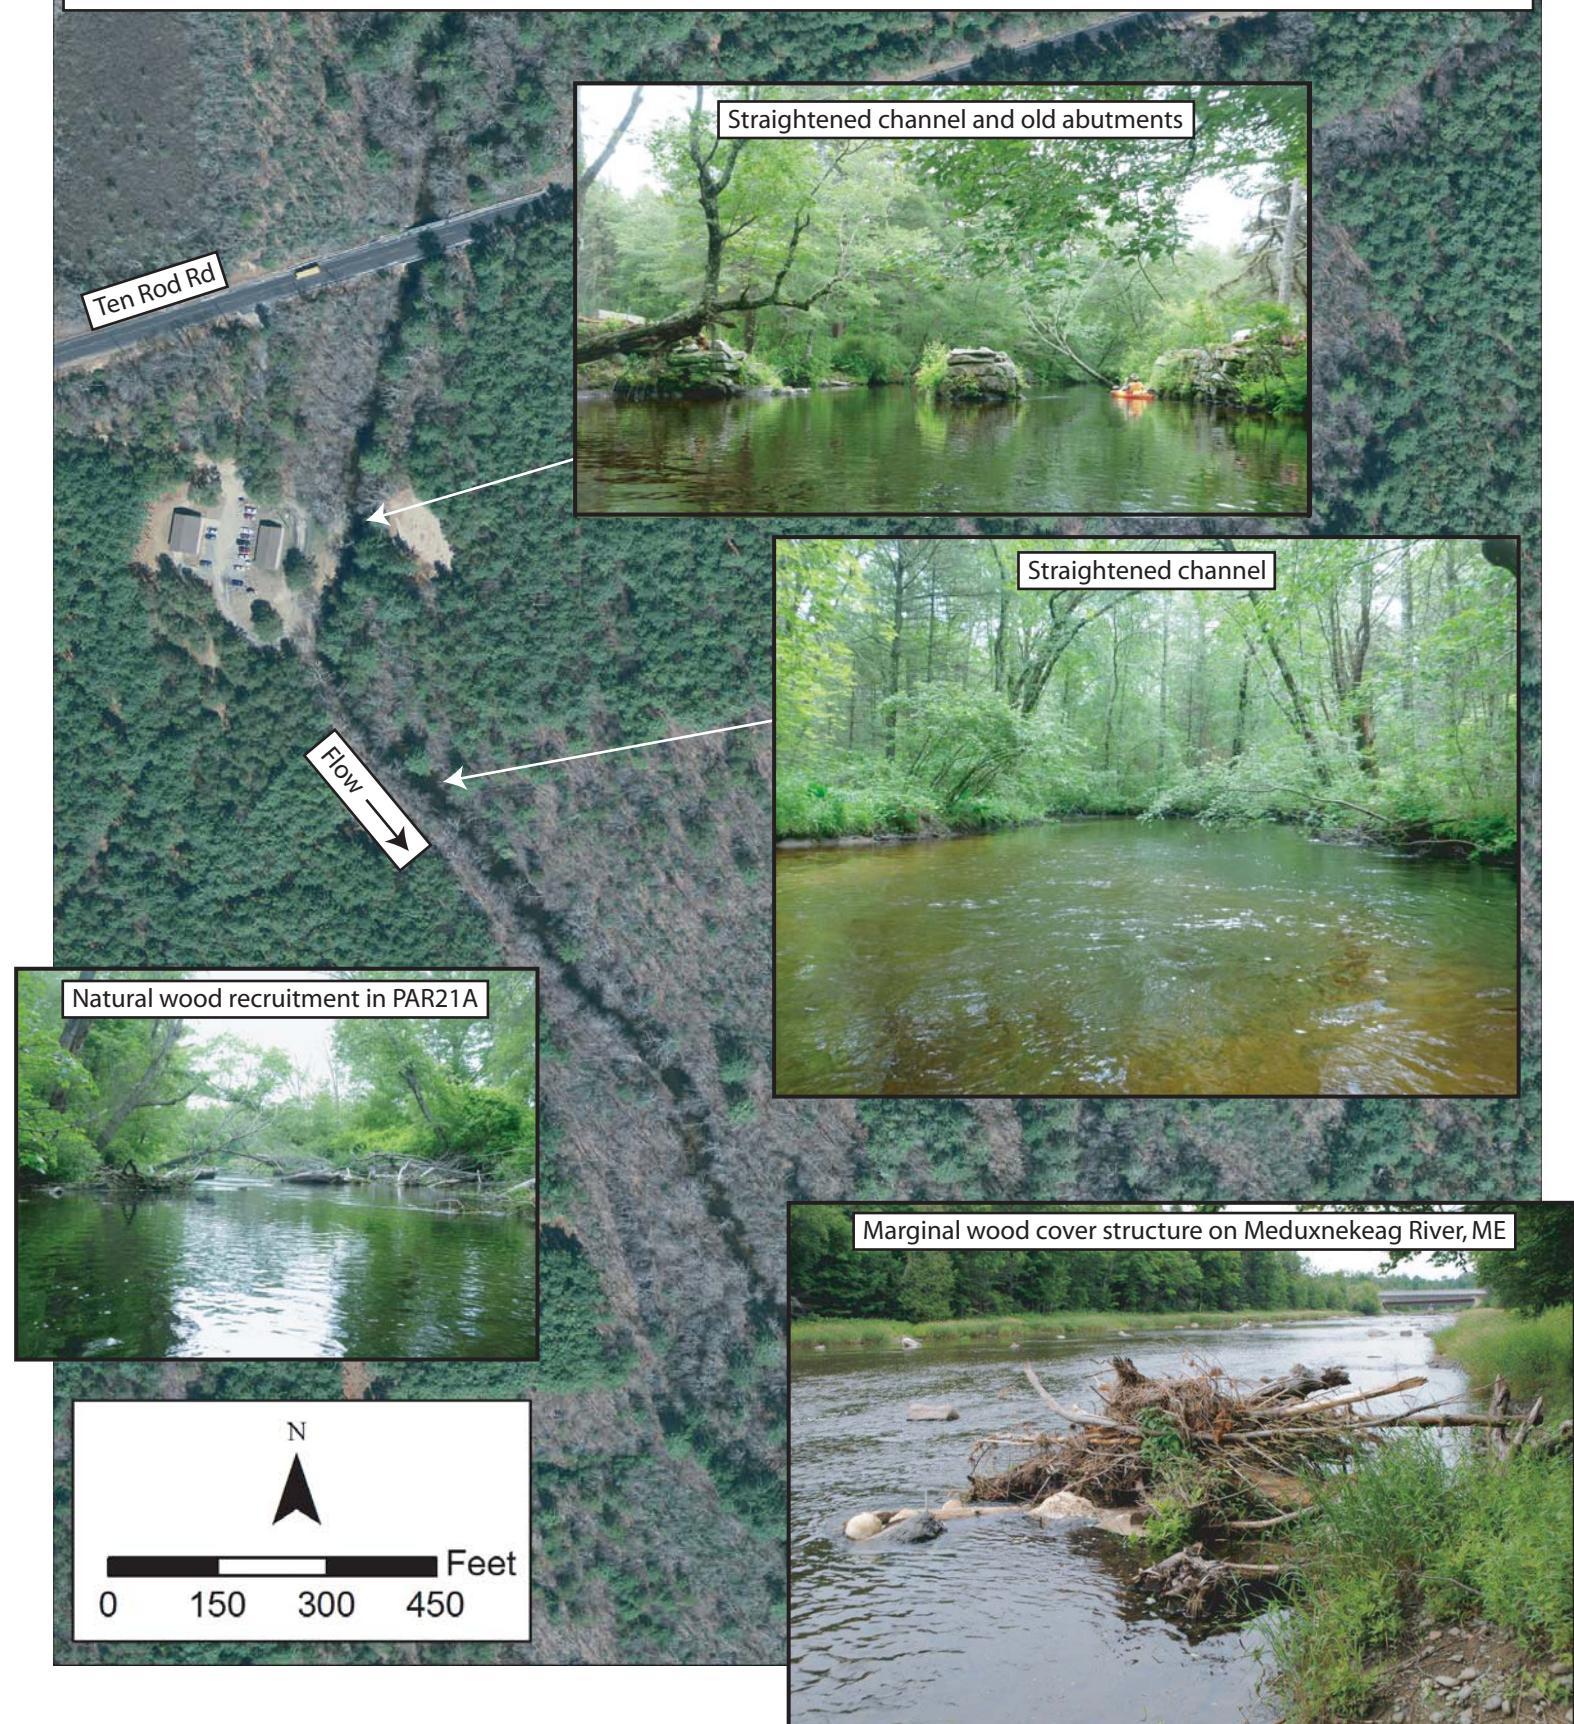
WOR16 and 15 - Upper Wood River

Artificially straightened channel flowing through forested land in the Arcadia Wildlife Management Area, owned and managed by the Watershed Association. This area of the Wood River is a popular fly fishing destination. Proposed design consists of marginal wood cover structures and wood additions to encourage meander formation and sediment storage to reduce downstream flooding and sediment loading while providing high quality cover habitat.

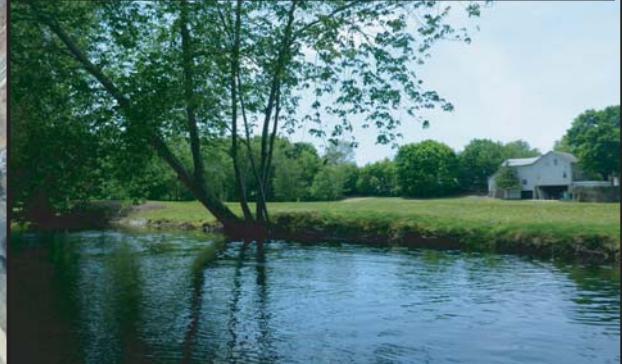
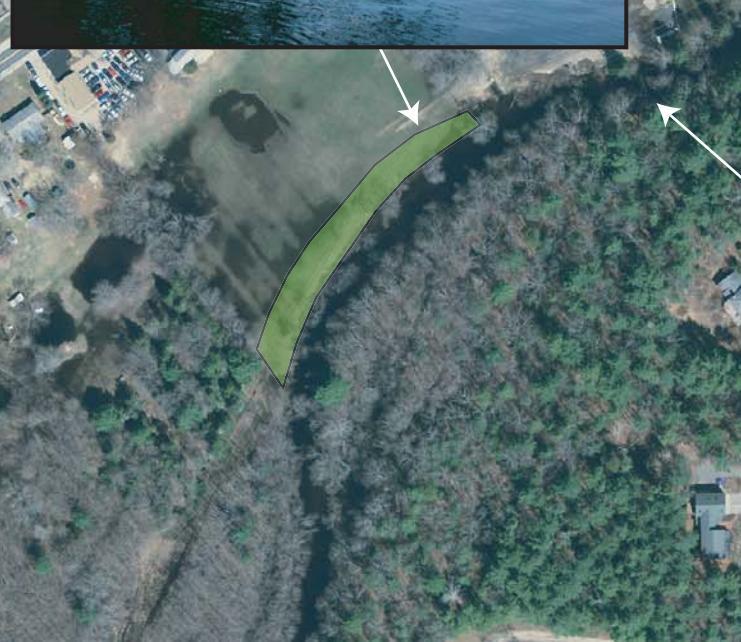
WOR09 - Upper Wood River

Artificially straightened channel downstream of Wyoming Pond Dam, flows through the village of Hope Valley along town athletic fields and residential parcels. Propose riparian buffer establishment and installation of toe wood structures. This centrally located reach, with high potential for recreational use could be enhanced by addition of marginal wood structures and possible stabilization of mass failure.

Location for buffer planting and toe wood structures

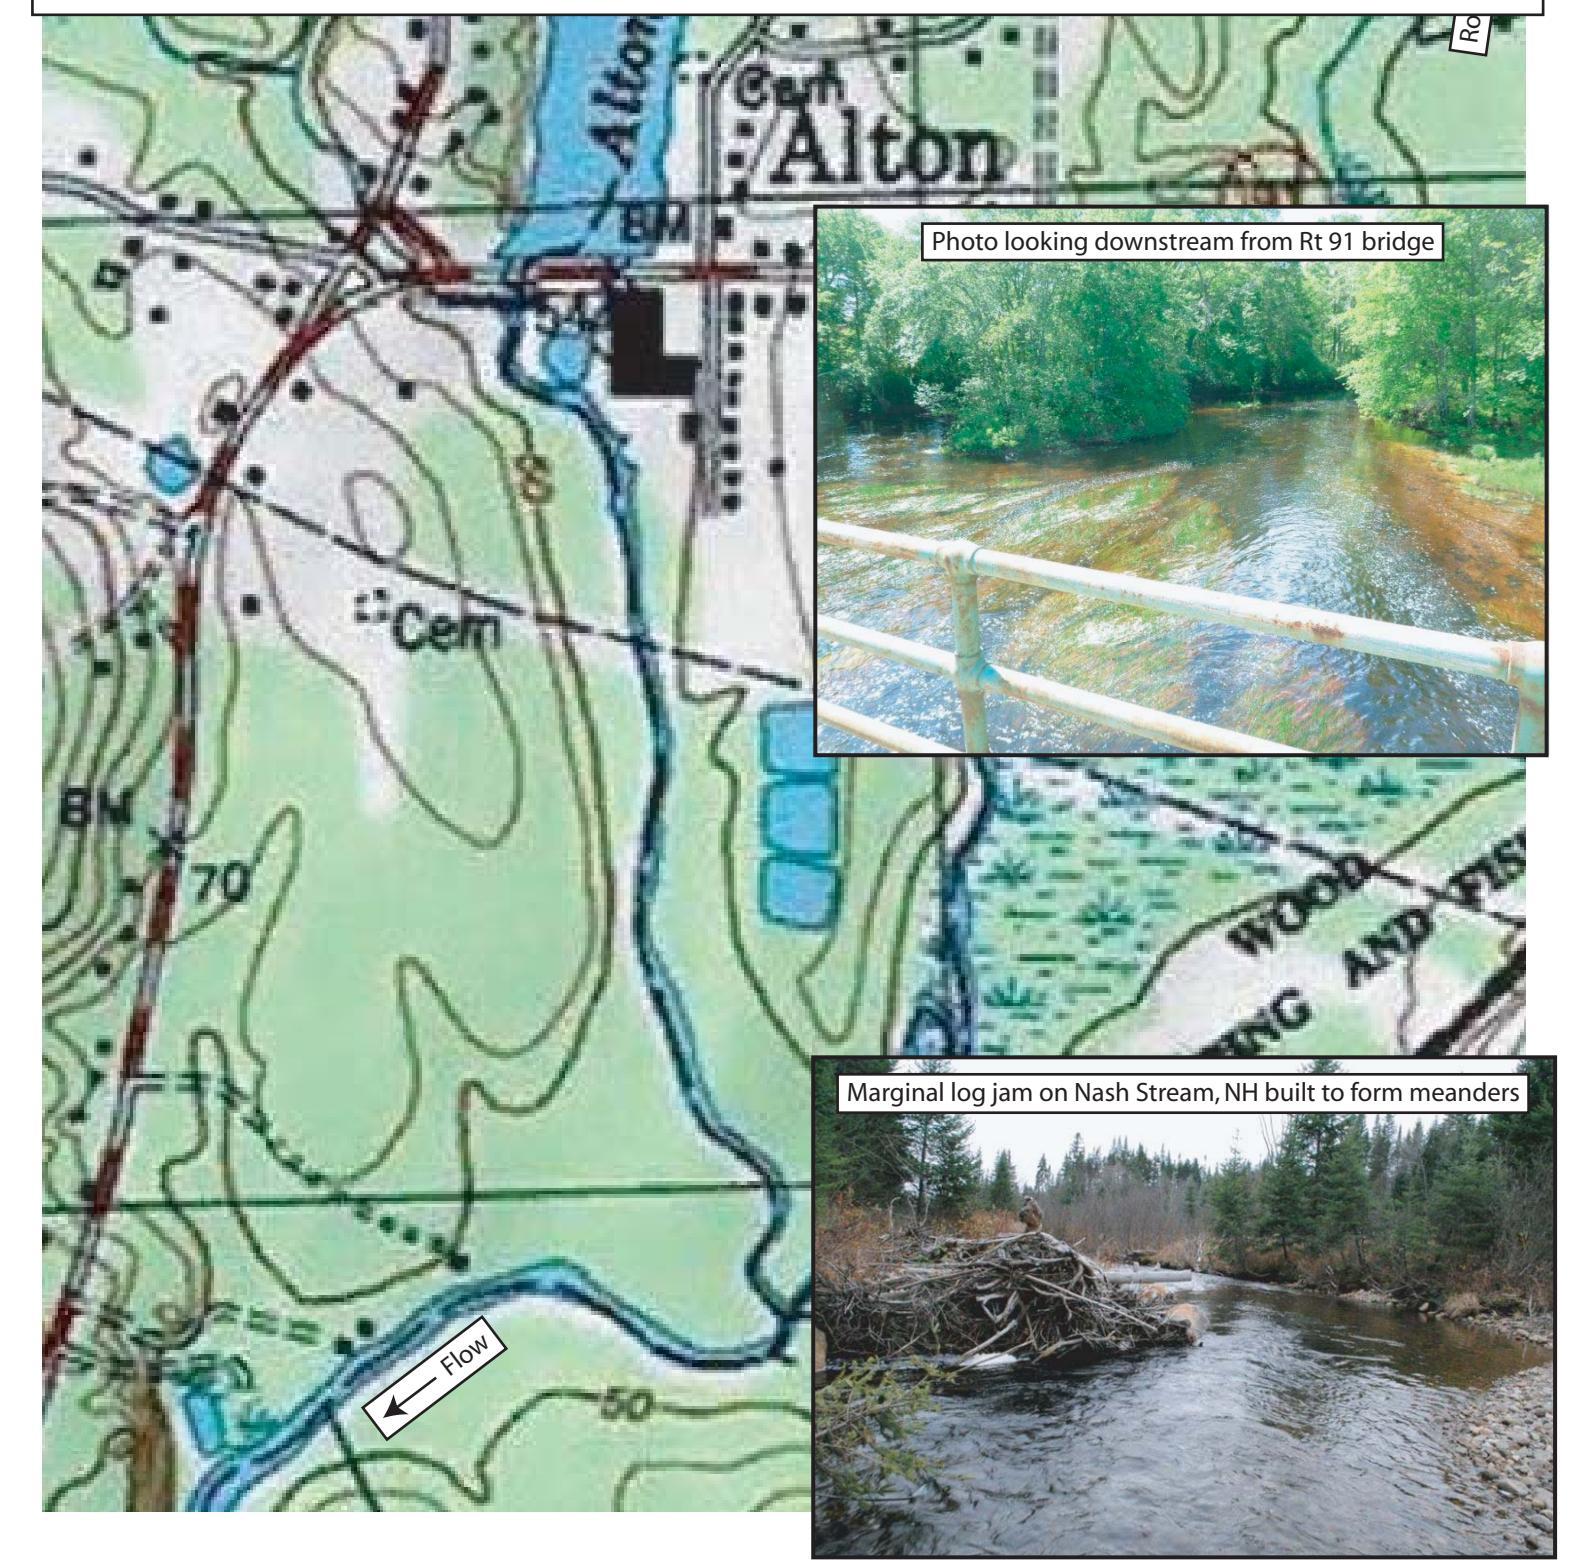
WOR01 - Lower Wood River 📗

Artificially straightened channel at lower end of Wood River with considerable gravel deposition that is slowly leading to meander development. Meander development could be further enhanced with addition of log jam structures on margins of channel that would deflect flow into opposite bank. Such restoration efforts would: 1) reduce downstream sediment loading by retaining sediment within reach, 2) decrease flood peaks by increasing length of flow paths and improving floodplain access, and 3) improve aquatic habitat with increased cover and flow complexity. Presence of old mill site complicates restoration because of potential for releasing toxins into river if meander growth were to extend into contaminated areas, although carefully planning the location of meander growth could reduce the potential that the ongoing natural and unplanned growth of meanders might eventually cause contamination.

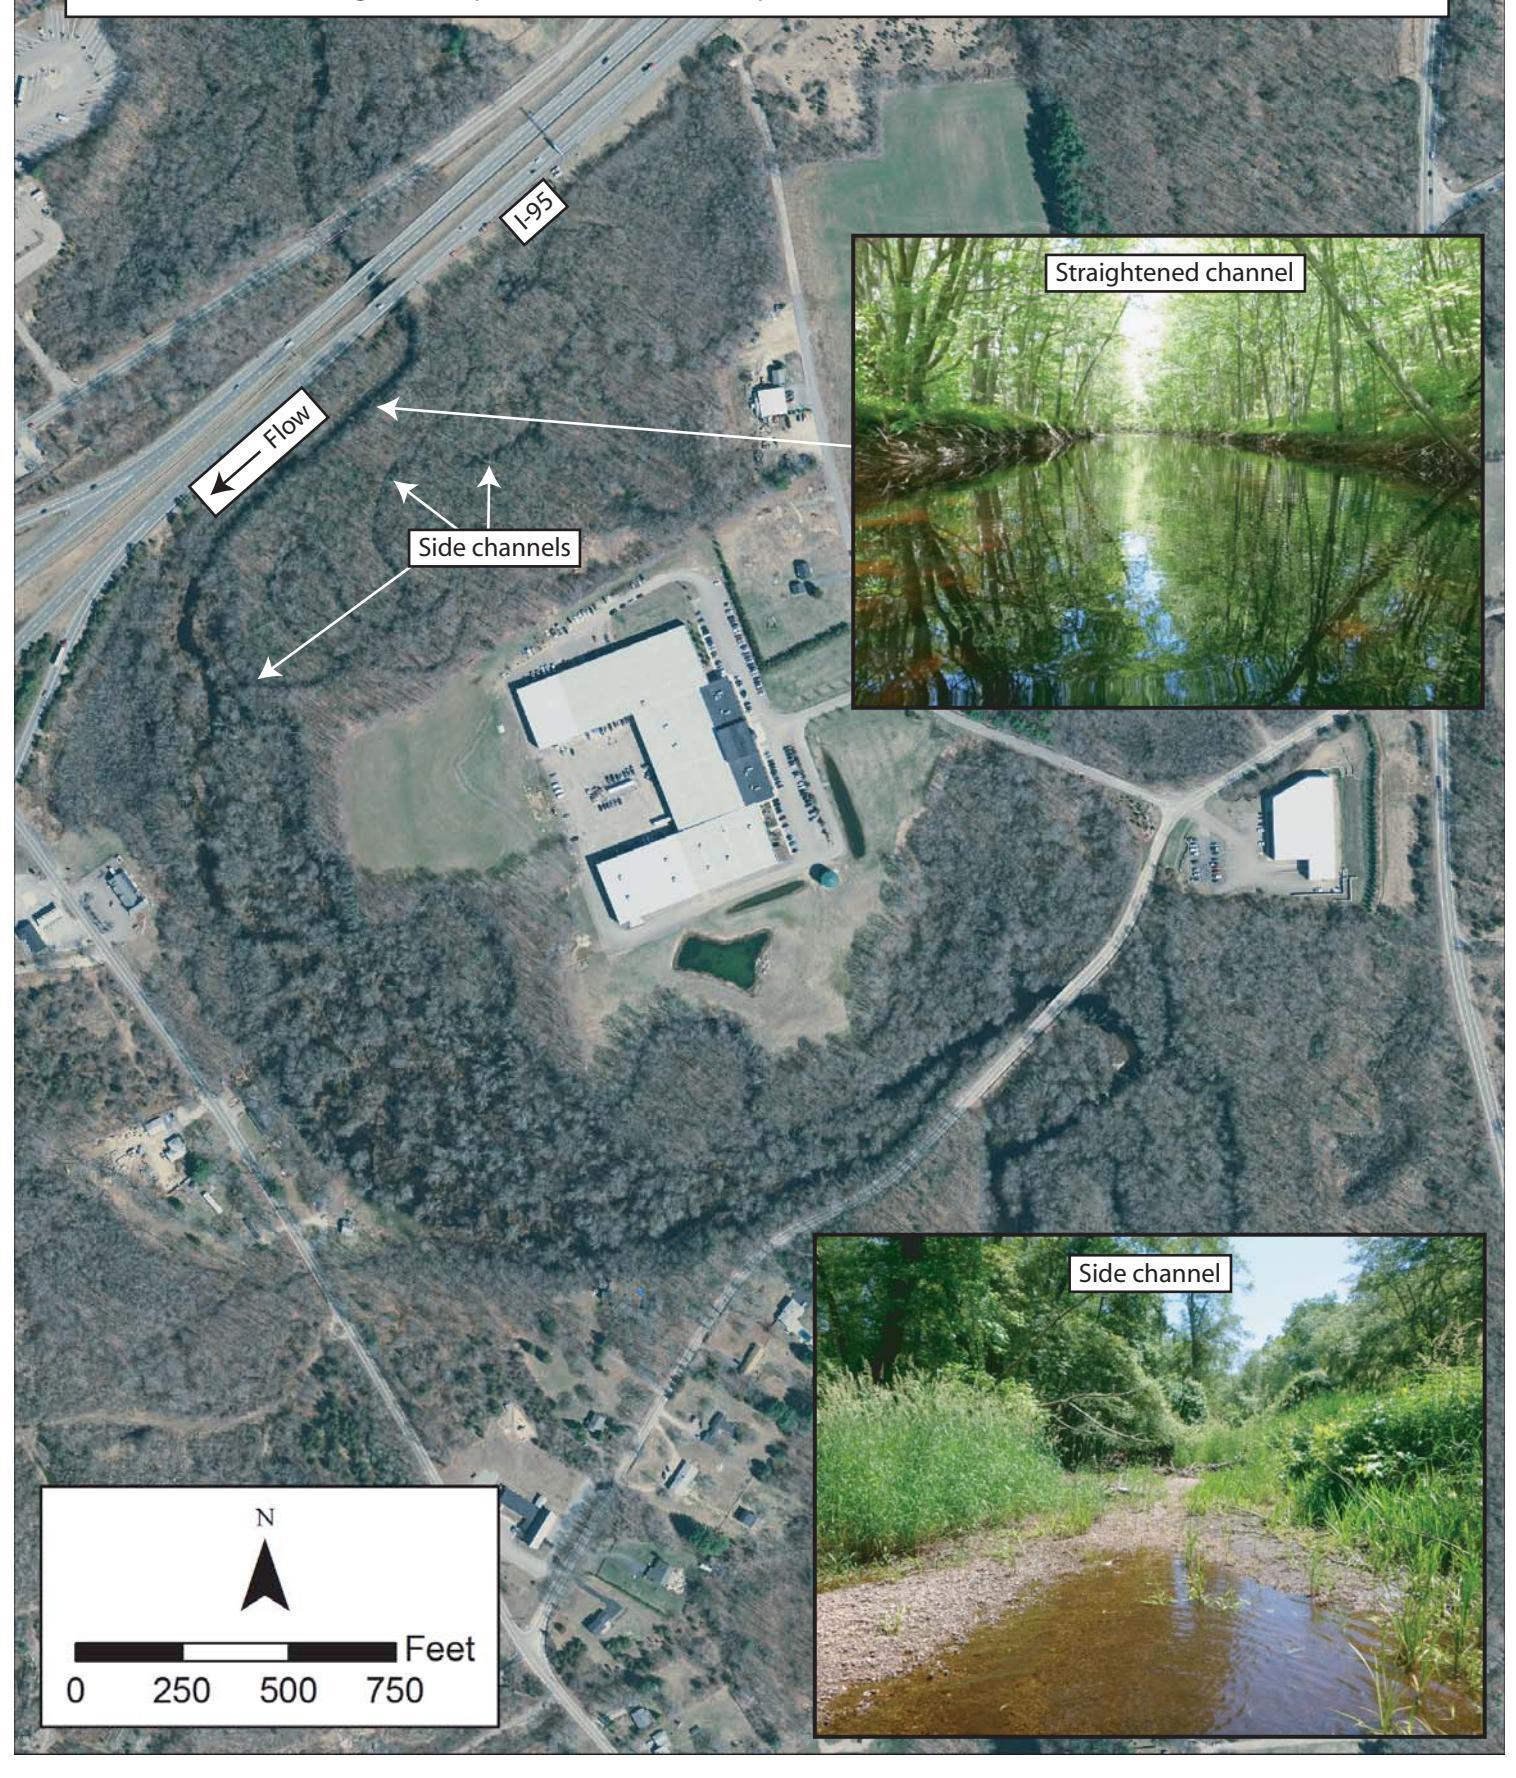
GAS04 - Ashaway River

Artificially straightened channel along I-95 with abundant side channels. Proposed design includes accessing side channels through bank cutting and flow diversion to increase sediment storage, reduce downstream flooding, and improve instream and riparian habitat.

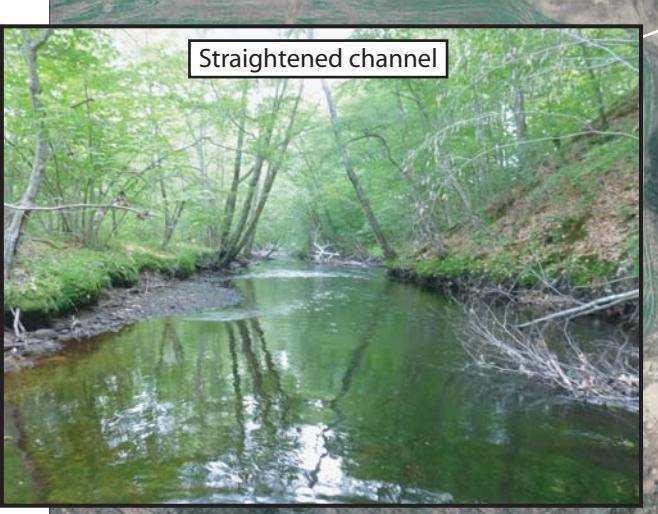
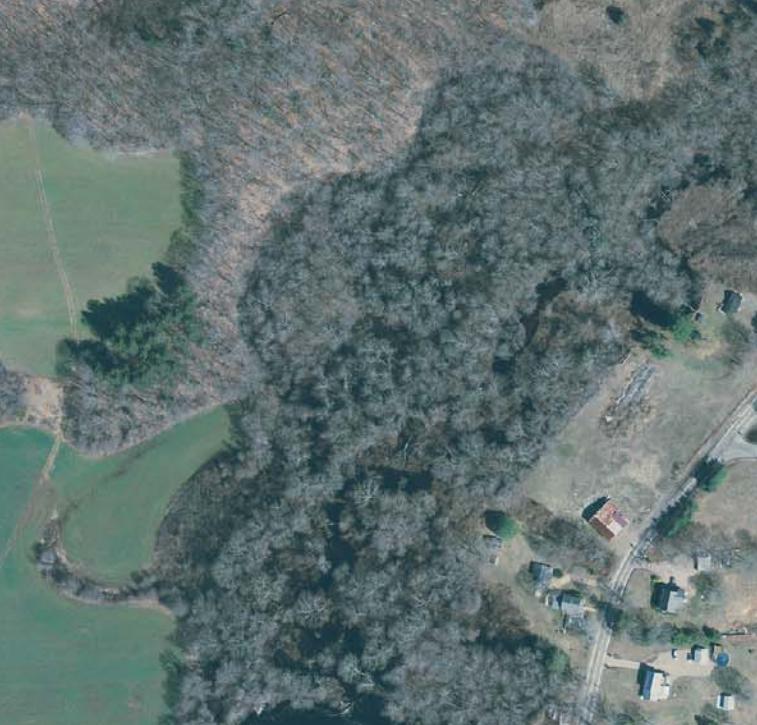
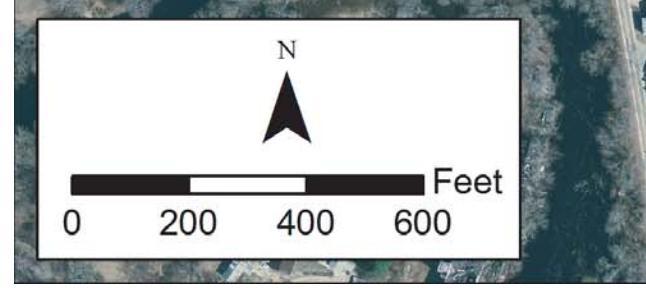
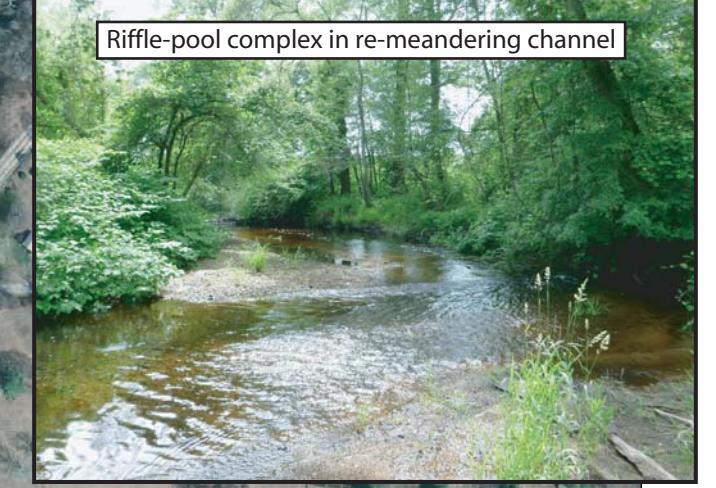
GAS01 - Ashaway River

Natural re-meandering driven by sediment deposition in a previously straightened reach of the Ashaway River has created a dynamic stream channel with high flow complexity. Propose corridor protection to conserve this important high-quality aquatic and floodplain forest habitat.

High quality instream and riparian habitat

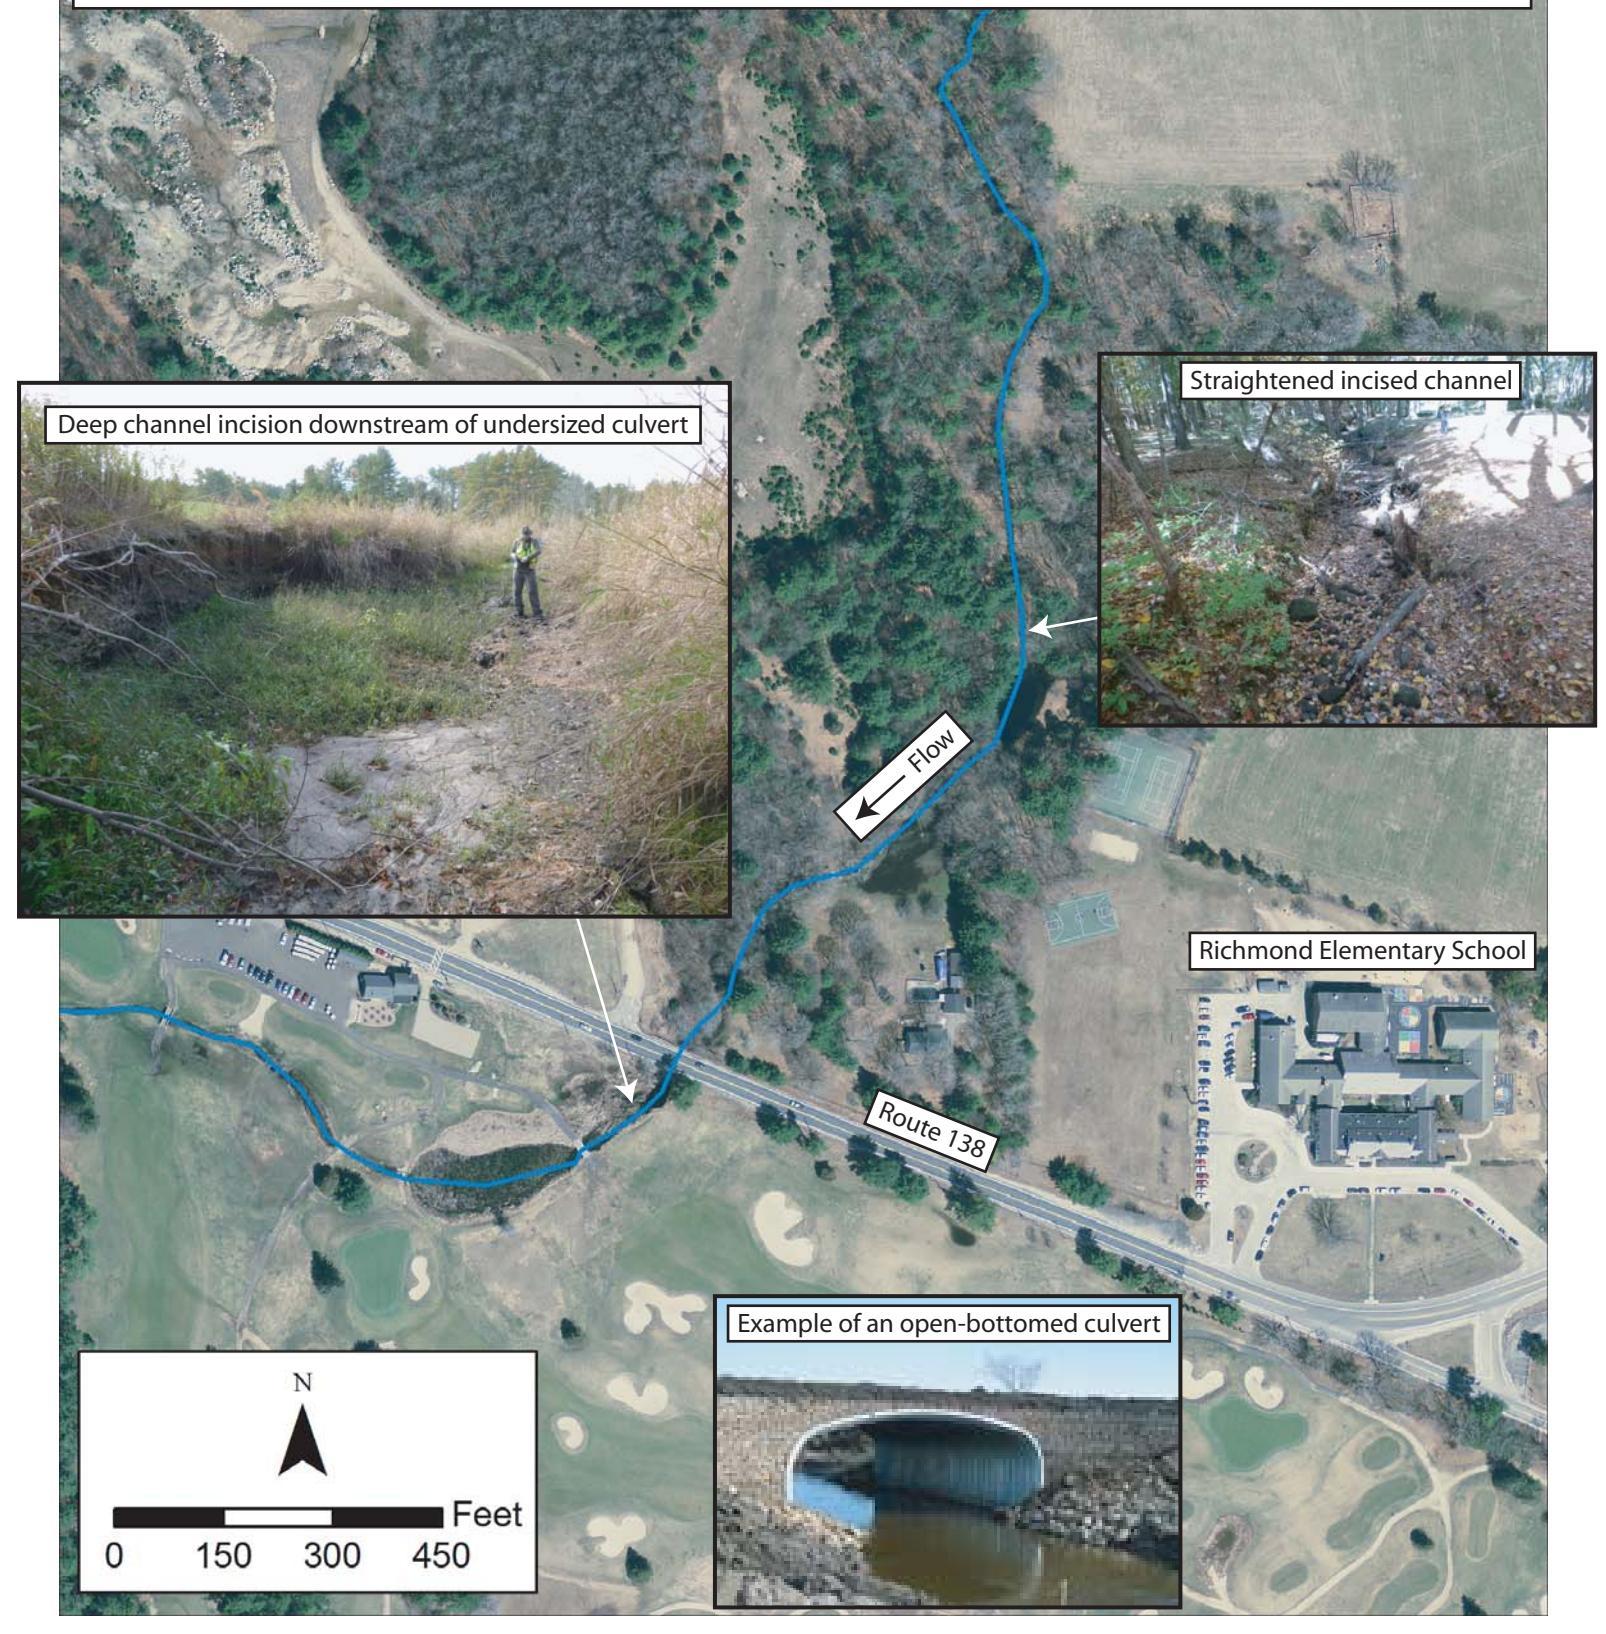
MEB08B - Meadow Brook

Four feet of scour and channel incision has occurred downstream of the undersized culvert at Rt 138 on Meadow Brook in Richmond. Scour is exacerbated by channel straightening upstream. Propose replacing culvert with appropriately-sized bottomless arch culvert that spans full channel width and adding roughness elements in channel to encourage aggradation and reverse incision. Possible channel-spanning wood or stone structures to re-establish channel grade. Nearby elementary school and golf course provide potential project partners.
