# **The RI River and Stream Continuity Project**

## **Follow Up Meeting**

**April 18, 2007**

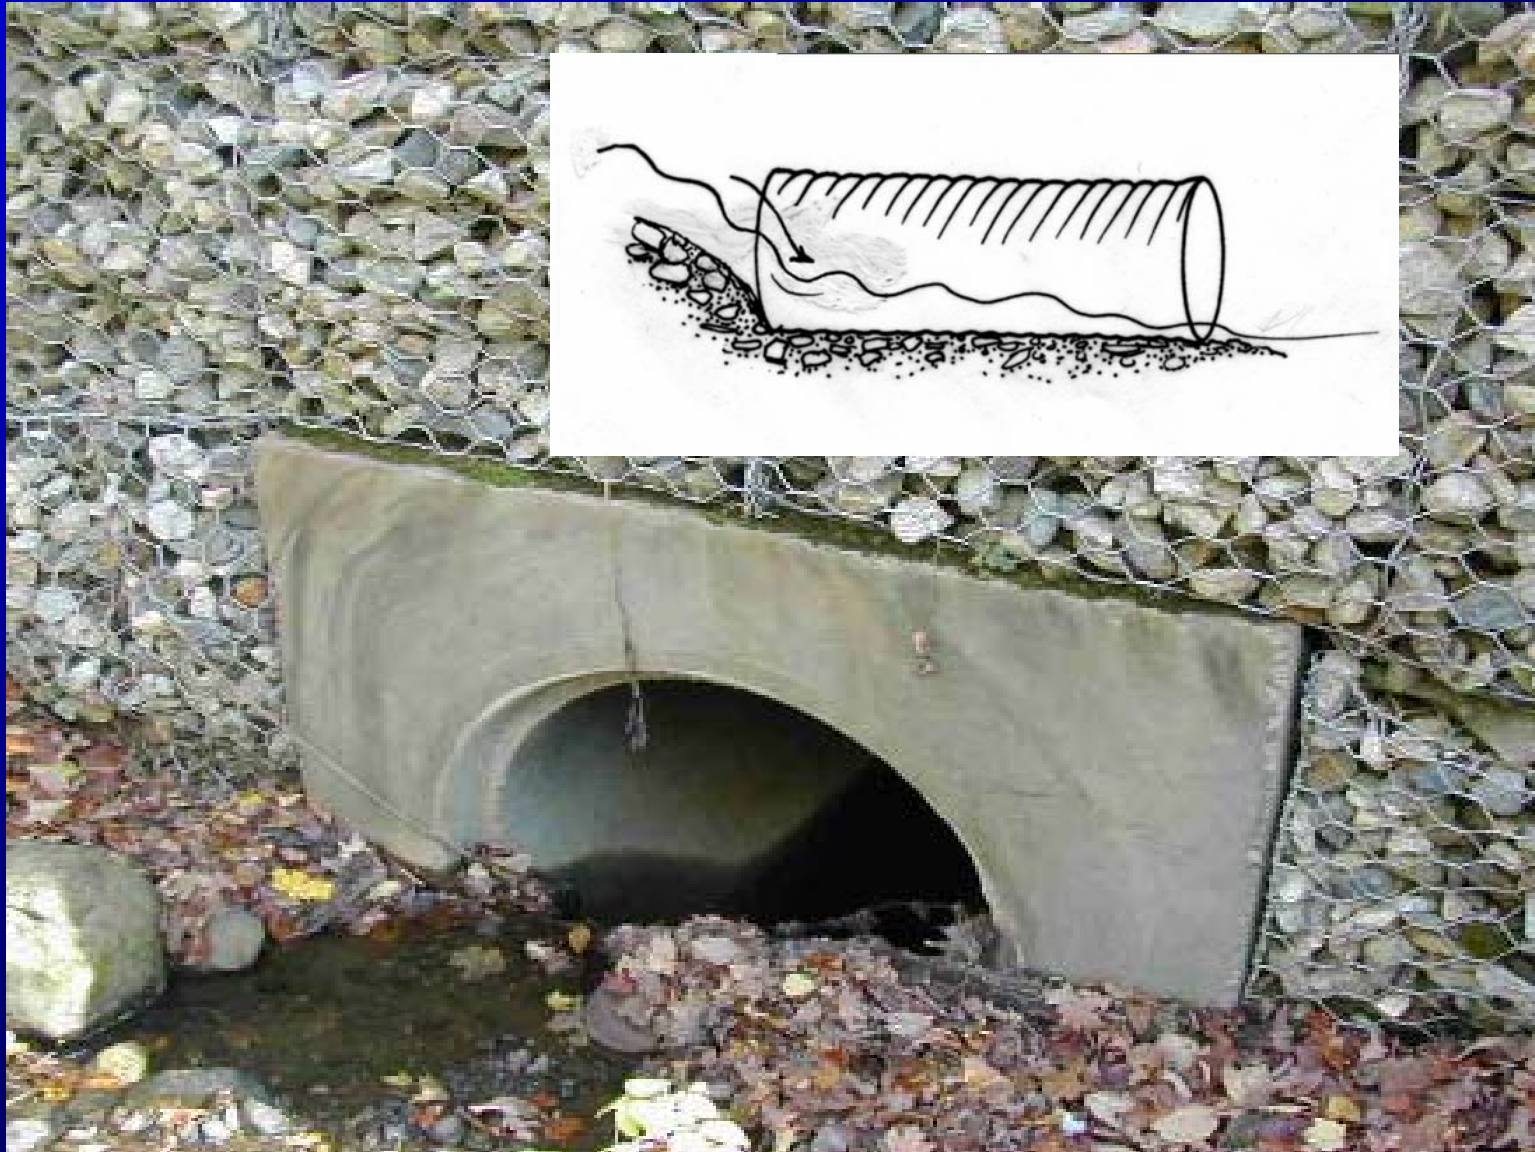
# Inlet Drop

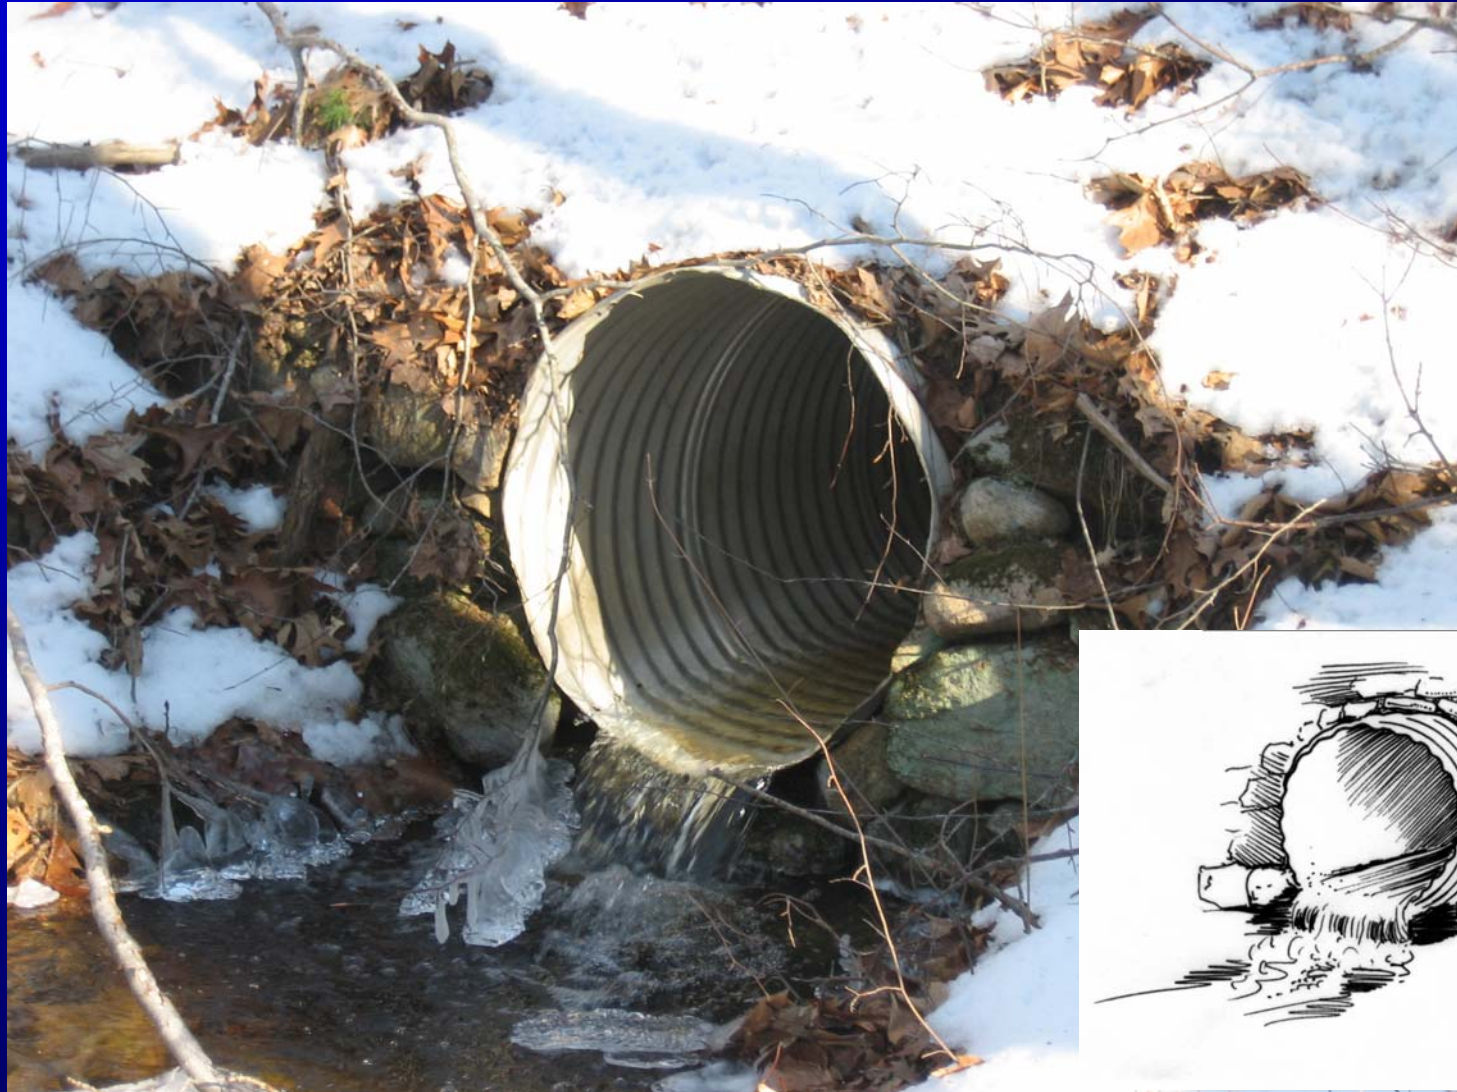
# Outlet Perch

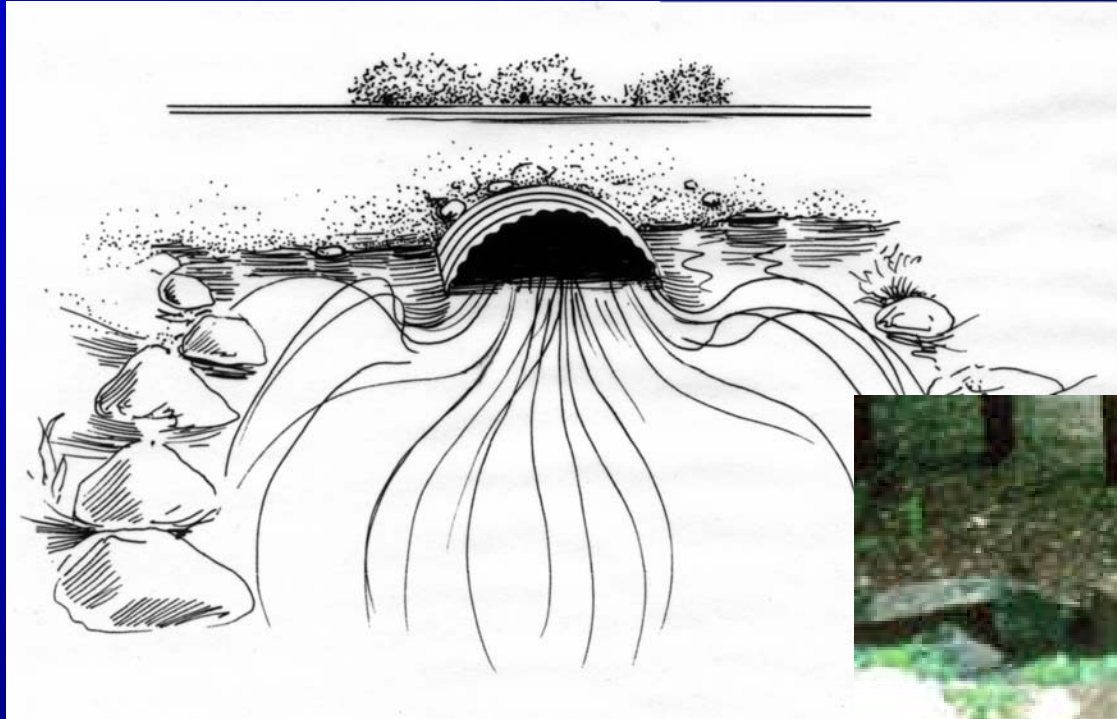
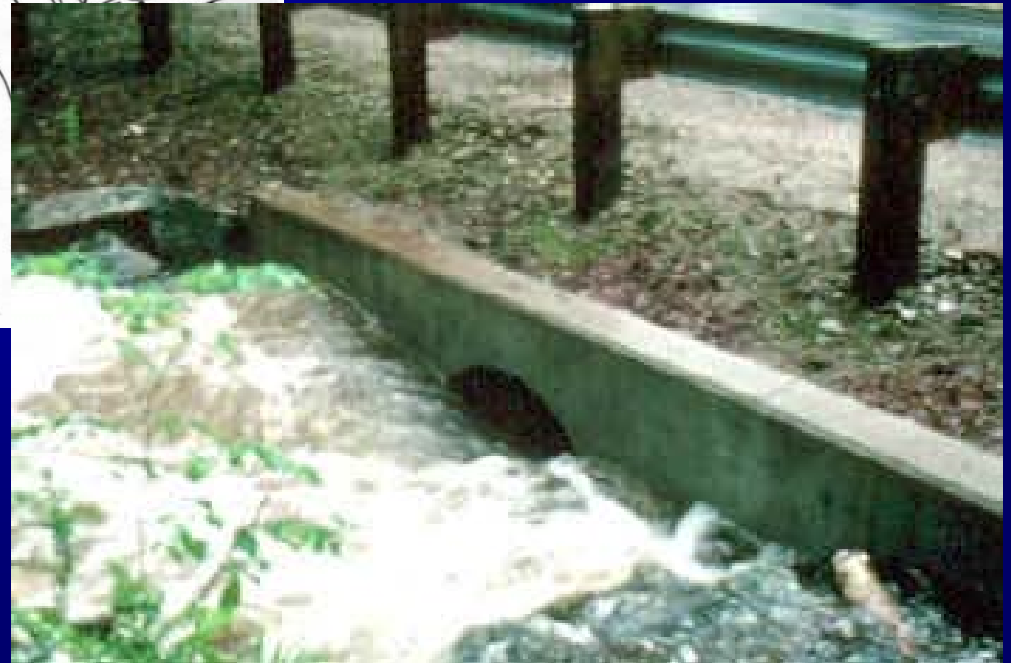
# Flow Contraction

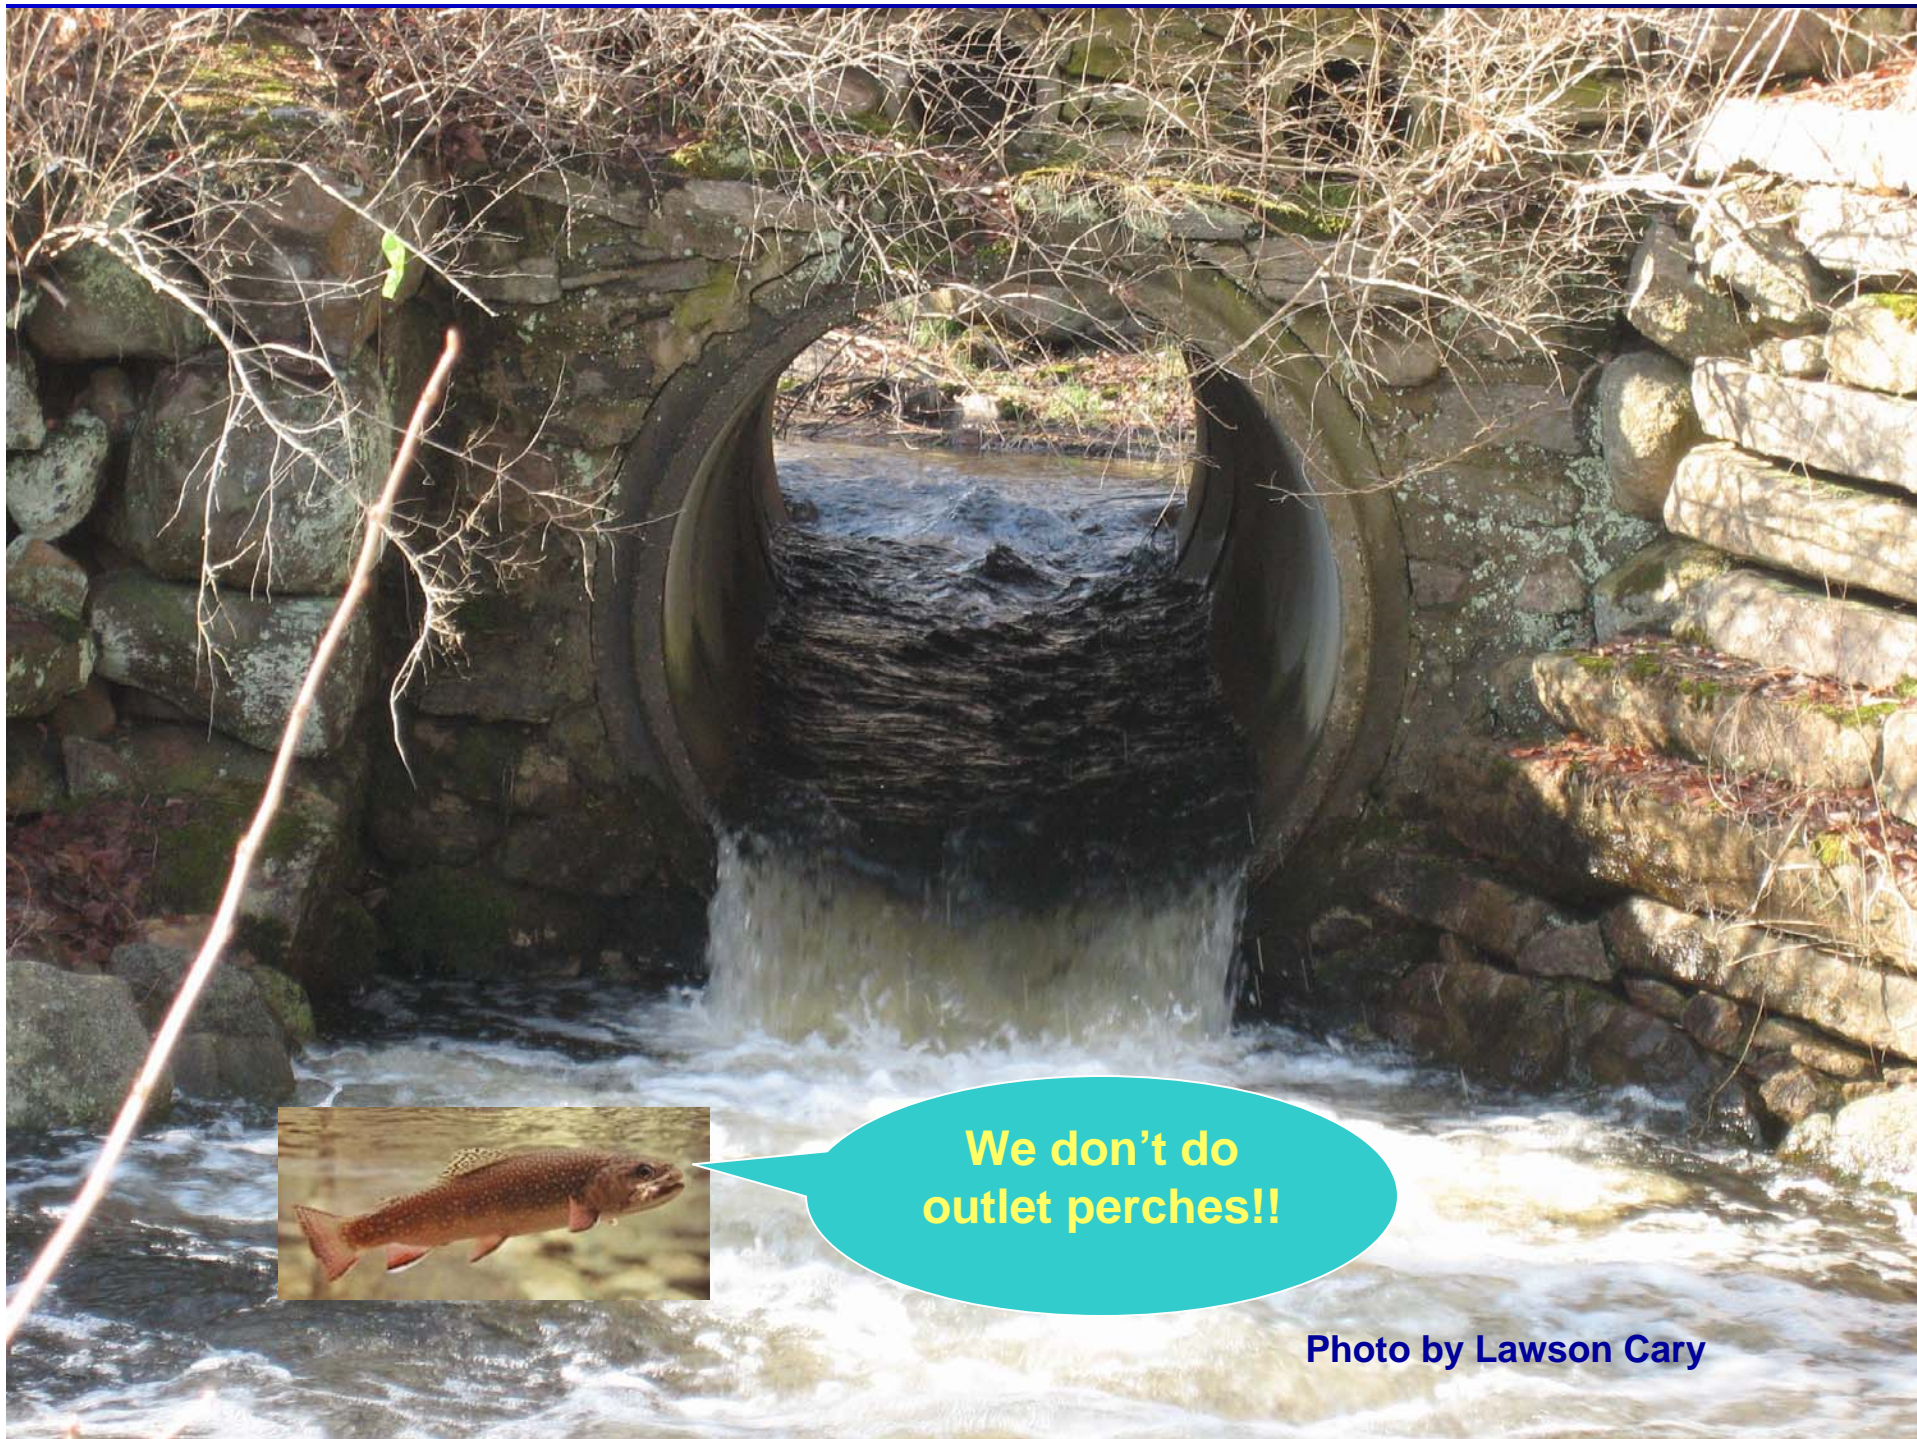
**We don't do  
outlet perches!!**

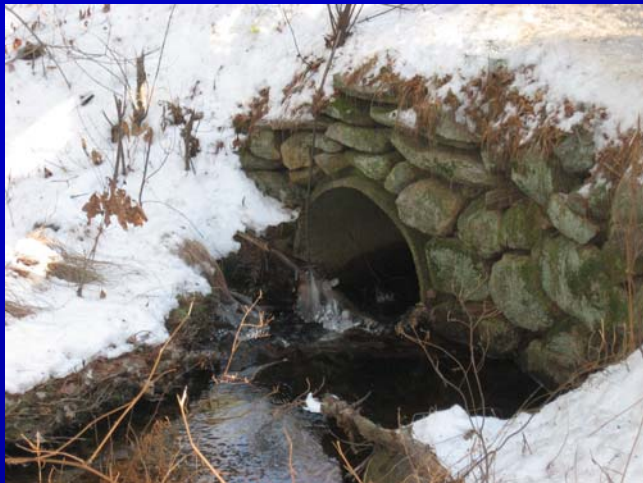
Phillips Brook and Plain Meetinghouse Road

# Severe Barriers

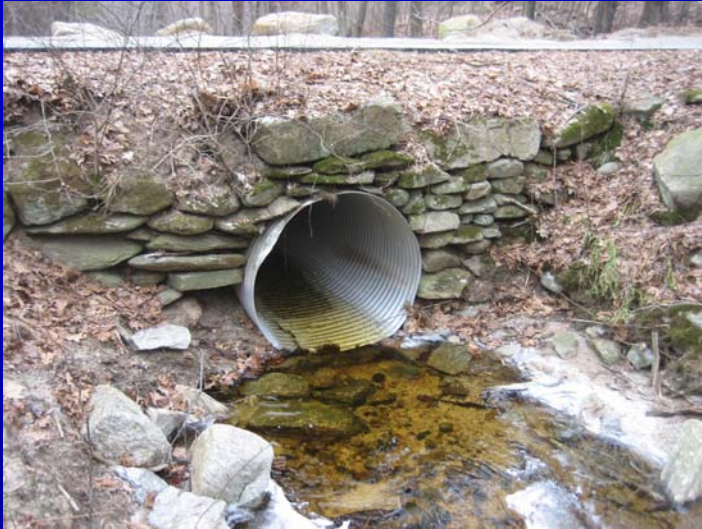
Unnamed Brook and  
Hazard Road

# Moderate Barriers

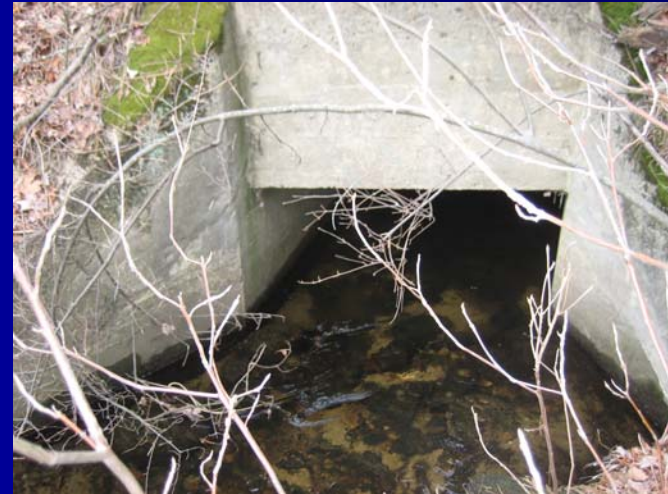
Unnamed Brook and Nooseneck Hill Road

# Minor Barriers
