River Corridor Plan for the Wood-Pawcatuck Watershed, RI and CT

Prepared for
Wood-Pawcatuck Watershed Association
Hope Valley, RI

Prepared by
John Field
Field Geology Services
Farmington, ME

June 2016

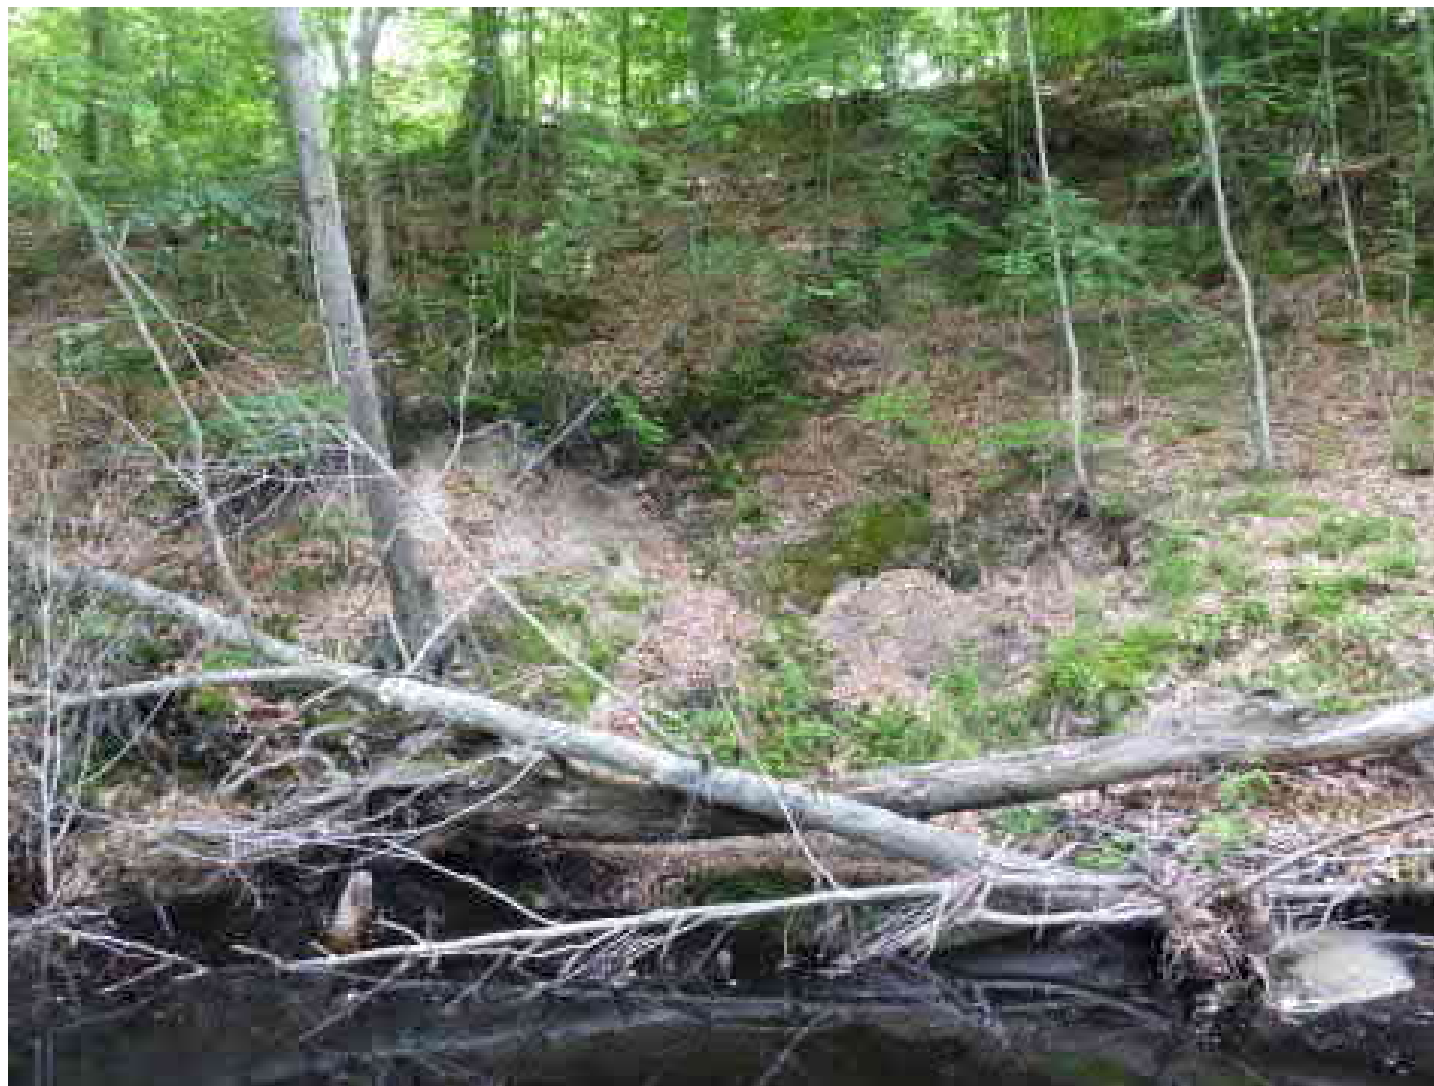
Figure 3. Mass wasting in GAS-1.

Large mass failures occur in a few places in the Wood-Pawcatuck Watershed and supply large amounts of sediment to the river (Figure 3). Stabilizing mass failures could reduce downstream sediment supply, but also could be costly, technically difficult, and could lead to new mass failures forming adjacent to the stabilized areas. Flow deflection techniques, such as log jam or boulder deflectors (Figure 10a-b), are likely to be the most effective in such settings. In lieu of stabilization efforts, another approach may be to monitor the mass wasting sites and manage downstream areas in such a way that rapid and large increases of sediment supply from the mass failures can be adequately accommodated. Without nearby attenuation assets for sediment storage, the chances are greater that rapid deposition and associated bank erosion could damage infrastructure elsewhere along the river.

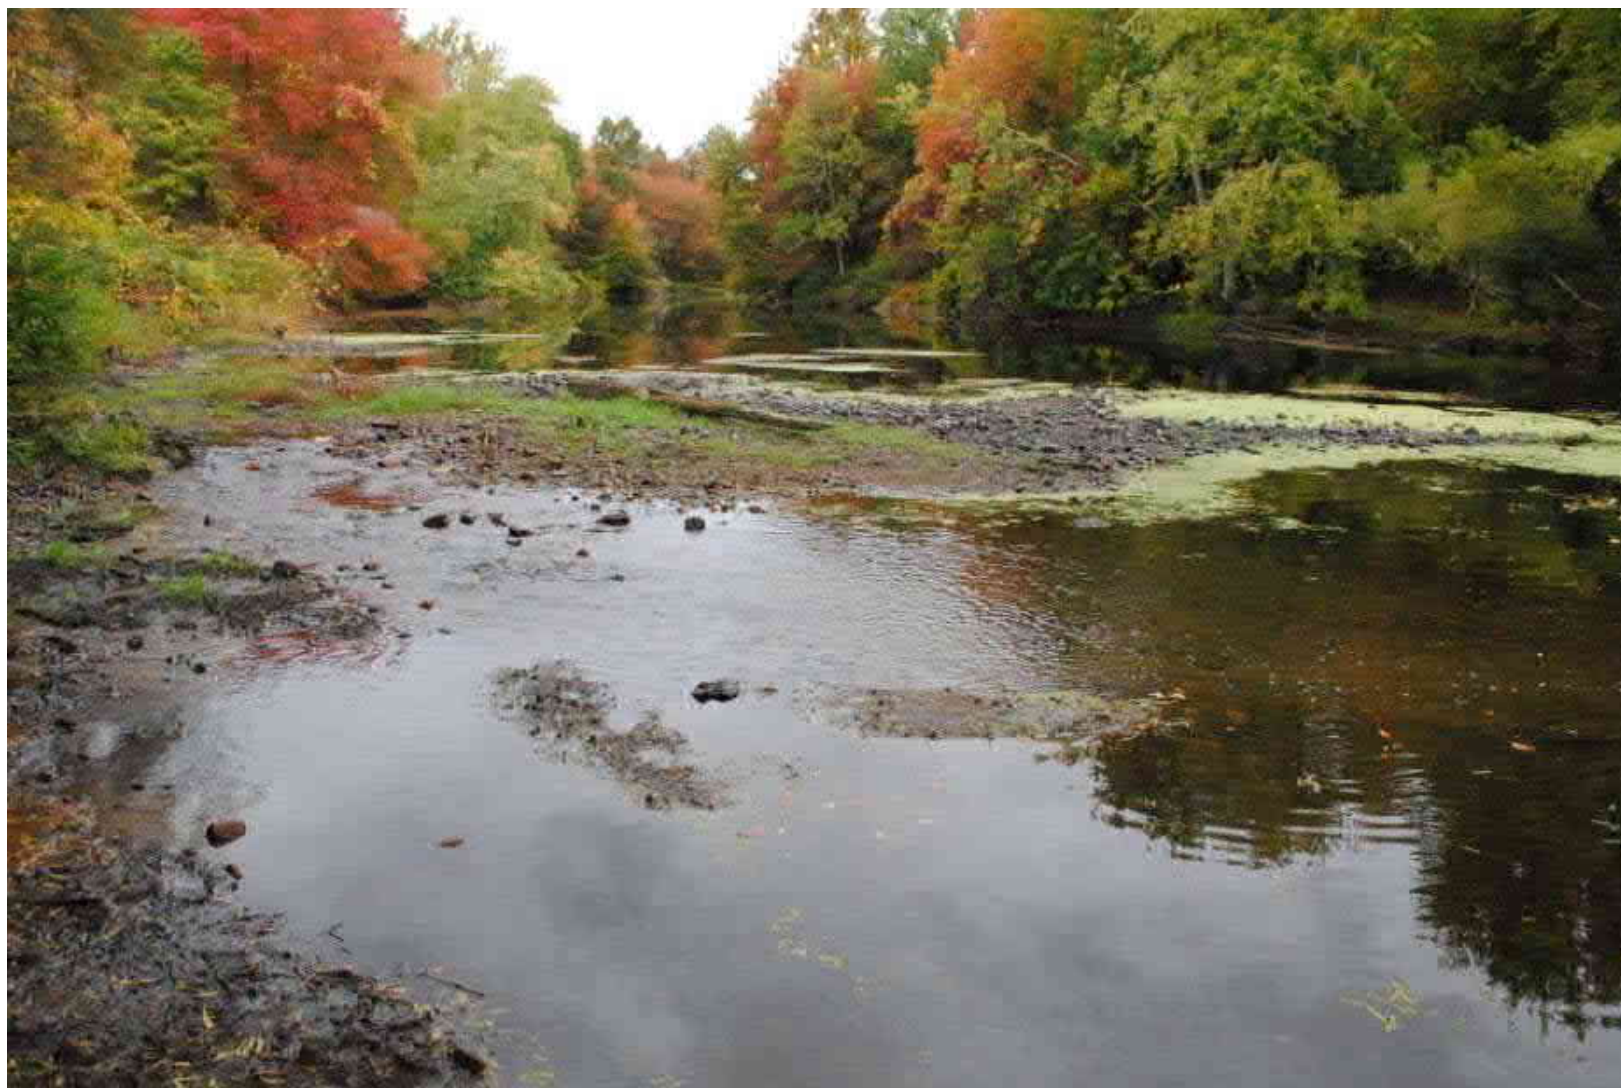
Figure 4. Deposition upstream of White Rock Dam (before its removal) at the mouth of the Shunock River confluence in PAR-5.

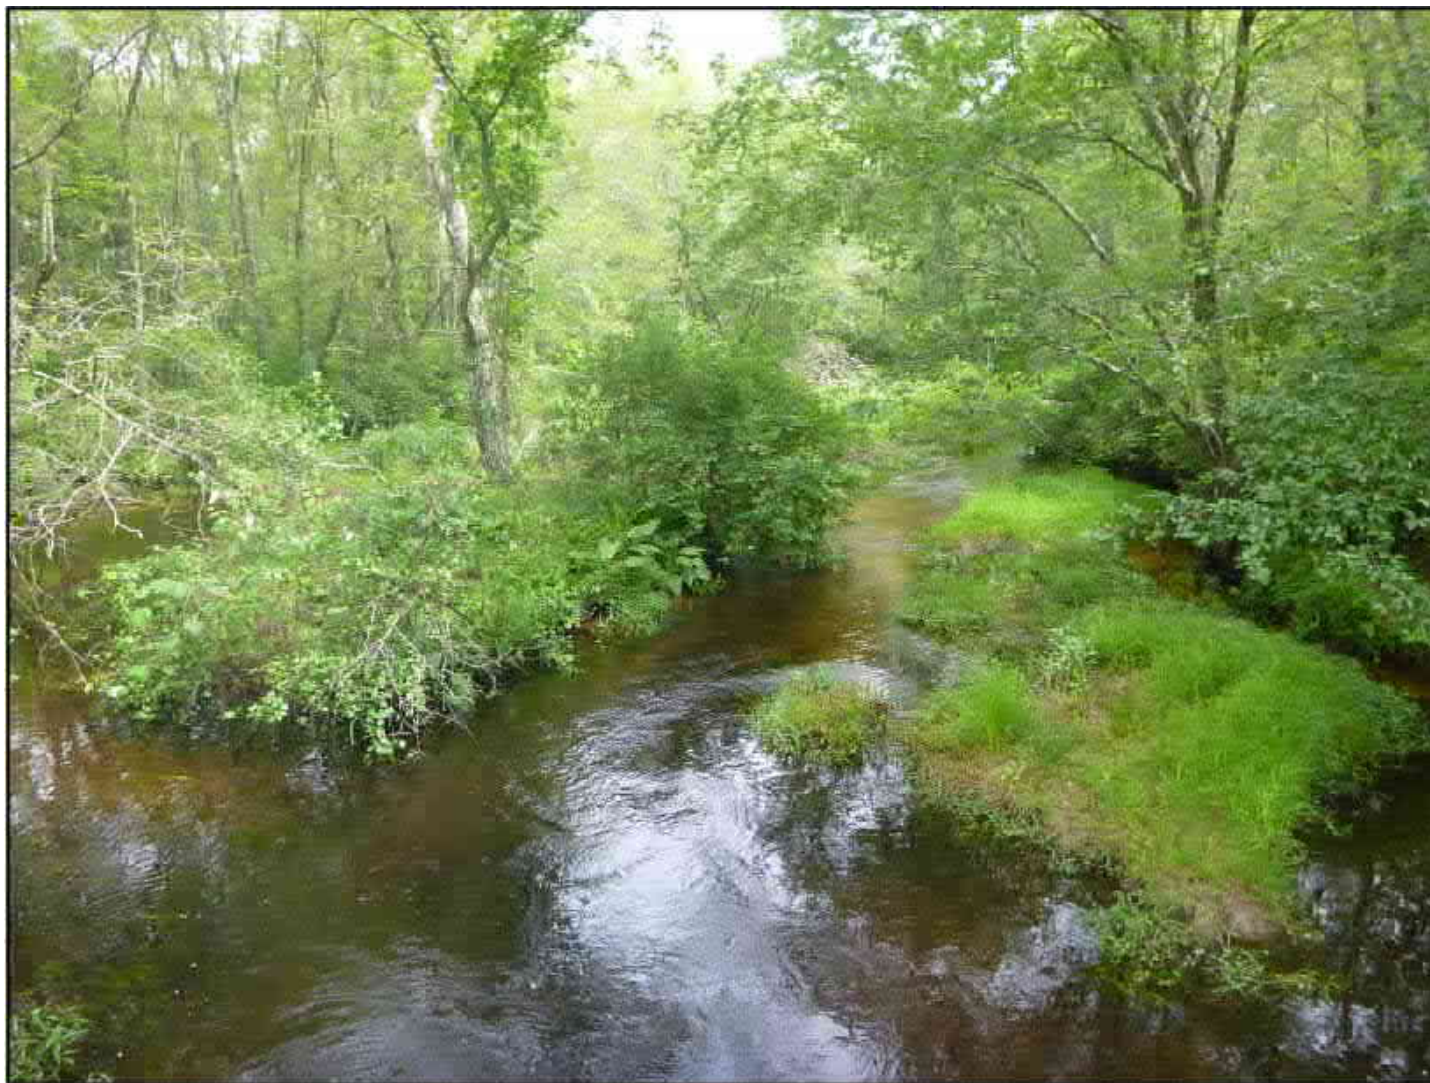
Figure 5. Deposition upstream of an undersized culvert in Reach QUS-11.

floodplain, the river can undergo the necessary lateral adjustments to evolve back to an equilibrium condition in most locations. Sediment deposition is typically concentrated at undersized crossings, dams, or other grade controls located downstream of straightened reaches (Figure 5). Plane-bed features of poor habitat quality characterize straightened reaches with a uniform depth across the channel as the result of limited sediment deposition. Therefore, the recreation of meanders can lead to a greater complexity of habitat types and increased sediment storage while reducing flood and erosion hazards downstream, because sediment and flow energy expenditure will be more evenly distributed throughout the watershed.

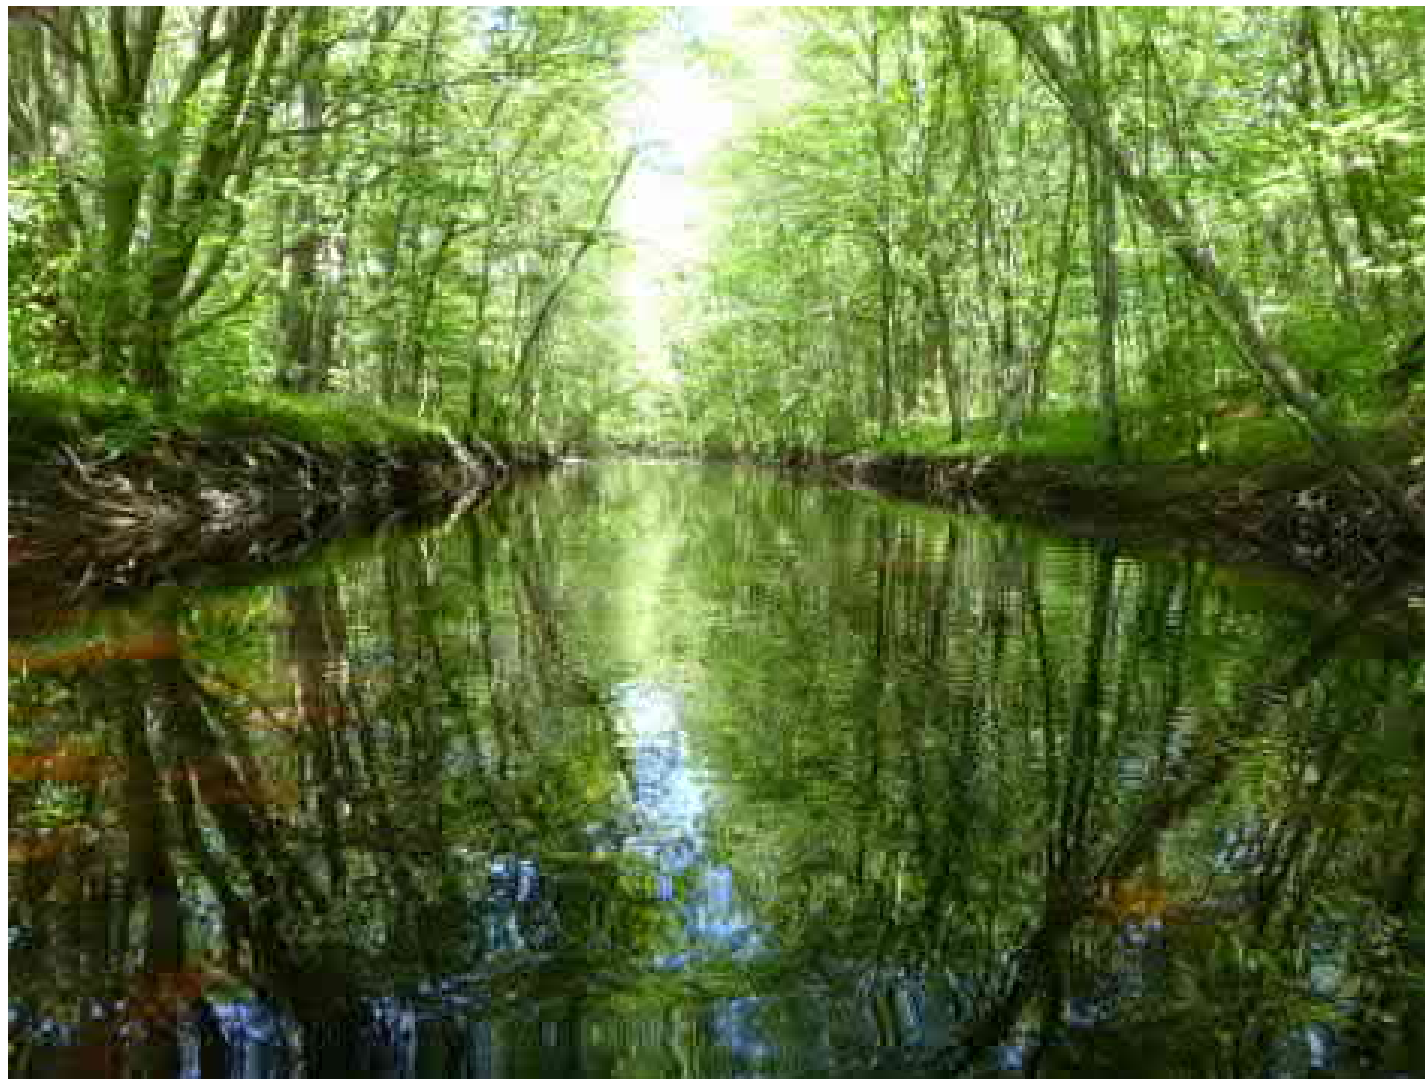
Figure 6. Upstream view of artificially straightened channel in GAS-4.

A river in geomorphic equilibrium matches the sediment delivered to a stream reach with the river's capacity to transport sediment through that reach. This is achieved through mutual adjustments in the channel's width, depth, slope, and boundary conditions (e.g., coarseness of sediment substrate). This equilibrium balance in sediment movement through a reach can be disrupted by changes in the amount of sediment delivered to the channel (i.e., sediment load) and/or changes in the channel's capacity to move sediment through the reach relative to upstream conditions. Aggradation, or sediment accumulation, occurs when the sediment load is increased, as at mass wasting sites (Figure 3), or the river's capacity to transport sediment is decreased, such as upstream of dams (Figure 4) or undersized stream crossings (Figure 5). Degradation, or loss of sediment through erosion, occurs when the sediment load is decreased (e.g., downstream of impoundments) or capacity to transport sediment increased (e.g., along straightened reaches). Identifying potential sediment sources (or lack of sources) and disruptions in transport capacity is, therefore, critical for anticipating the type and location of channel adjustments along the river. Erosion and deposition occurs naturally along rivers in equilibrium, but rapid changes engender significant channel adjustments that can harm aquatic habitat as is seen in the form of shallow braided channels where aggradation is occurring (Figure 5) or wide plane-bed channels where degradation removes sand/gravel bars and simplifies flow complexity (Figure 6).

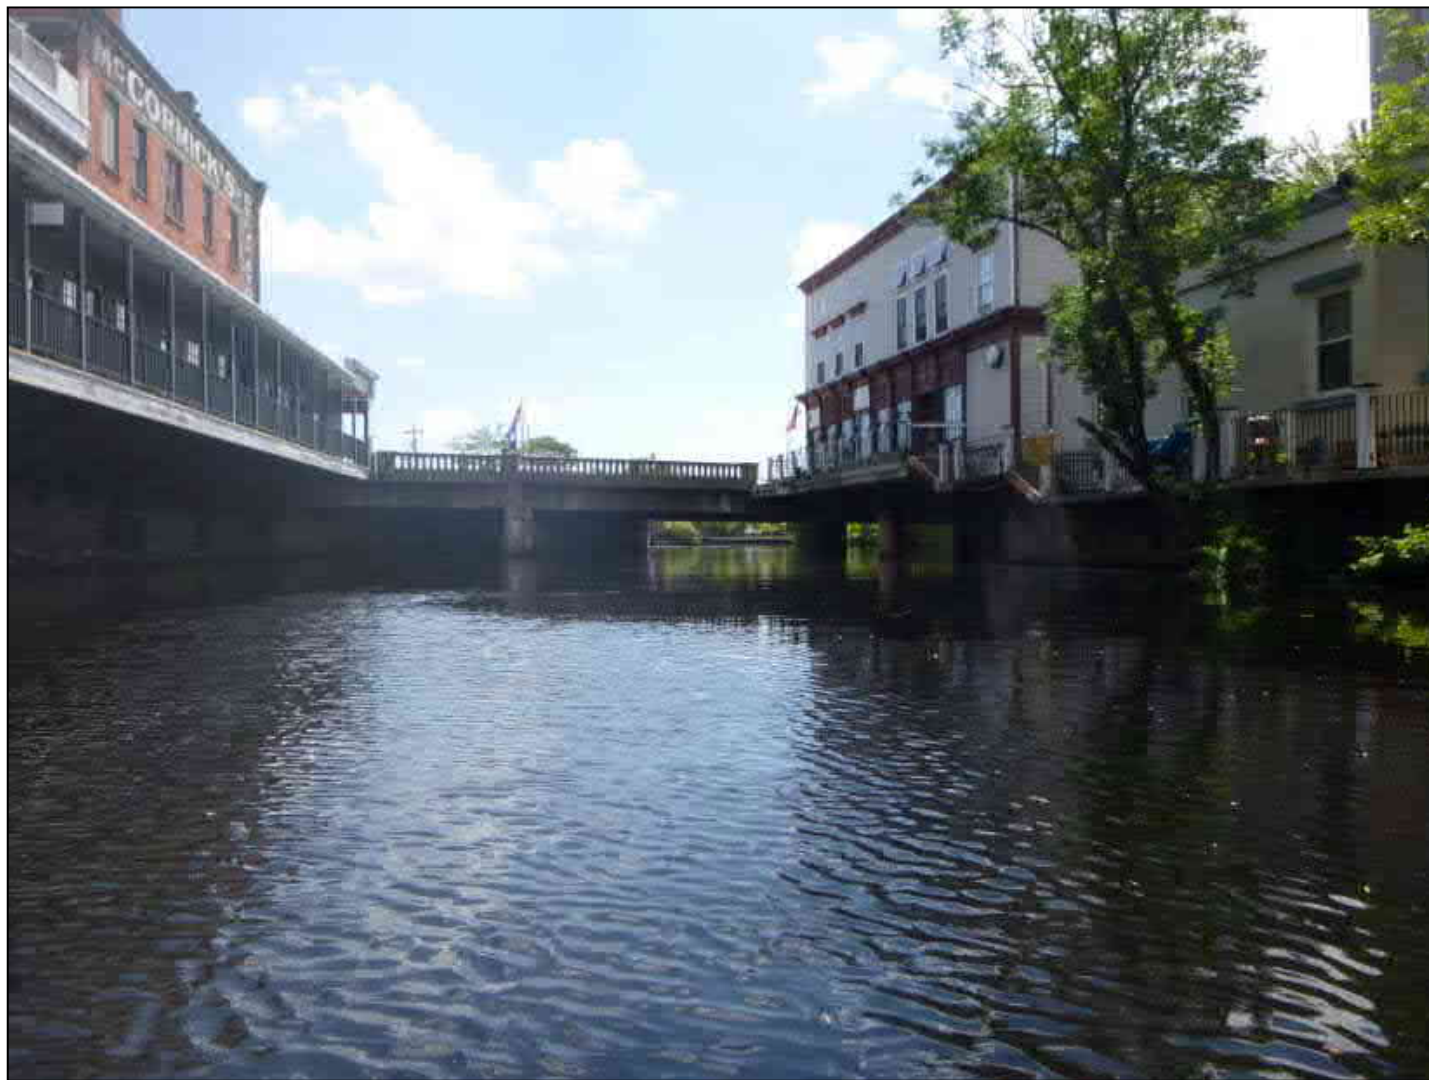
Figure 8. Human development constrains channel adjustment on the lower Pawcatuck River.

Human development in the watershed has created, in some locations, permanent constraints to channel evolution and is preventing the reestablishment of equilibrium conditions, particularly on the floodplain in Westerly, RI and Stonington, CT (Figure 8). However, overall levels of urbanization in the largely forested watershed have not reached a threshold level to precipitate system-wide channel adjustments in the Wood-Pawcatuck Watershed. Therefore, if further constraints in the watershed can be avoided in the remaining undeveloped areas of the

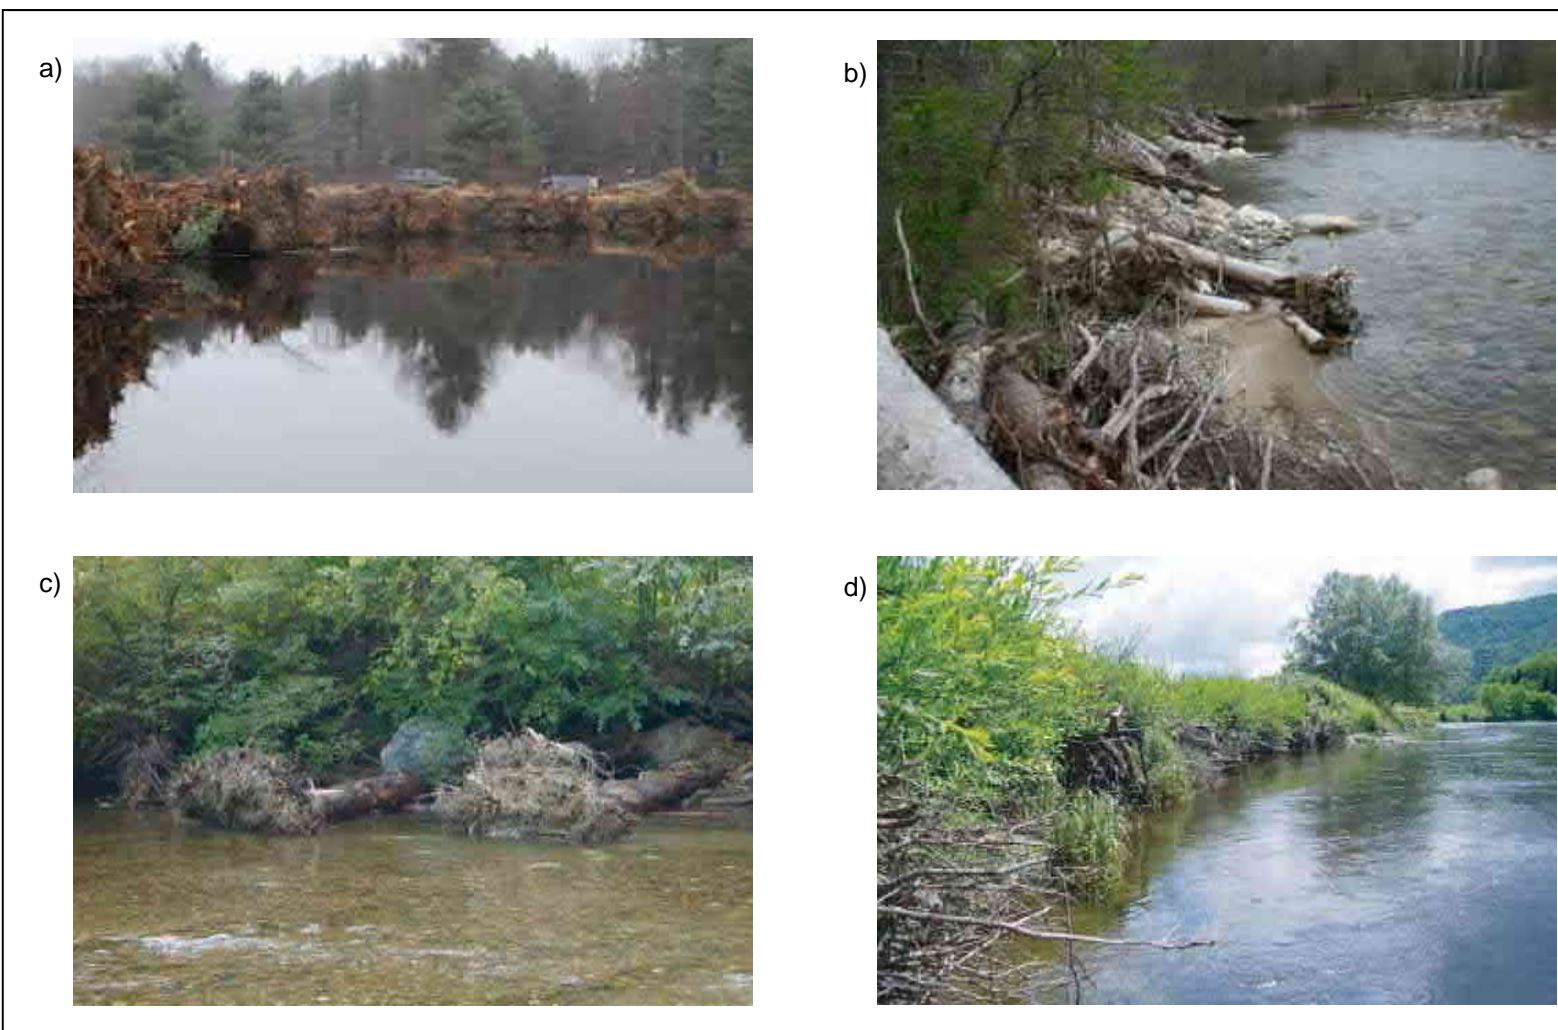
Figure 10. Examples of bioengineering techniques for bank stabilization include use of a) marginal log jams (Souhegan River in Merrimack, NH), b) boulder and log deflectors (Sunday River in Newry, ME), c) root wad revetments (Batten Kill in Arlington, VT), and d) willow stakes above root wad revetment (Connecticut River in Colebrook, NH).

Long-term remedies of bank erosion depend on reducing erosive forces within the reach and restoring conditions in upstream reaches that are the ultimate cause for the destabilizing incision or aggradation. Channel evolutionary processes that will bring the channel back into equilibrium often result in bank erosion and require a supply of sediment from upstream to sustain the required channel adjustments. Consequently, the need for bank stabilization must be closely examined in order to avoid slowing the process of channel evolution. However, short term bank stabilization may be required where: 1) human infrastructure is imminently threatened; 2) a reduced rate of lateral erosion on a reach is necessary to give riparian buffer plantings ample time to mature; or 3) a valuable resource might be permanently lost such as fertile floodplain soils. Bank stabilization efforts should avoid permanently armoring the banks, especially on incised reaches, because the necessary adjustments to achieve equilibrium will be hindered. Ideally, bank stabilization should consist of bioengineering methods that reduce the flow energy impinging on the banks through flow deflection (Figure 10). Bioengineering treatments, such as willow staking, are less successful if not accompanied with the toe treatments required to reduce erosive forces along the bank (Figure 10d).

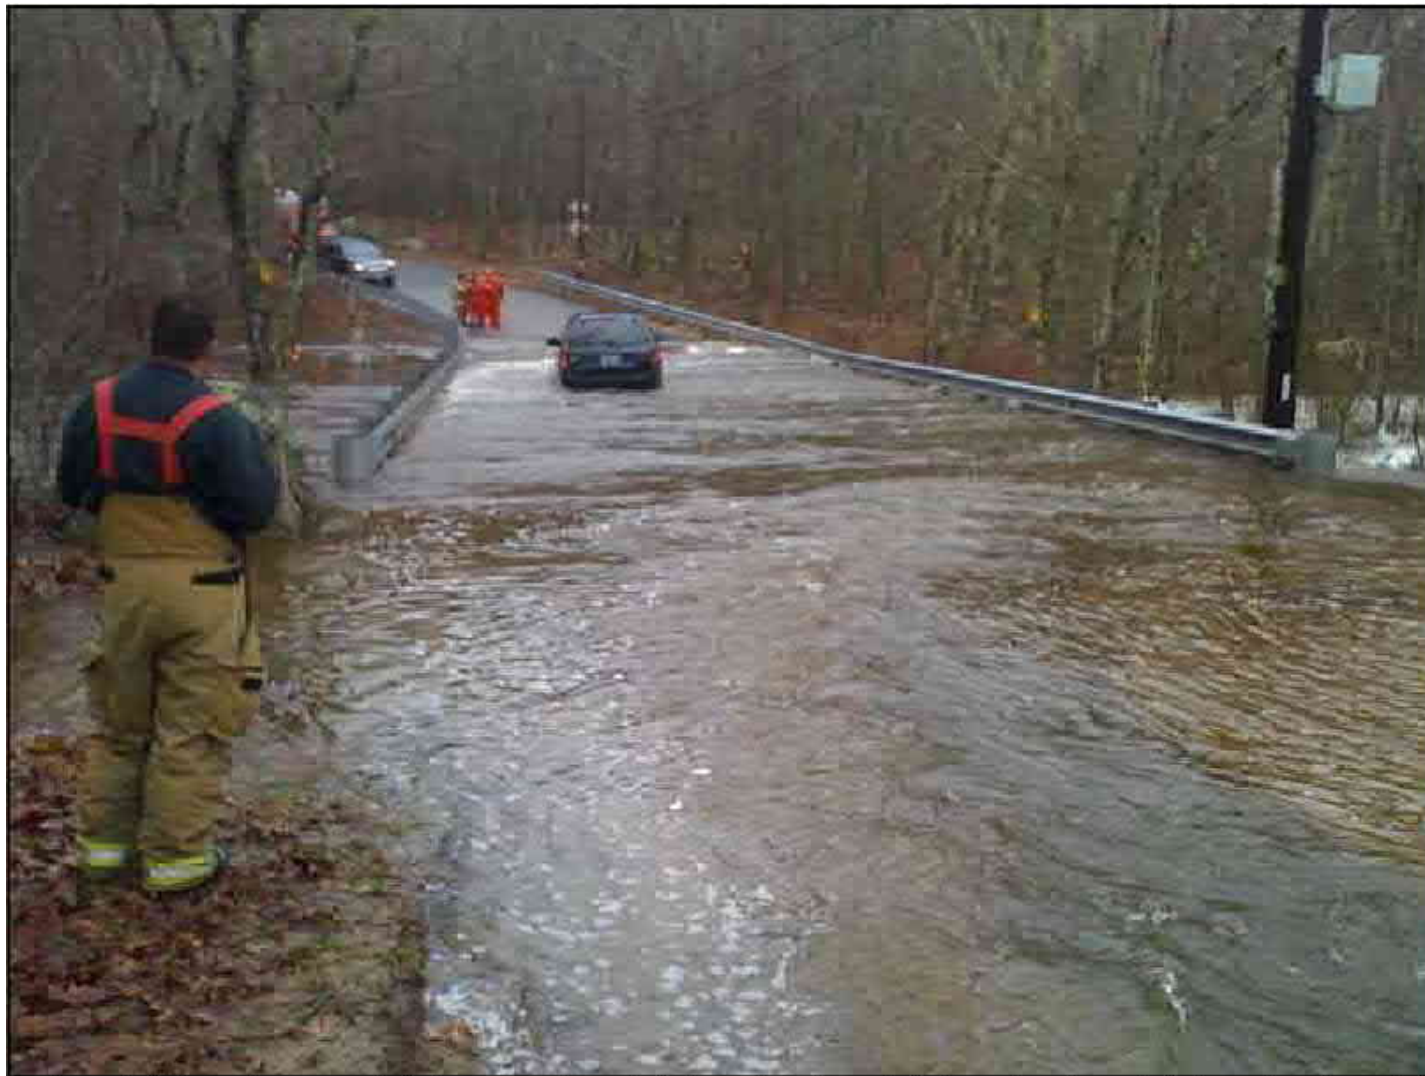
Figure 12. Hillsdale Road overtopped due to backwatering behind undersized culvert during 2010 flood on Beaver River in Richmond, RI.

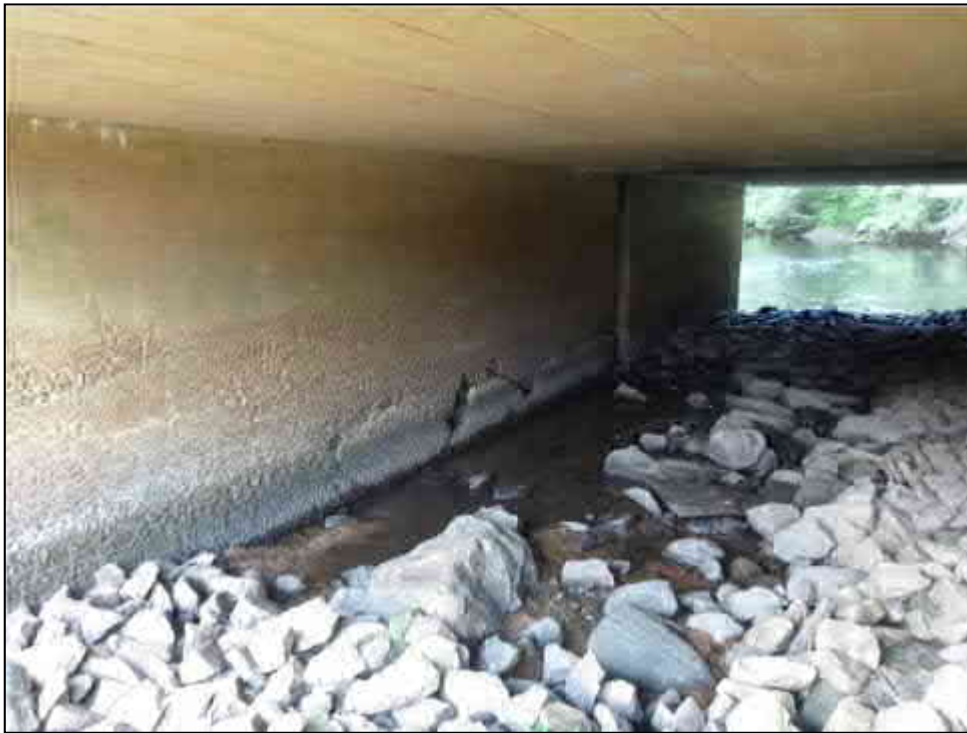
Figure 13. Old Shannock Road Bridge in PAR-23 showing a) upstream overview and b) close up of scour damage and subsequent riprap protection.

Many bridges and culverts in the assessed reaches are significantly undersized (i.e., narrower than the bankfull channel width), resulting in flood hazards (Figure 12) and causing channel adjustments upstream and downstream of the structure (Figure 5). These localized adjustments have caused considerable damage to several structures in the Wood-Pawcatuck Watershed (Figure 13). Replacing undersized structures with larger spans will reduce hazards and effects on channel morphology that potentially damage the structures themselves while creating better hydraulic conditions for aquatic organism passage. Since stream crossings represent the majority of encroachments in the river corridor, their replacement and retrofitting should be a high priority.

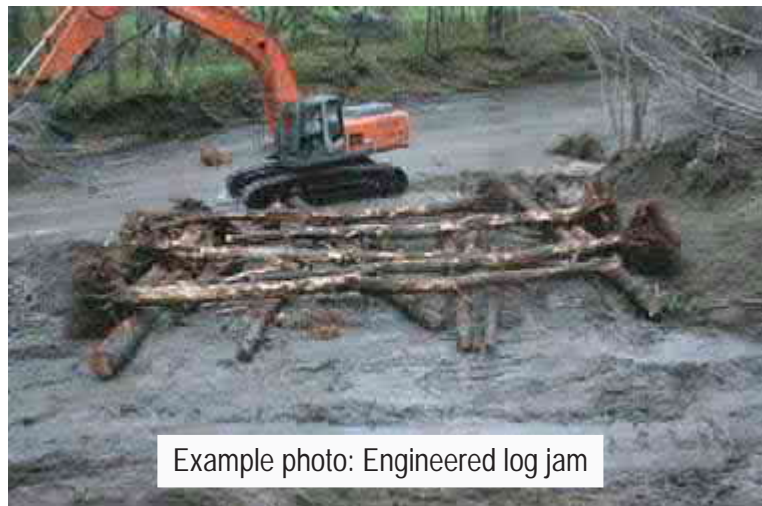
Figure 14. Design typical for an engineered log jam.

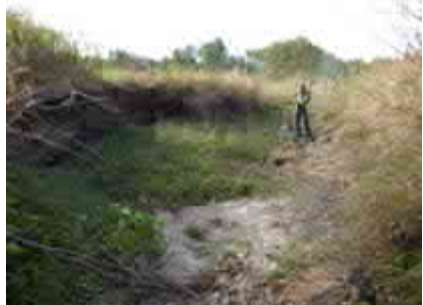
Bridge/ Culvert	Location					
Reach	Town	Code	Lat.	Long.	Priority	Description	Photograph	
Culvert Replacement								
MEB-8B	Richmond, RI	3016	41.501	-71.665	High	Severe erosion immediately downstream, head cut up to culvert outlet, undersized

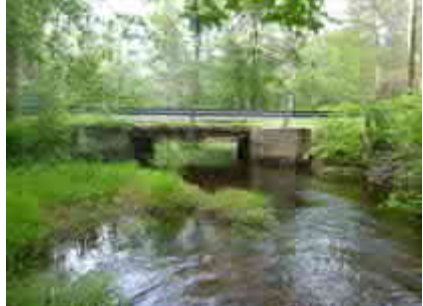
QUS-11	Exeter, RI	4768	41.539	-71.569	High	Severe deposition upstream, downstream scour, low bridge probably overtopped frequently

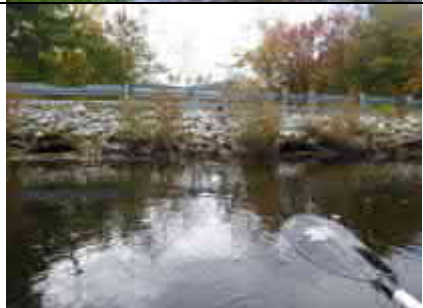
CHIP-8	Exeter, RI	4509	41.506	-71.531	High	Beaver dam occupied, probably overtopped frequently

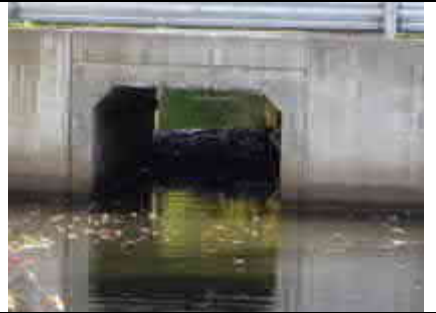
Reach	Town	Bridge/ Culvert Code	Location Lat.	RCPA Long.	Priority	Description	Photograph
CHIP-8	Exeter, RI	4455	41.518	-71.526	High	Significantly undersized, beaver occupied

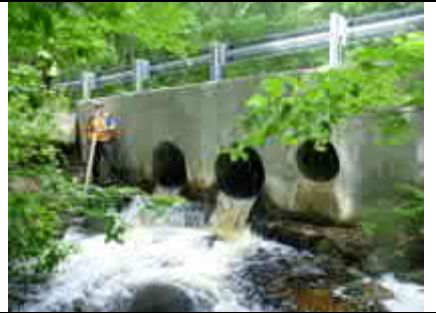
BER-7	Richmond, RI	2967	41.526	-71.639	High	Undersized, perched at outlet, culvert was overtopped in 2010

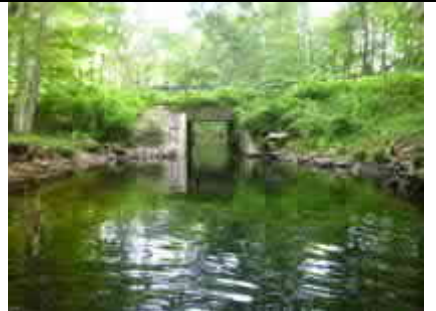
GAS-8	North Stonington, CT	347	41.472	-71.816	Low	Undersized, side channels and aggradation upstream, large scour pool downstream

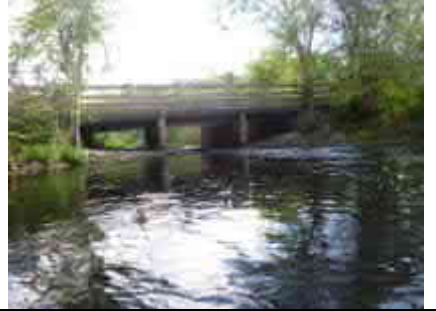
Reach	Town	Bridge/ Culvert Code	Location Lat.	RCPA Long.	Priority	Description	Photograph
Bridge Replacement							
PAR-23	Charlestown, RI	3869	41.448	-71.645	High	Scour issues in bed and downstream, undersized

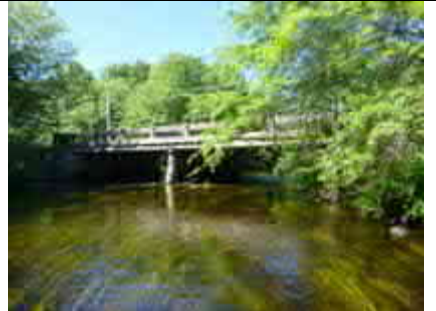
PAR-17	Charlestown, RI	3739	41.433	-71.694	High	Poor condition, oversized riffle upstream

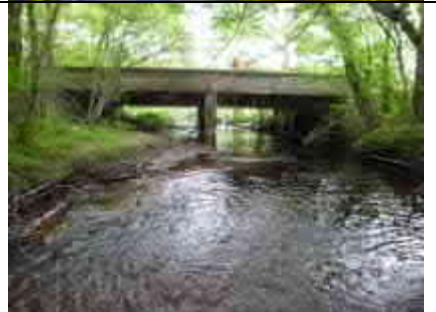
GAS-4	Hopkinton, RI	719	41.443	-71.796	High	Severely damaged

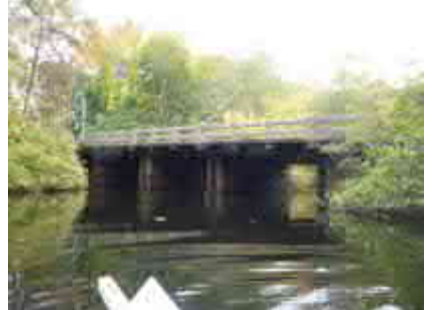
Reach	Town	Bridge/ Culvert Code	Location Lat.	RCPA Long.	Priority	Description	Photograph
GAS-2	Hopkinton, RI	699	41.425	-71.790	High	Should be replaced with dam removal

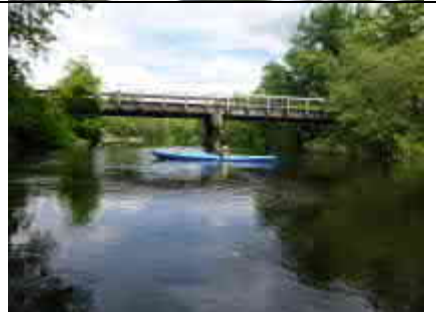
PAR-6	Westerly, RI	69	41.418	-71.823	High	Boom Bridge Road, heavily damaged and currently closed

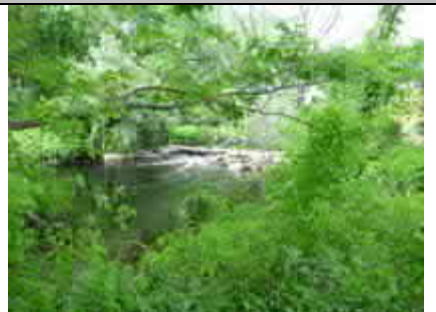
Dam Removal							
GAS-1	Hopkinton, RI		41.423	-71.792	High	Low head dam but prevents fish passage up the Ashaway River

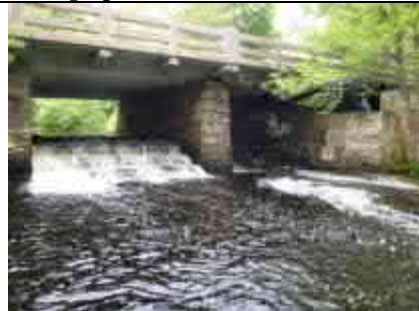
Reach	Town	Bridge/ Culvert Code	Location Lat.	RCPA Long.	Priority	Description	Photograph
GAS 2	Hopkinton, RI		41.425	-71.790	High	Causing vibration damage to adjacent house, raises water level around bridge potentially

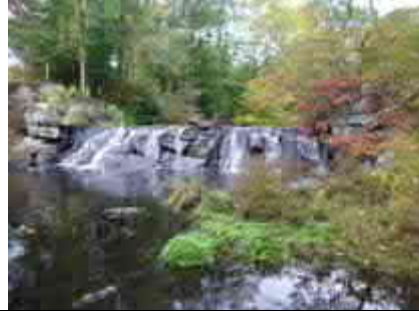
GAS-2	Hopkinton, RI		41.431	-71.790	High	Dam not in use, partially broken down, blocking fish passage to high quality habitat

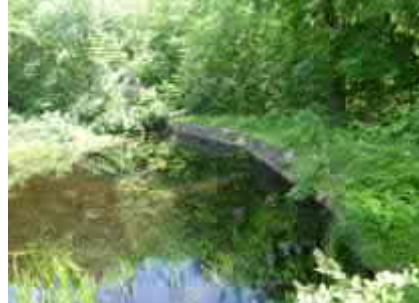
BER-6b	Richmond, RI		41.521	-71.640	High	Pond not in use but backs water up to road, potentially high quality habitat with connectivity

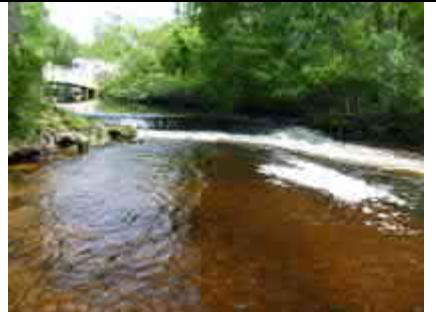
Reach	Town	Bridge/ Culvert Code	Location Lat.	RCPA Long.	Priority	Description	Photograph
PAR-18	Charlestown, RI		41.443	-71.681	Low	Only dam/weir without some sort of fish ladder on mainstem, gage could function without weir

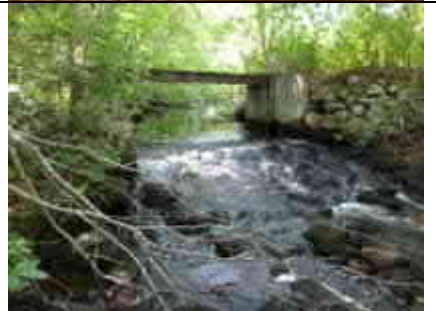
BER-4	Richmond, RI		41.498	-71.631	Low	Splits up good habitat, not in use, contributed to trail washout

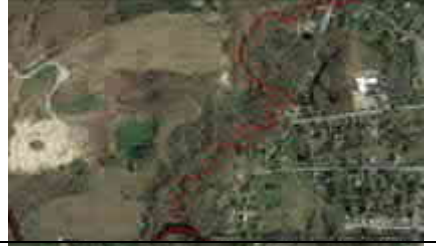
Reach	Town	Bridge/ Culvert Code	Location Lat.	RCPA Long.	Priority	Description	Photograph
Corridor protection							
GAS-1	Hopkinton, RI		41.418	-71.797	High	Entire reach should be protected, very dynamic, great habitat, poor location for development, luckily development has not encroached significantly

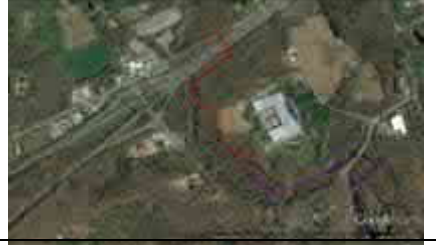
GAS-4	Hopkinton, RI		41.441	-71.797	High	Dynamic channel, recent avulsion, good habitat

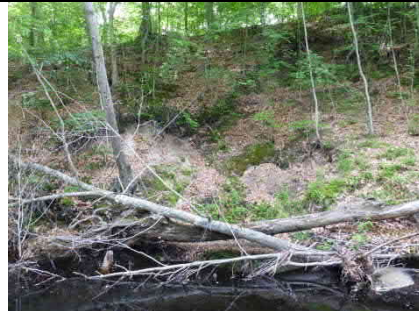
Bank stabilization							
GAS-1	Hopkinton, RI		41.422	-71.796	High	Logjams at the toe of mass failures represent potential stabilization option, house frontage is being eroded

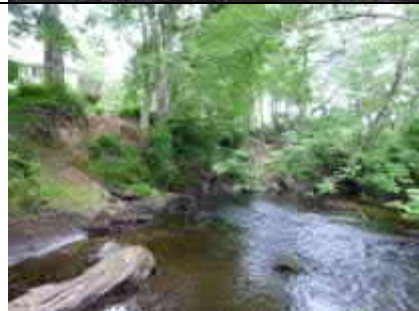
GAS-1	Hopkinton, RI		41.418	-71.796	High	House frontage is being eroded

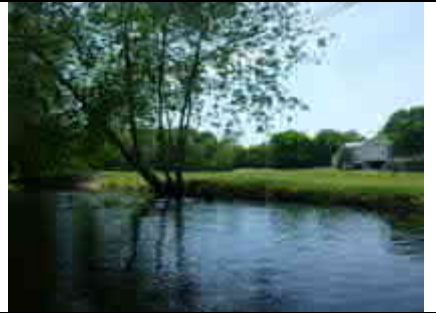
Reach	Town	Bridge/ Culvert Code	Location Lat.	RCPA Long.	Priority	Description	Photograph
WOD-9	Hopkinton, RI		41.511	-71.708	Low	Eroding bank with no riparian buffer

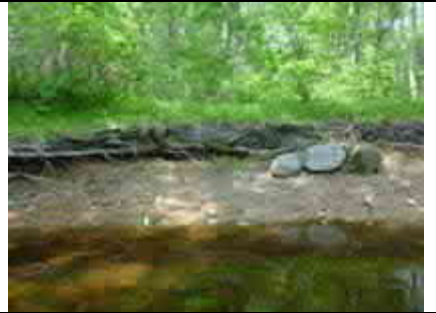
PAR-20	Charlestown, RI		41.457	-71.674	Low	Erosion common in reach, could create log jams to protect banks and create habitat

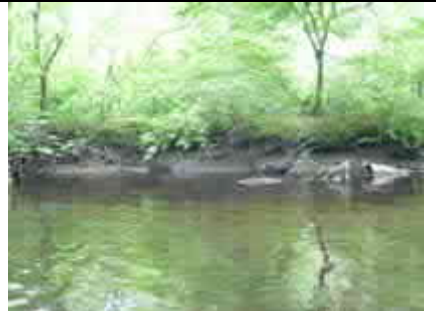
PAR-21	Charlestown, RI		41.461	-71.670	Low	Erosion common in reach, could create log jams to protect banks and create habitat

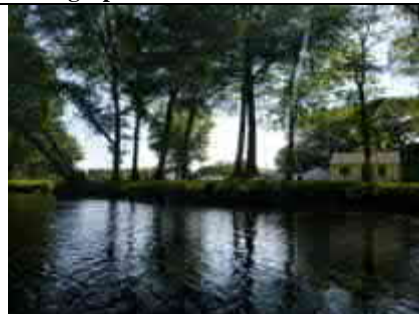
Reach	Town	Bridge/ Culvert Code	Location Lat.	RCPA Long.	Priority	Description	Photograph
PAR-3	Westerly, RI		41.402	-71.842	Low	Eroding and no riparian buffer but priority low

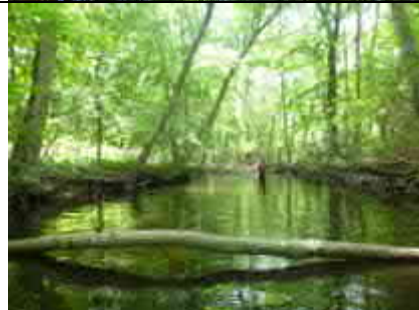
GAS-8	North Stonington, CT		41.472	-71.816	High	Install marginal log jams to help channel aggrade and form meanders, downstream of Puttker Road

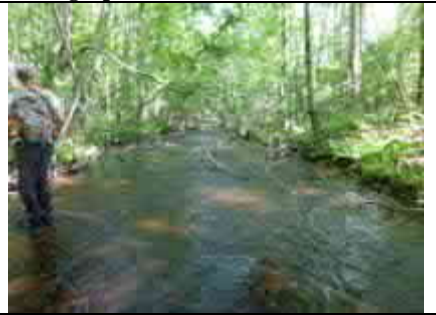
Reach	Town	Bridge/ Culvert Code	Location Lat.	RCPA Long.	Priority	Description	Photograph
BER-6-7	Richmond, RI		41.521	-71.640	High	Wood additions to create habitat complexity and increase use of side channels

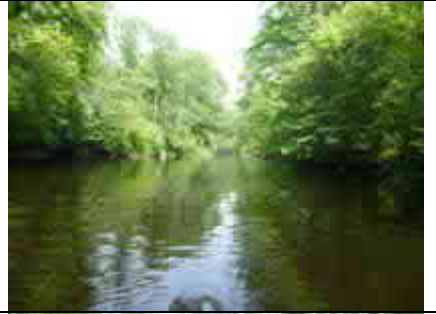
PAR-18	Charlestown, RI		41.443	-71.681	High	Log jams could be used to help reform meanders

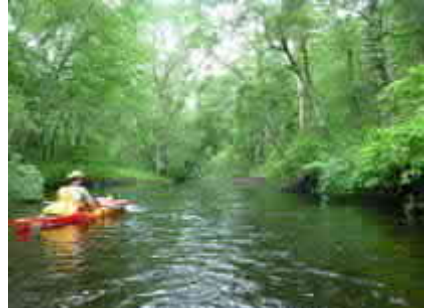
WOD-14-16	Exeter, RI		41.560	-71.714	Low	Improve already good habitat with additional wood to create log jams

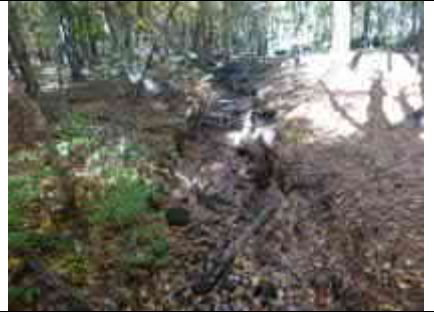
Reach	Town	Bridge/ Culvert Code	Location Lat.	RCPA Long.	Priority	Description	Photograph
MEB-8b	Richmond, RI		41.500	-71.667	Low	Reform meanders with wood additions along incised channel upstream of golf course running along the elementary school

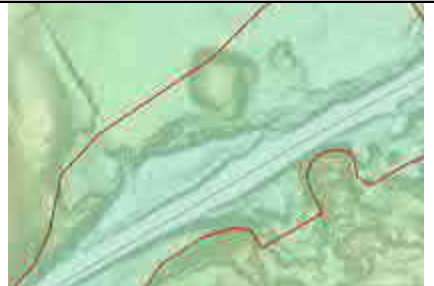
Removal or retrofitting of encroachment							
PAR-5	Westerly, RI		41.413	-71.832	High	Removal of right bank berm from past gravel mining to increase floodplain access at the upstream end of reach

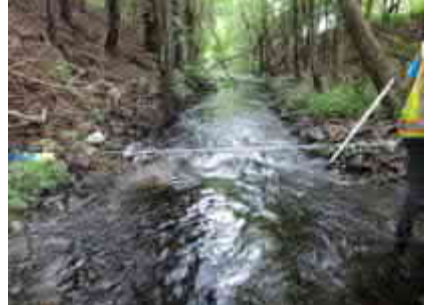
SHUN-10b	North Stonington, CT		41.462	-71.908	Low	Berm removal to lower flood stages downstream of the bridge and to keep flow off of steep hillslope on left bank that could become stabilized

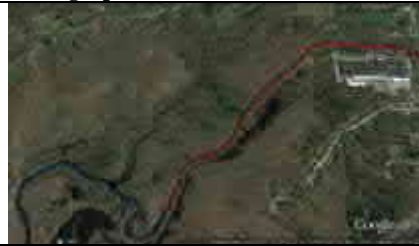
Reach	Town	Bridge/ Culvert Code	Location Lat.	RCPA Long.	Priority	Description	Photograph
PAR-12	Westerly, RI		41.403	-71.760	Low	Ponds downstream of Bradford mill complex should be moved further away from stream to remove avulsion hazard and increase floodplain width

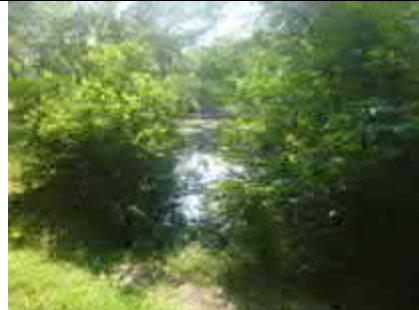
BER-2	Richmond, RI		41.478	-71.624	Low	Pond takes lots of water out of stream, potential avulsion risk

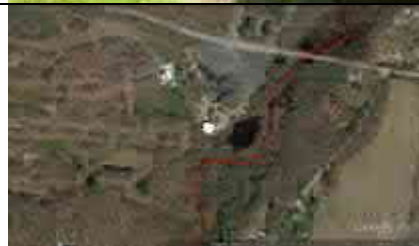
CHIP-8	Exeter, RI		41.517	-71.526	Low	Pond/berm that could be breached to increase floodplain access

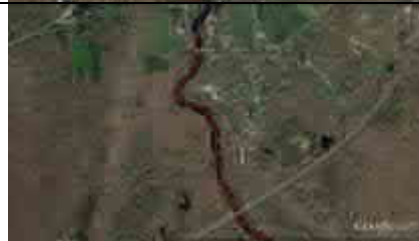
PAR-15	Charlestown, RI		41.411	-71.726	Low	Artificial floodplain constriction that could be alleviated with flood relief culverts, development present upstream

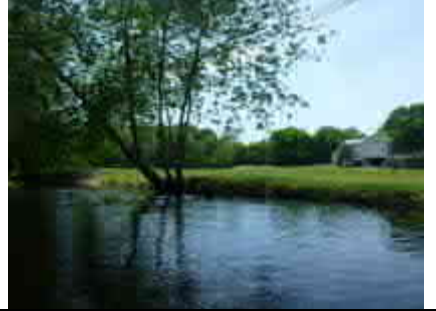
Reach	Town	Bridge/ Culvert Code	Location Lat.	RCPA Long.	Priority	Description	Photograph
Riparian buffer planting							
WOR-9	Hopkinton, RI		41.511	-71.708	High	Replant of buffer on right bank

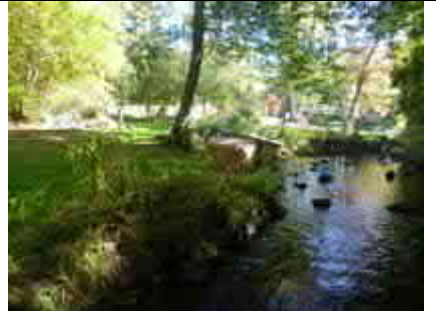
CHIP-10	North Kingstown, RI		41.536	-71.517	High	Encourage buffer planting along the left bank where residences abut the channel

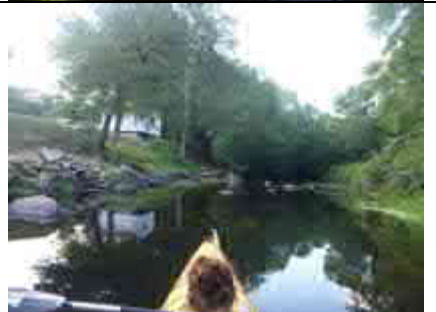
PAR-23	Charlestown, RI		41.452	-71.651	High	Encourage planting of woody vegetation at residential river frontages

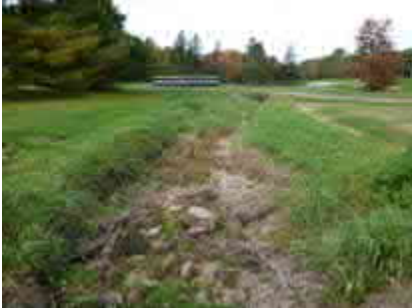
Reach	Town	Bridge/ Culvert Code	Location Lat.	RCPA Long.	Priority	Description	Photograph
MEB-8B	Richmond, RI		41.504	-71.664	High	Turn the series of ponds and garbage at Meadow Brook Golf Course into a more distinct stream channel

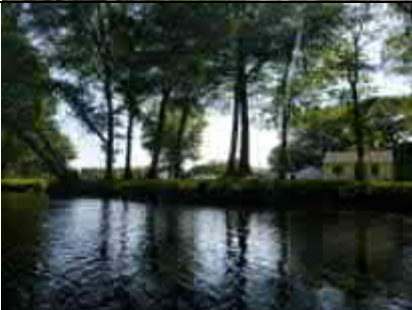
PAR-3	Westerly, RI		41.402	-71.842	High	Gravel pit/ concrete business on the right bank, bank without buffer has suffered some erosion
