Pawcatuck River Watershed Flood Resiliency Management Plan

Rhode Island League of Cities and
Towns Annual Convention

January 29, 2015

Wood-Pawcatuck Watershed Association

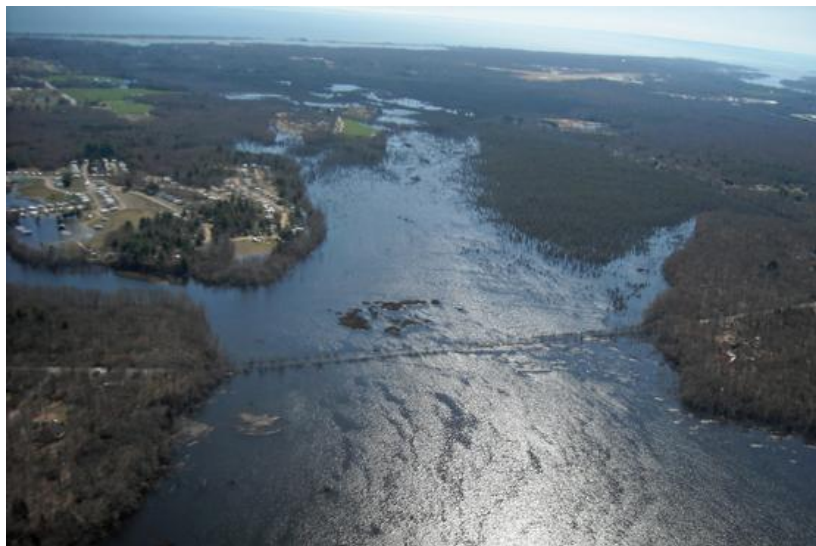
Pawcatuck River, Westerly, April 2010

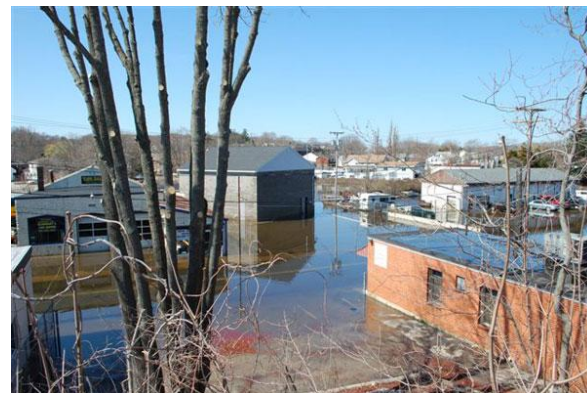
Pawcatuck River, Westerly, April 2010

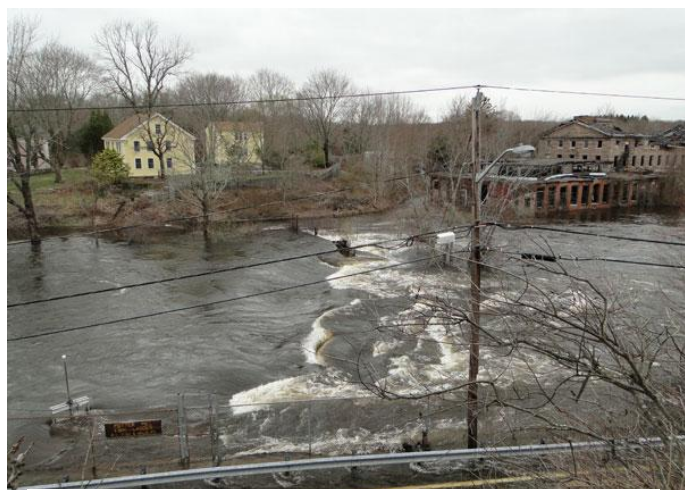
Pawcatuck River, Ashaway, April 2010

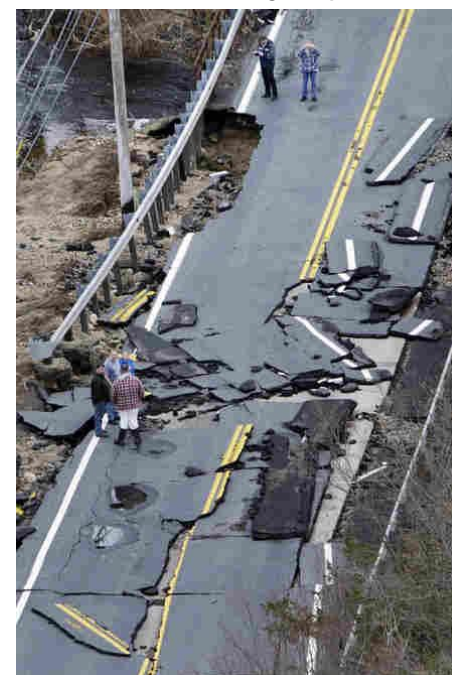
Wood River, Hopkinton, April 2010

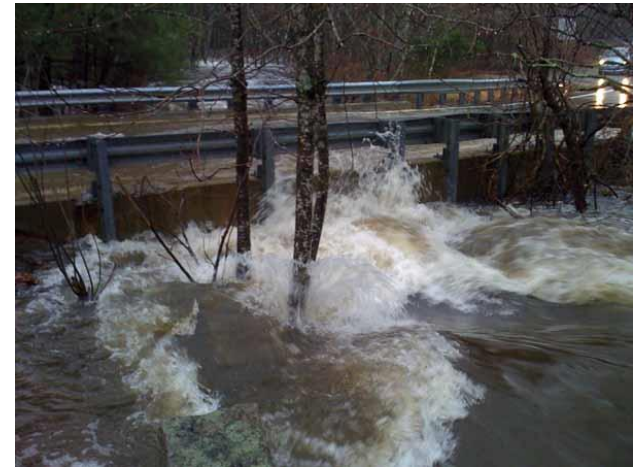
Arcadia Road Bridge, Wood River, March 2010

- Assessment of hydraulic structures in the watershed
- Bridges and Culverts
 - Conveyance capacity and flooding/erosion potential
 - Aquatic connectivity
 - Build on work by USGS, FEMA, USACE, and RI RC&D
- Dams (over 100 in watershed)
 - Flood/erosion damage potential due to breach or failure
 - Dam removal and fish passage feasibility

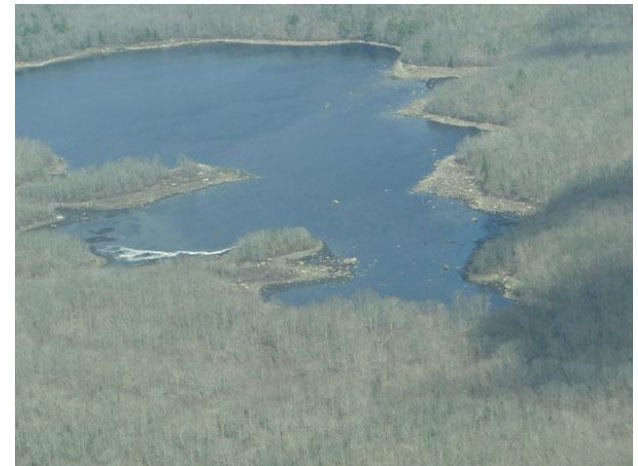
Blue Pond Dam Breach, Rockville, RI, March 2010

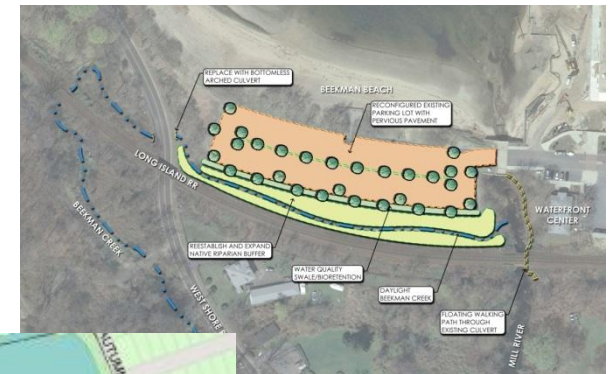
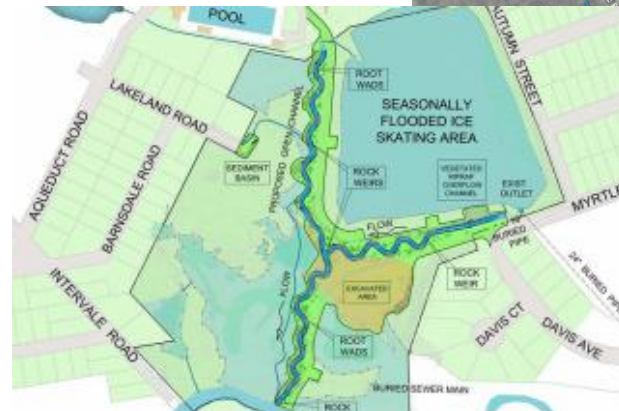
-
- LANDSCAPED MEDIAN
- PERVIOUS PAVEMENT AT INTERSECTIONS AND ON-STREET PARKING BAYS
- CURB CURB
- BIORETENTION FOR STORMWATER BASIN AT BULE-OUT
