MEMORANDUM

RE: Technical Assessment Methods and Geographic Priorities
Wood-Pawcatuck Watershed Flood Resiliency Management Plan

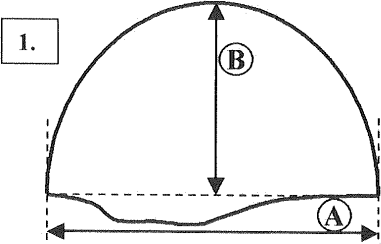
<p>1. Open Bottom Arch</p> </div>	<div style="text-align: center;">

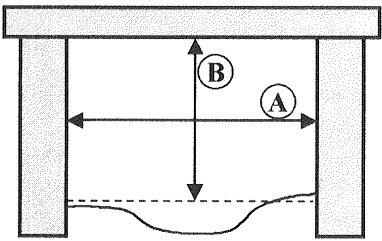
<p>2. Bridge with Abutments</p> </div>
<div style="text-align: center;">

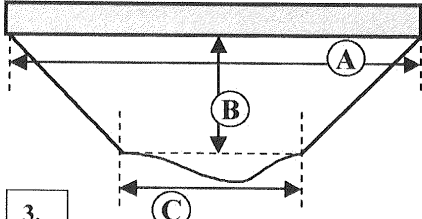
<p>3. Bridge with Side Slopes</p> </div>	<div style="text-align: center;">

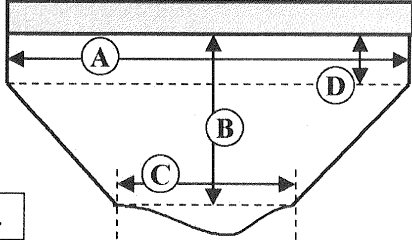
<p>4. Bridge w/ Side Slopes & Abutments</p> </div>
<div style="text-align: center;">
