# Horseshoe Falls Dam Fish Passage Project

Public Informational Meeting  
Richmond/Charlestown, RI

Wood-Pawcatuck Watershed Association

September 21, 2010

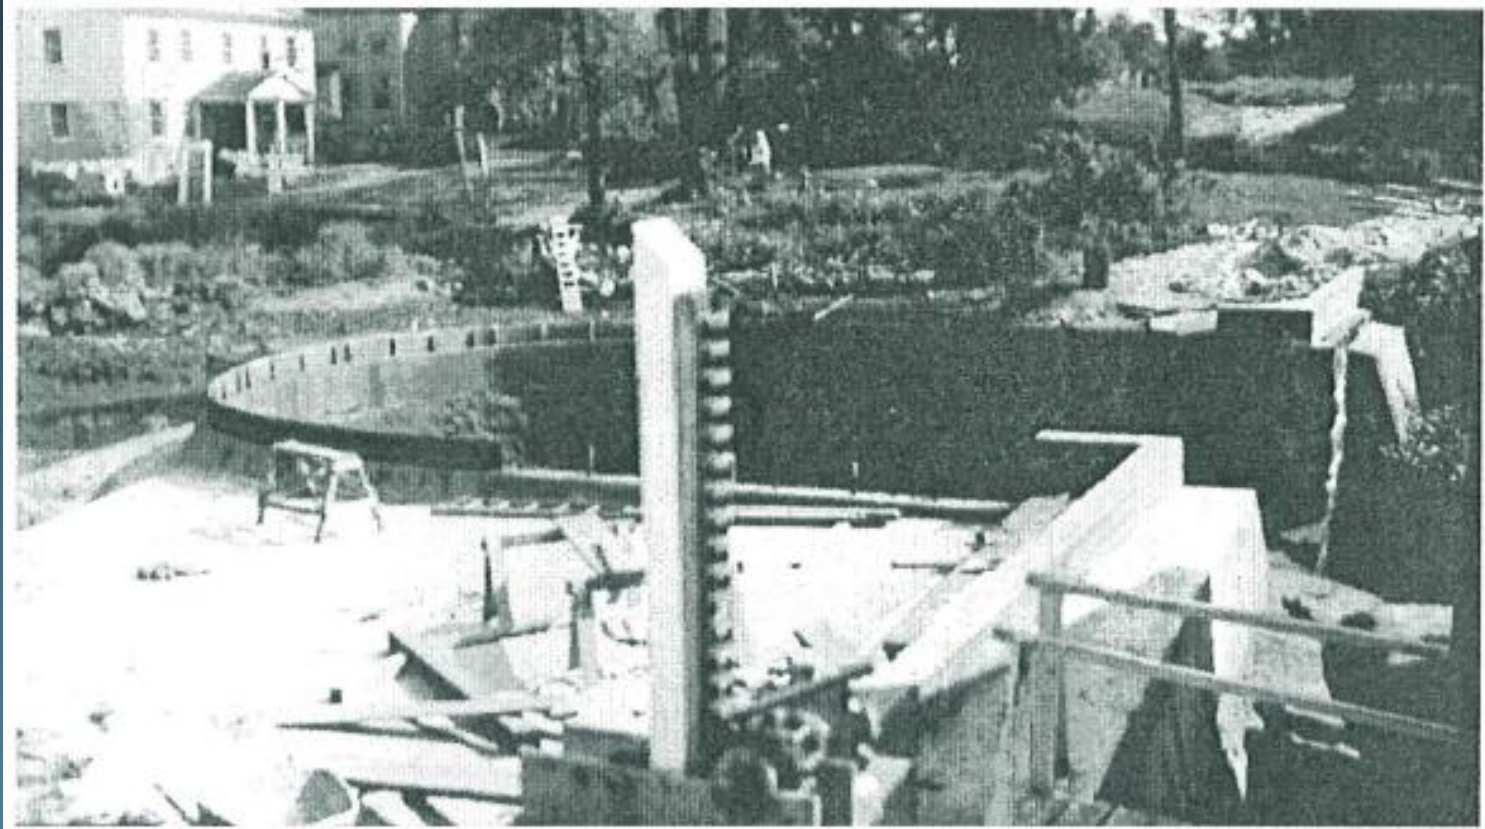
Dam Reconstruction Drawing (1945)

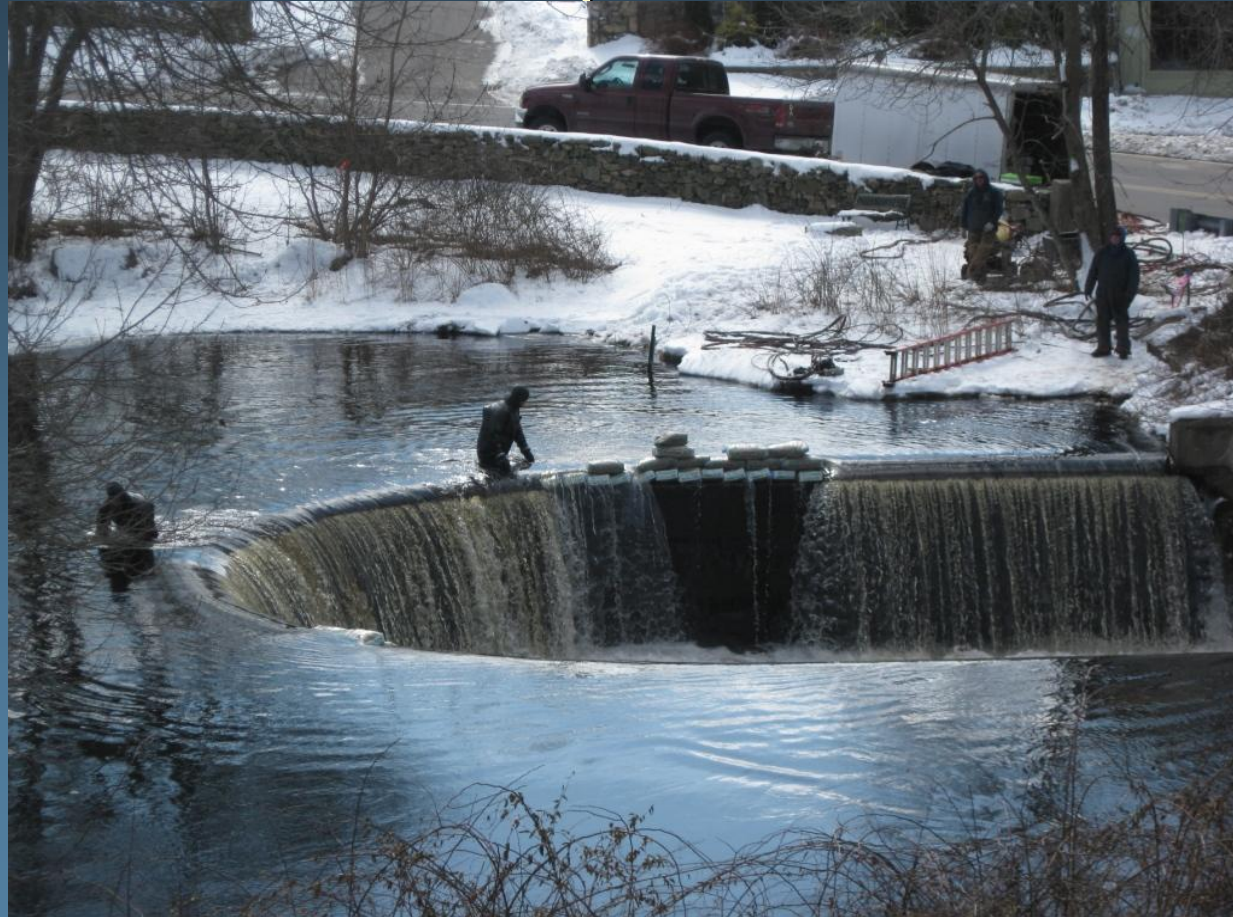
Horseshoe Dam Structural Inspection – February, 2010

- Current Dam Condition
  - *Spillway Remains in FAIR Condition*
    - *Cracks/Leakage in Concrete Apron Behind Spillway*
    - *Voids on Stone Masonry Spillway Face*
  - *Embankment Walls in Fair Condition*
    - *Left Wall to be removed during construction*
  - *Damage/Deficiencies Noted on Raceway Walls*

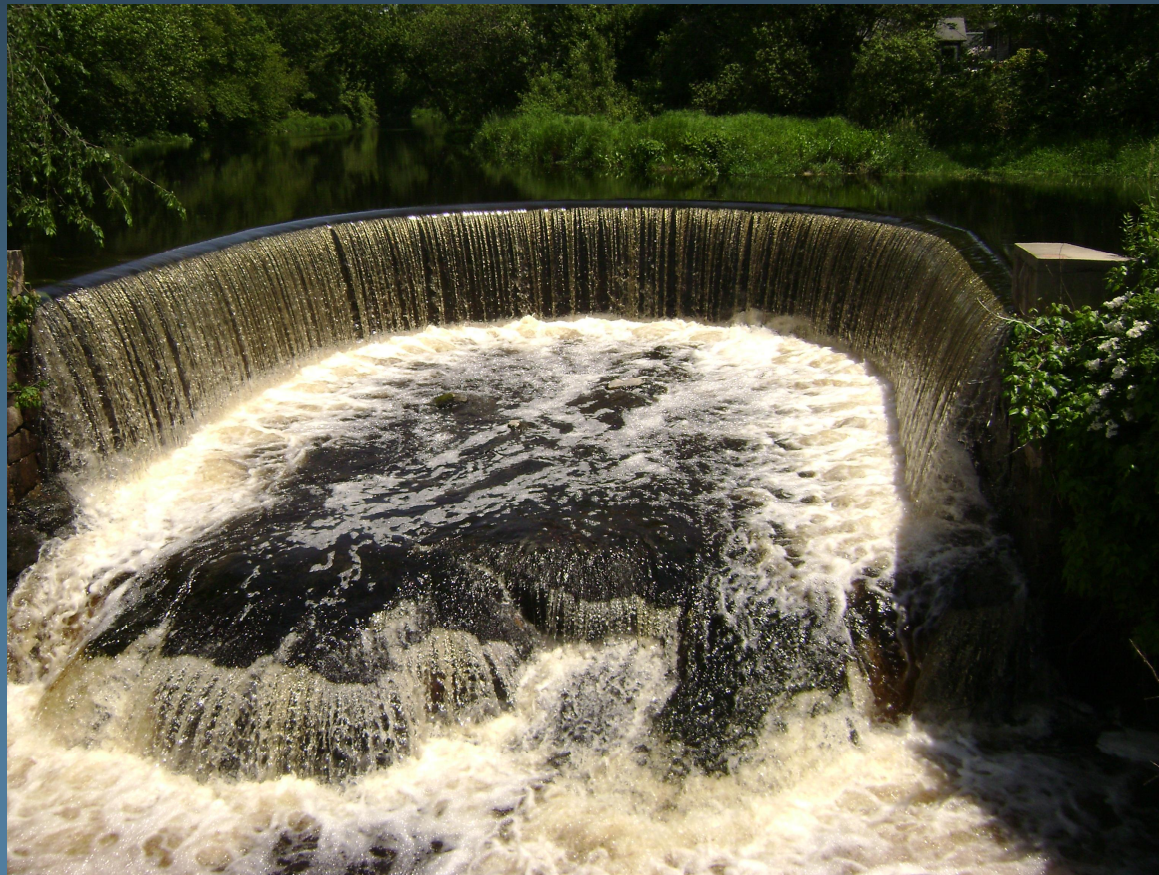
Horseshoe Dam – June, 2010

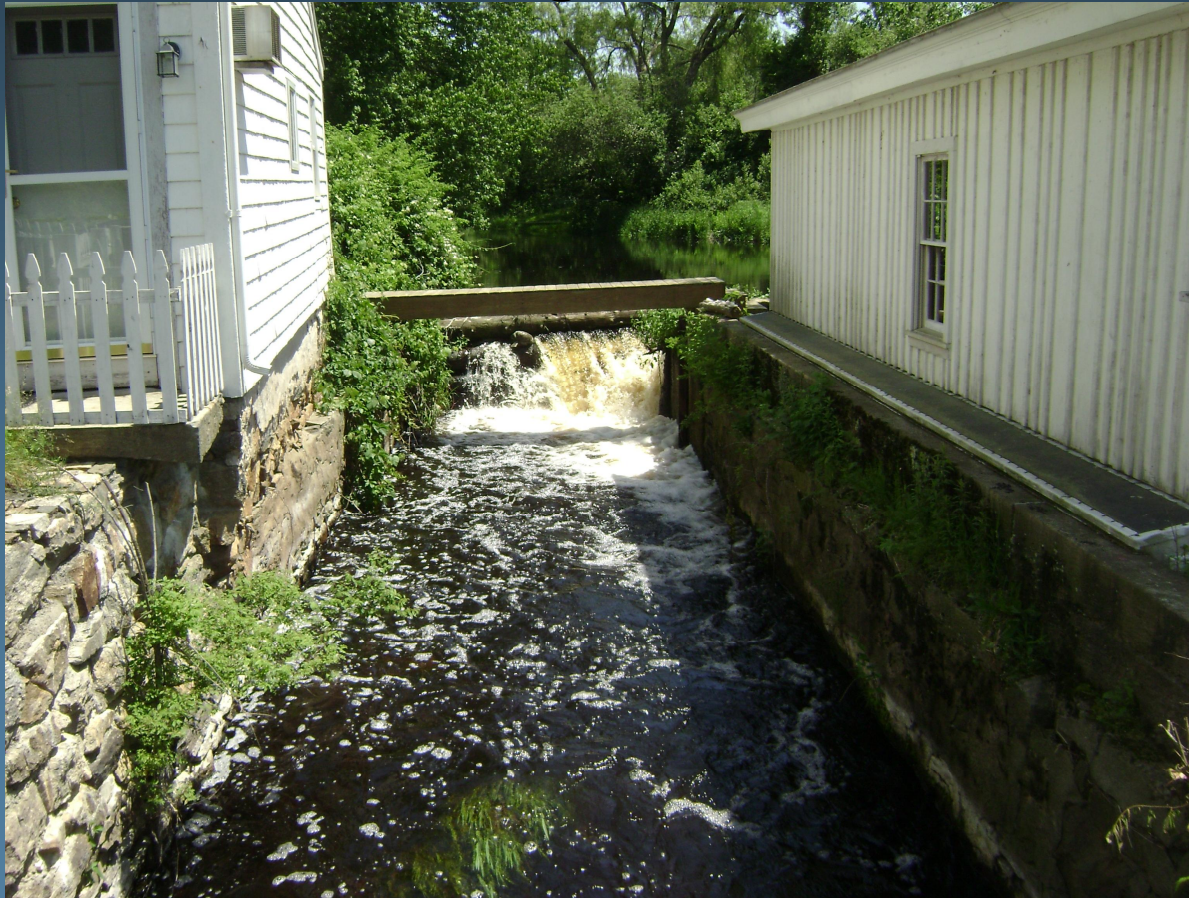
Raceway – June, 2010

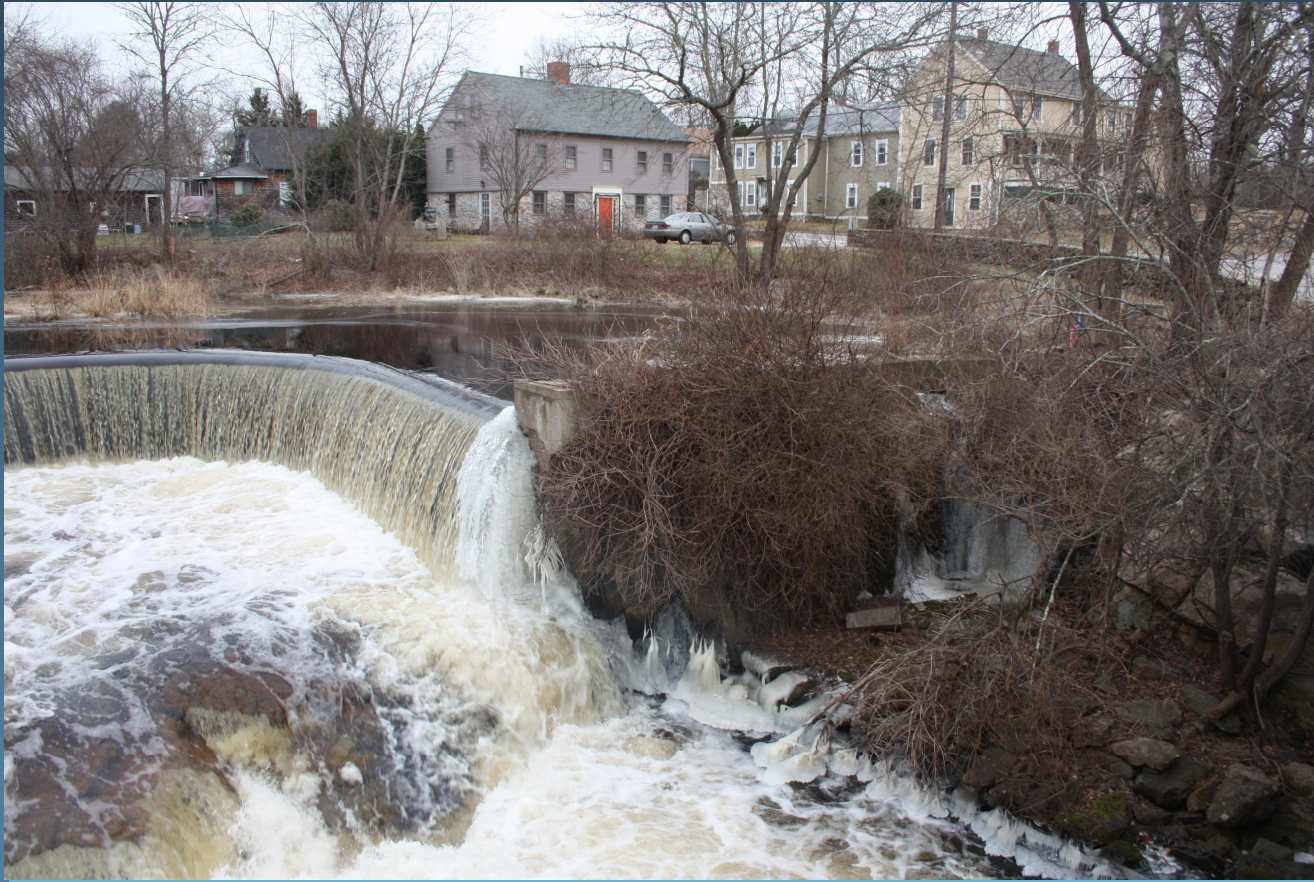
Left Embankment Wall – February 2010

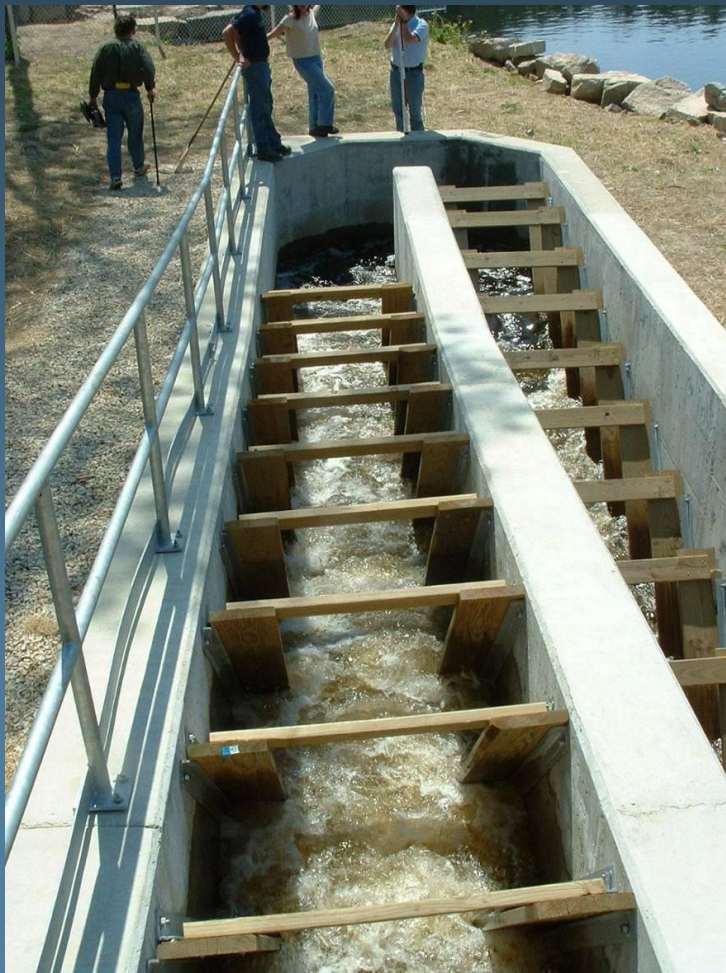
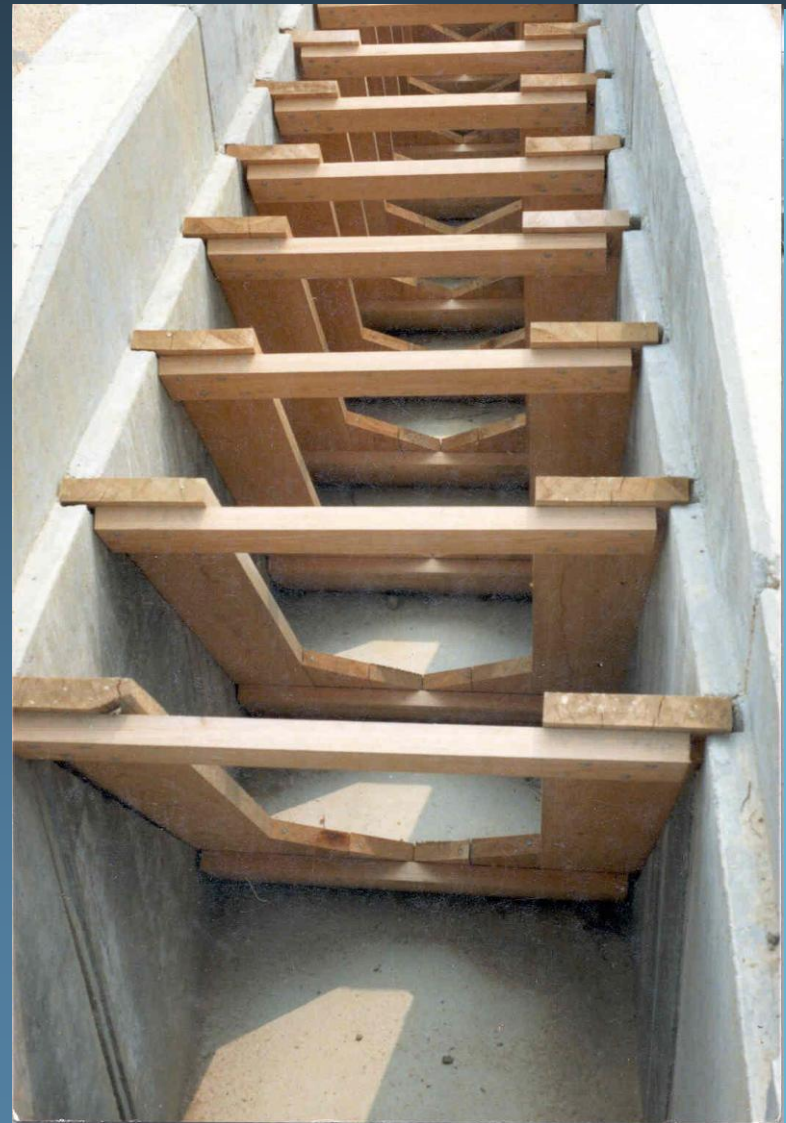
### Denil Fish Ladder

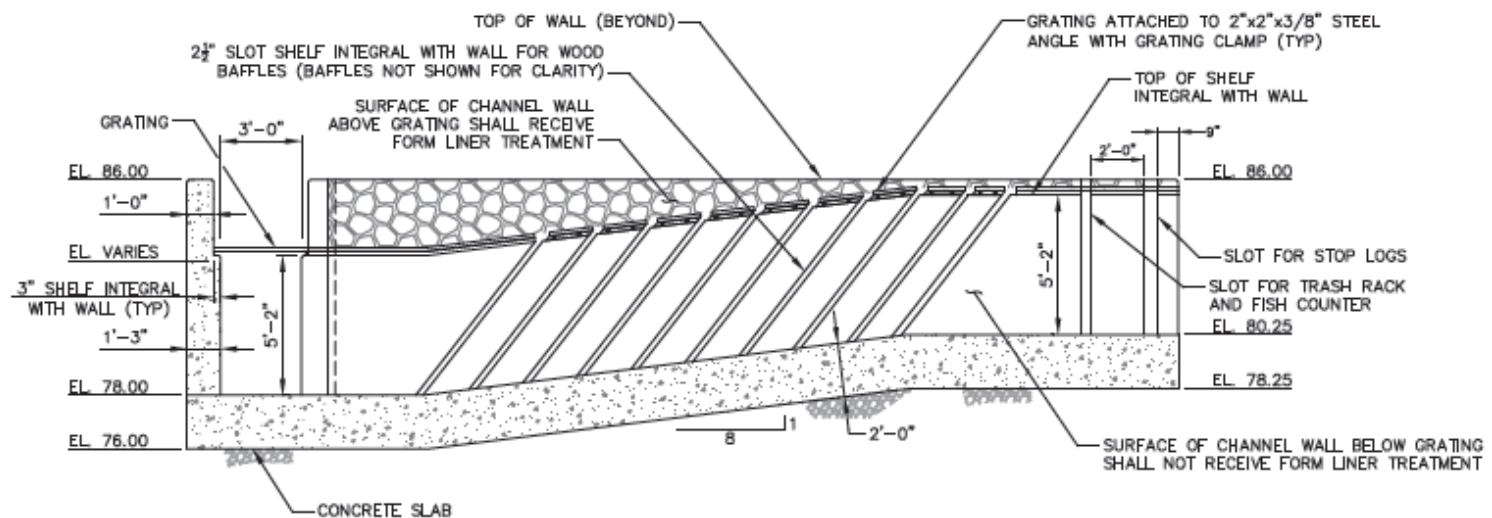
(D) SECTION THRU FISH LADDER  
SCALE: 1/4" = 1'-0"

Fish Ladder

Final Design Alternative – Fish Ladder at Left Abutment

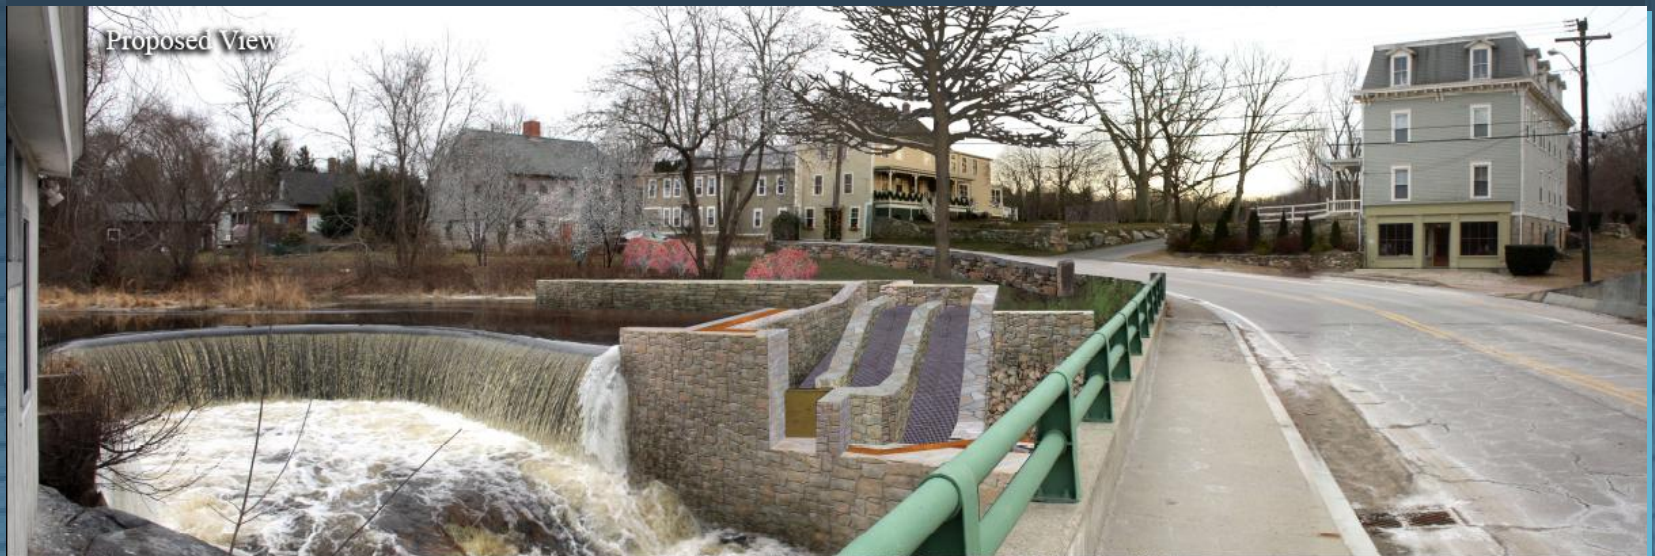
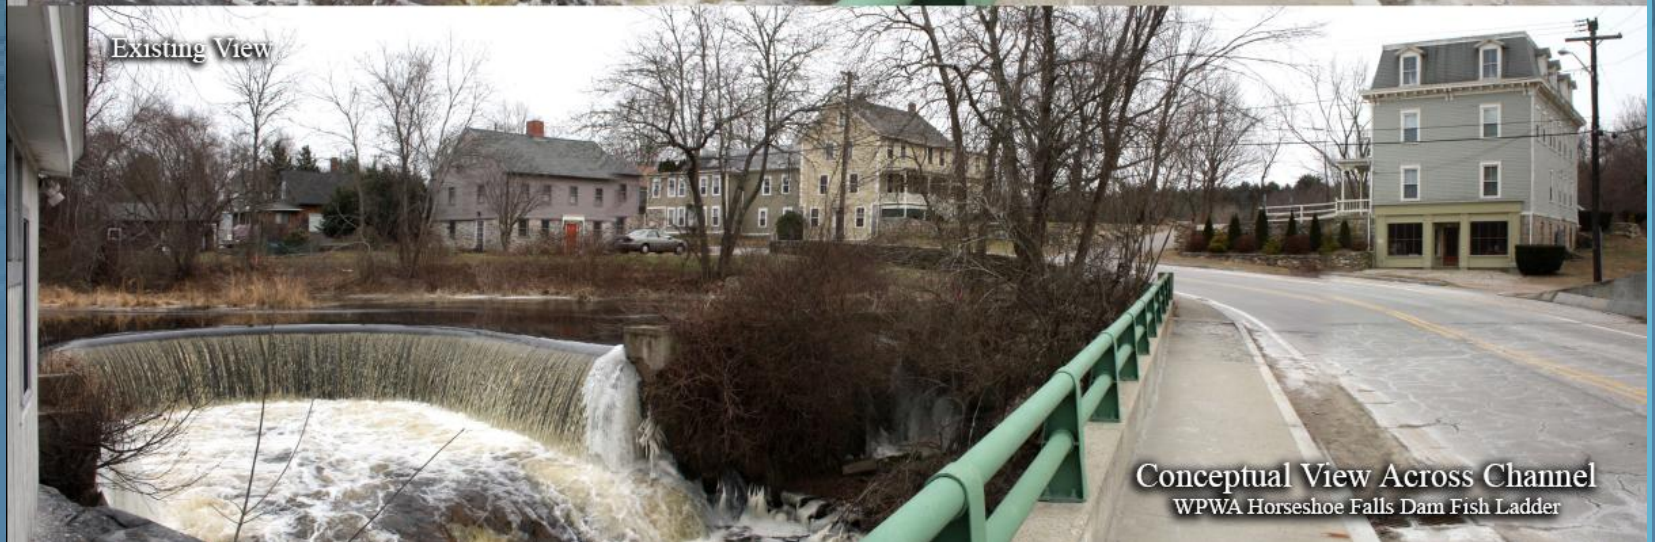
Conceptual View Across Channel  
WPWA Horseshoe Falls Dam Fish Ladder
