Wood-Pawcatuck Watershed Flood Resiliency Management Plan Community Meeting

October 20, 2016

Wood-Pawcatuck Watershed Association

Wood-Pawcatuck Watershed Baseline Assessment

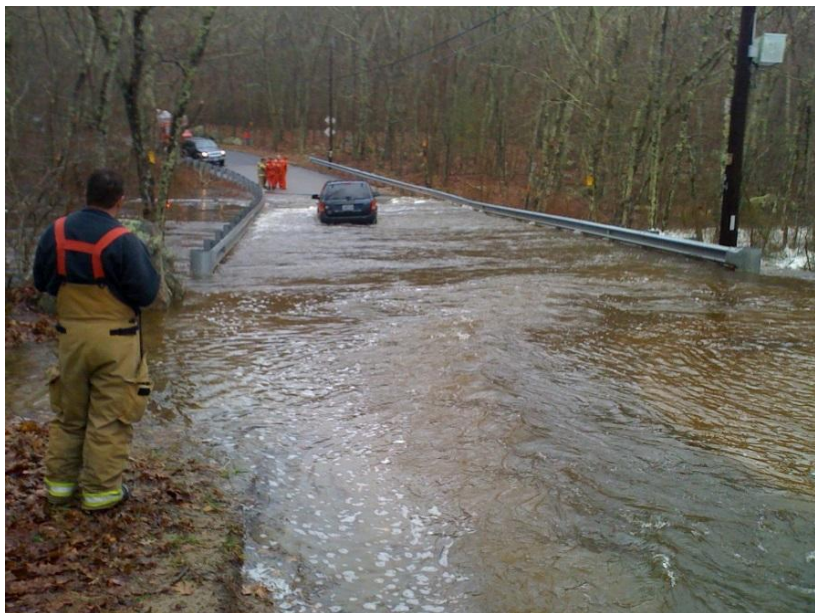
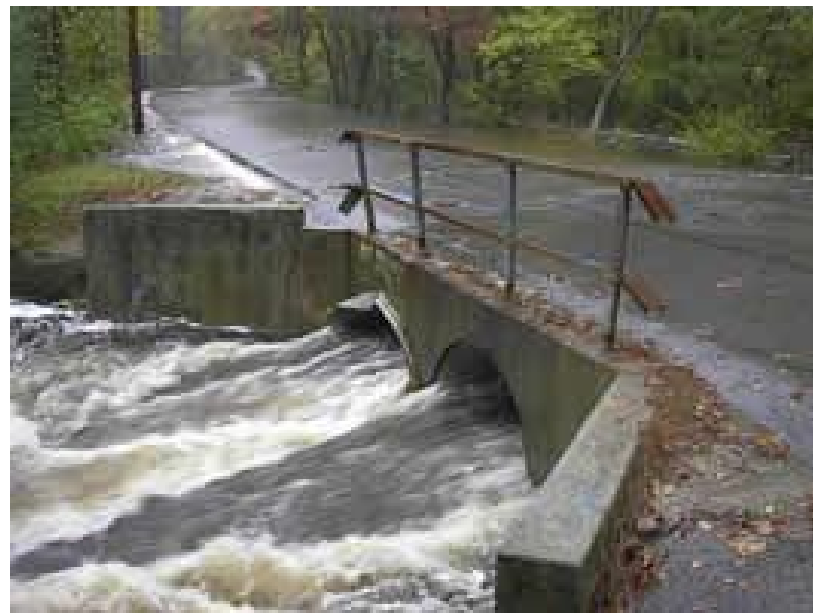
Hydrologic/Flooding

Problems with Road Stream Crossings

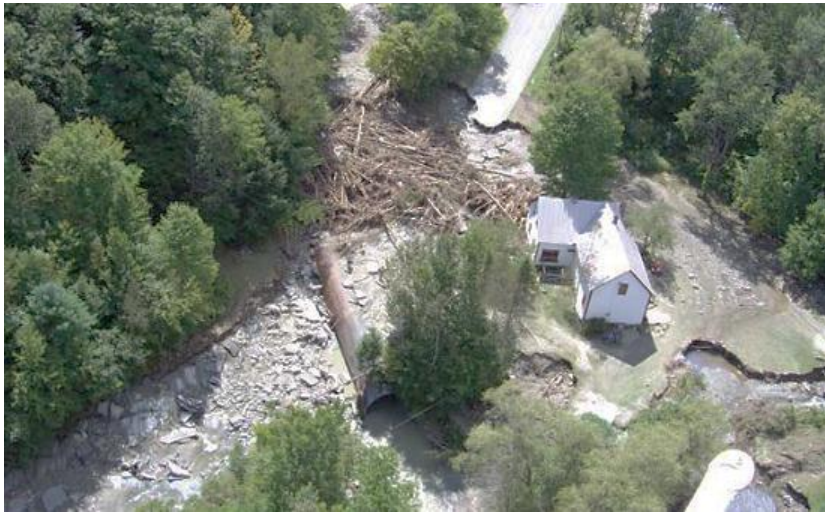
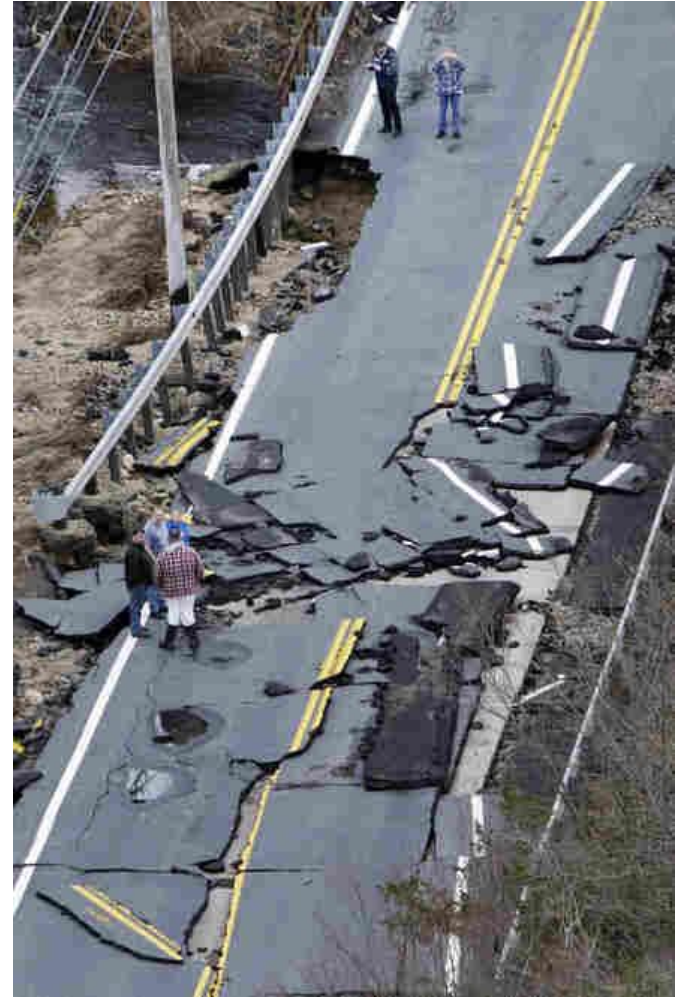
Geomorphic

- Sediment
- Woody debris
- Culvert blockage/failure
- Channel adjustment

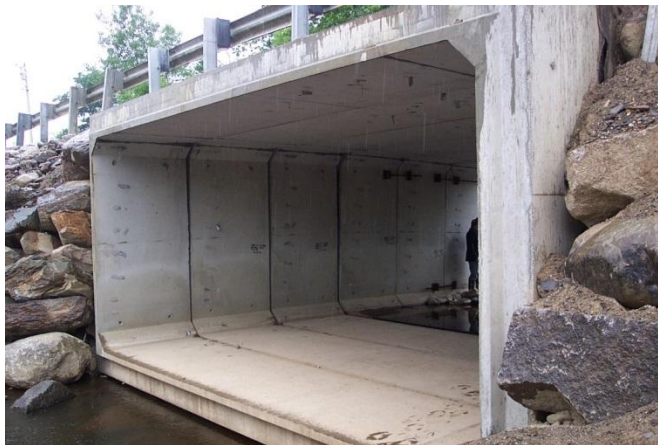
Ecological

- Barriers to physical passage by aquatic organisms
 - Perched culverts
 - Excessive velocities
 - Insufficient water depths
 - Inadequate openess

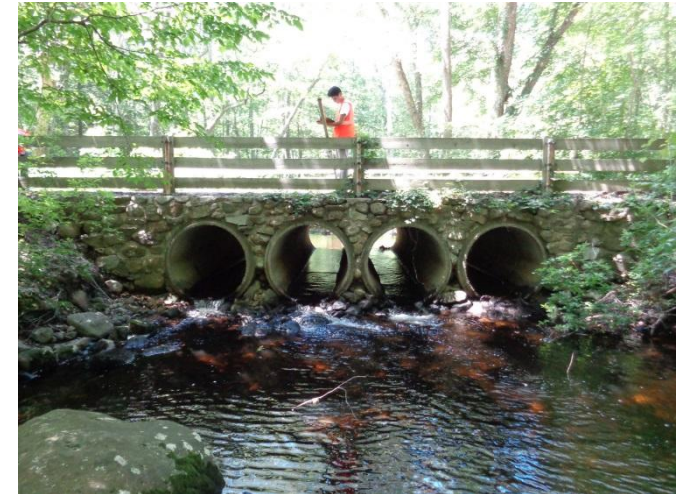
Appendix 2 Field data collection form, p. 3 of 5

- Adapted from Vermont's Stream Geomorphic Protocols and others used in the Northeast
- Information gathered
 - Site characteristics (e.g. sketch, street name, stream name)
 - Structure dimensions needed to assess hydraulic capacity
 - Deficiencies and condition of the structure
 - Upstream and downstream geomorphic conditions

Crossing Dimensions

Upstream Dimensions (ft.): A) _____ B) _____ C) _____ D) _____

Downstream Dimensions (ft.): A) _____ B) _____ C) _____ D) _____

Length of stream through crossing (ft.): _____ Crossing slope (%): _____

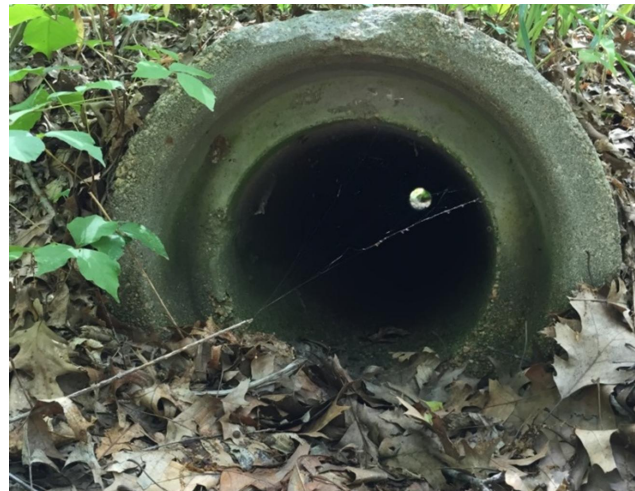
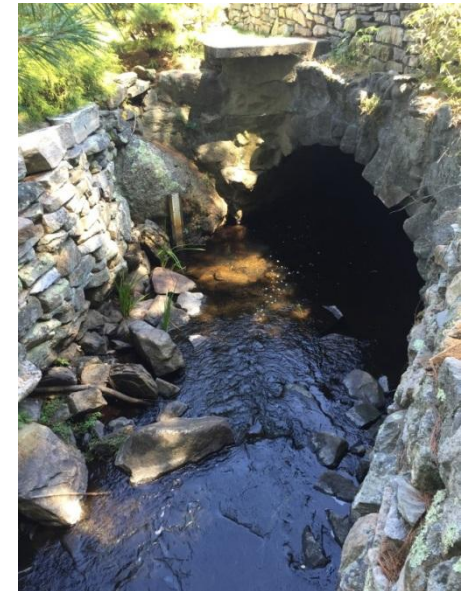
Bridges and Culverts - Findings

- 38% are presently hydraulically undersized (less than 25-year design flow capacity)
- 49% will be undersized under a Year 2070 climate change scenario
- Only 40% of stream crossings provide for full passage of aquatic organisms

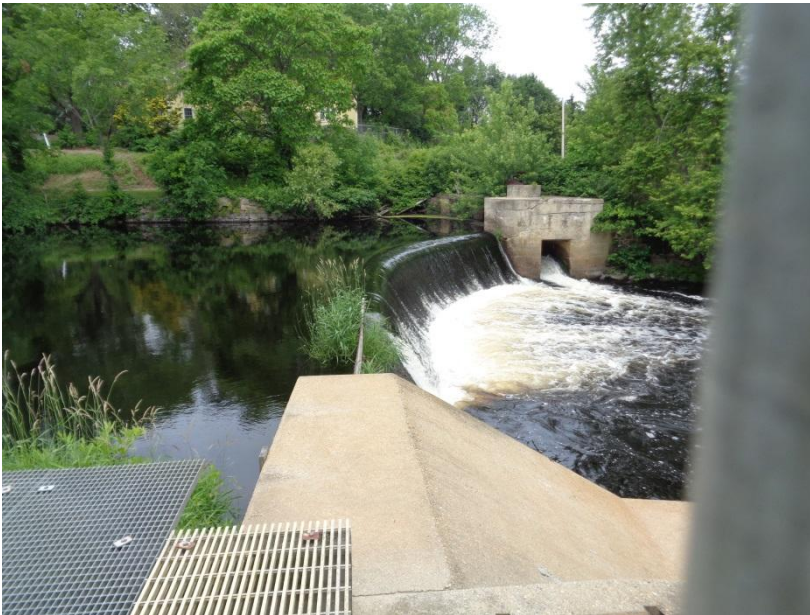
Dams – Field Inspections

- Dam inspection protocols modified from the Massachusetts Office of Dam Safety (Phase 1 Formal Dam Safety Inspection Checklist)

Inspection Items

- Embankment
- Dikes
- Upstream Face
- Downstream Face
- Appurtenances
- Concrete Structures
- Masonry Structures
- Spillway

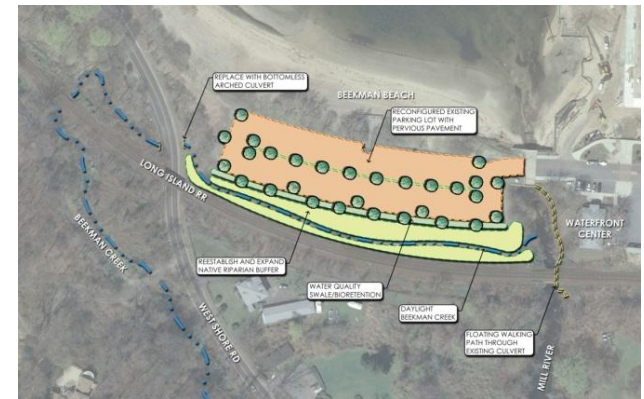
Parcel or Site-Based Retrofits

- Identify Opportunities for Green Infrastructure (GI) Retrofits
 - Enhance resiliency
 - Provide water quality and ecosystem benefits
- Approach
 - GIS Screening evaluation

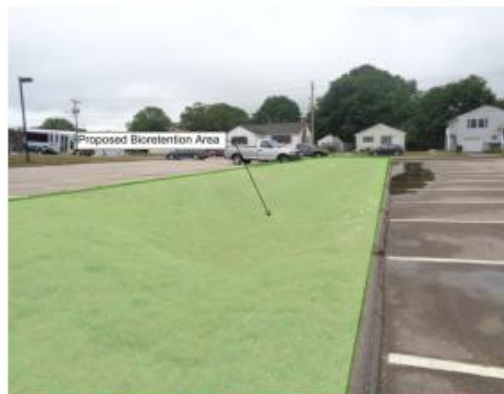
Retrofit the current swale as a bioretention/infiltration practice. The practice would be designed to accept runoff from the surrounding parking lot and additional areas of the site and parking lot. If desired, an overflow structure could be incorporated into the design and connected to current stormwater drainage infrastructure located on Westminster Street.

Image 1: Close-up view of proposed bioretention/infiltration area.

The proposed retrofit concept is located at the Westerly Senior Center near the intersection of Westminster and State Streets in Westerly, RI. The site consists of an asphalt parking lot divided into multiple parking areas. There is a swale located between two sections of the parking lot, and some runoff is directed to the swale but no overflow or formal BMP exists, nor does the swale capture all of the runoff that could be directed to it.

Total Drainage Area: 1.2 acres
Total Impervious Area: 1.0 acres
Total Water Quality Volume: 3,794.0 ft³
Runoff Reduction Volume: 379.4 ft³

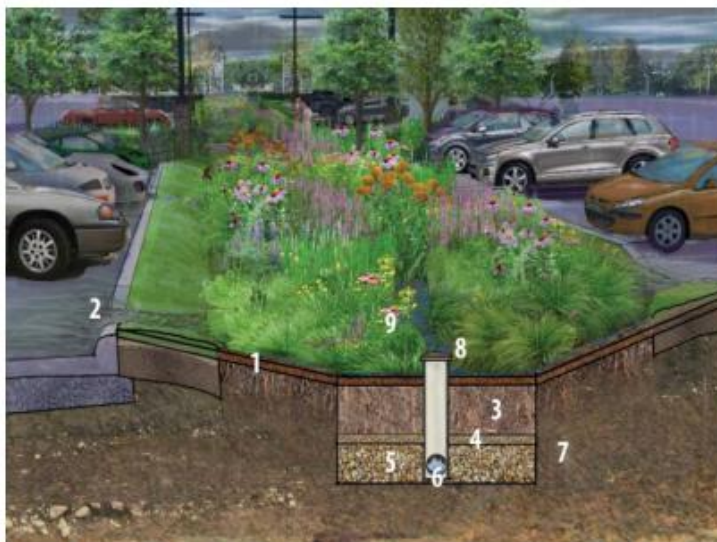
Image 2: Rendering of a typical bioretention area. (Image source: Johnson County Soil and Water District)

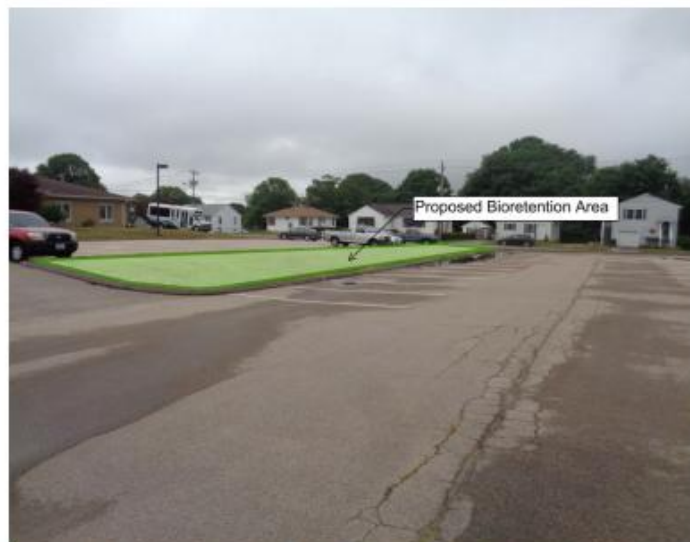
Image 3: View of proposed bioretention/infiltration area and some of the parking area that would drain to it.

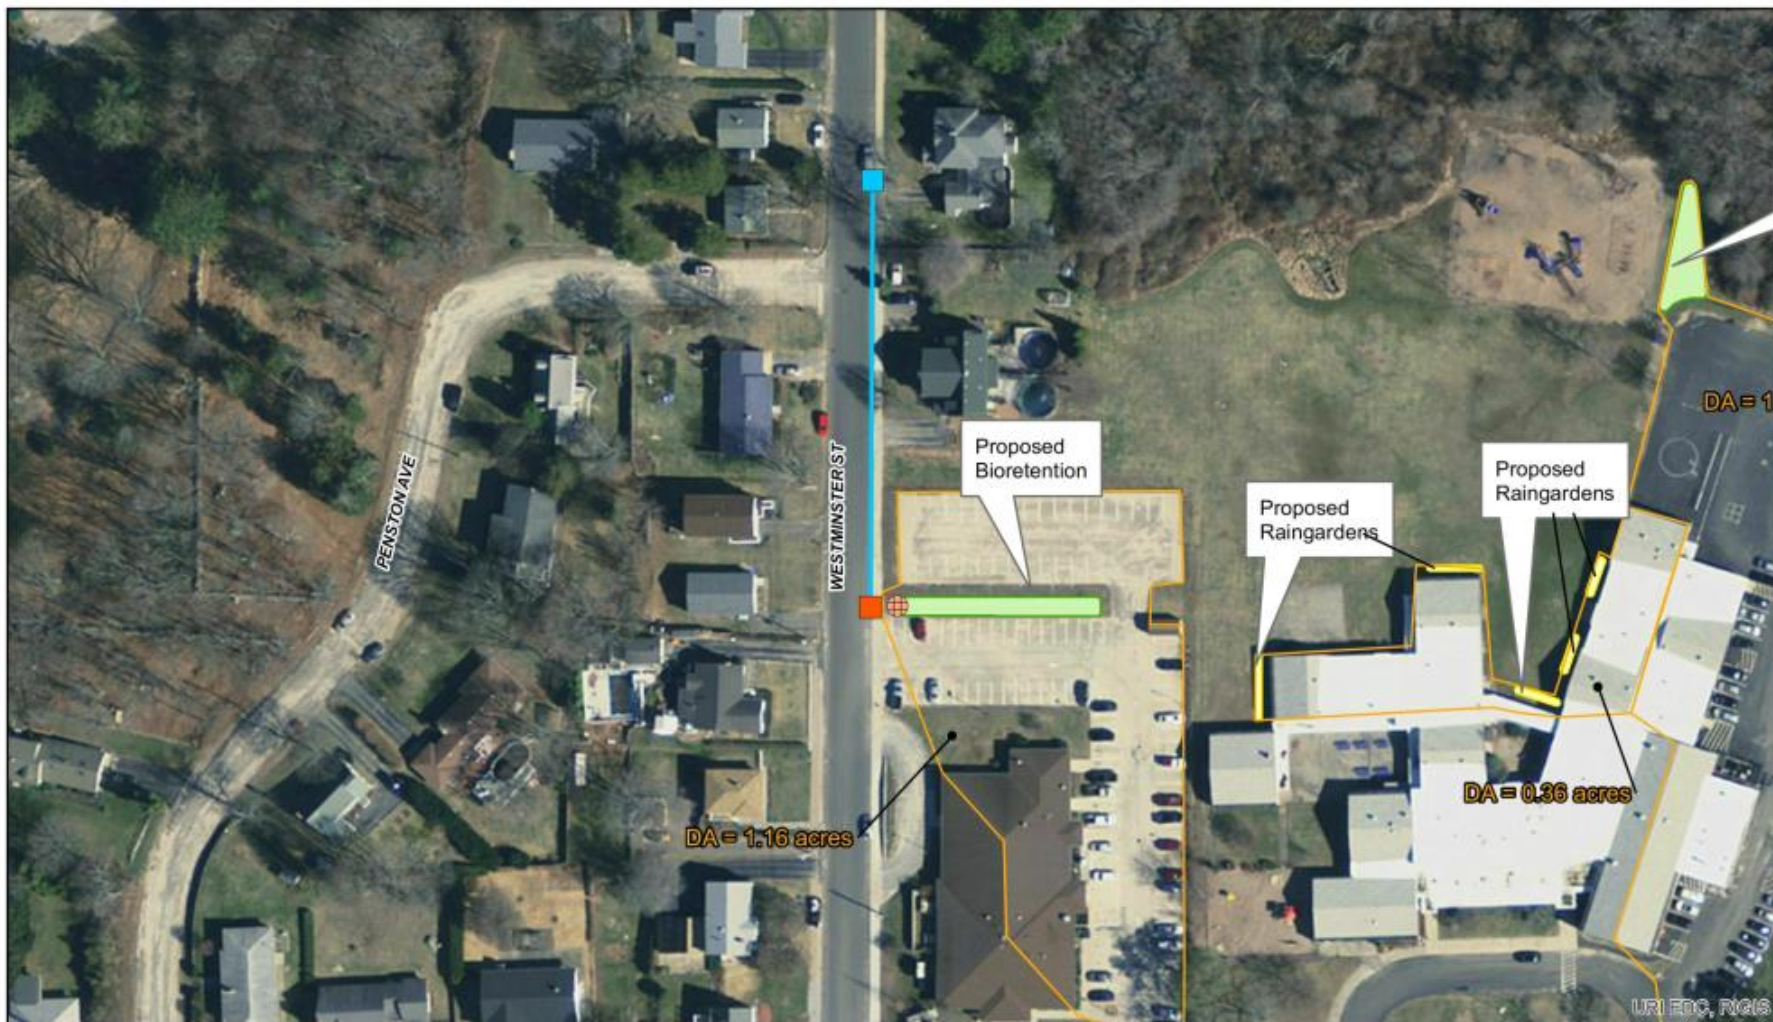
Stormwater Retrofit Concept

Westerly Senior Center (272 A)

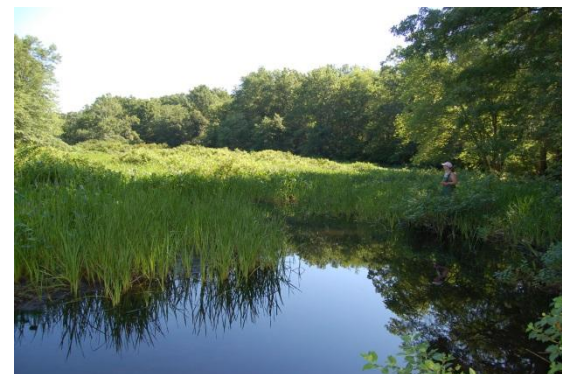
- Wetlands can provide flood mitigation, habitat, water quality, and other functions
- Identify and prioritize conservation and restoration opportunities
 - GIS-based screening
 - USFWS NWI Plus Dataset for RI and CT
 - Rhode Island Freshwater Wetland Restoration Strategy (Miller and Golet, 2001- URI)

NWIPlus: Geospatial Database for Watershed-level Functional Assessment

- 80 wetland complexes with flood protection function and human modification
- 24 assessed in the field for functions and values
- Several impoundments/dams with high conservation potential (Hazard Pond, Dolly Pond, Kasella Farm Pond)
- Other wetland restoration opportunities identified
