# **Fluvial Geomorphic Assessment and River Corridor Planning in the Wood-Pawcatuck Watershed, RI and CT**

Prepared for  
Wood-Pawcatuck Watershed Association  
Hope Valley, RI

Prepared by  
John Field  
Field Geology Services  
Farmington, ME

March 2016

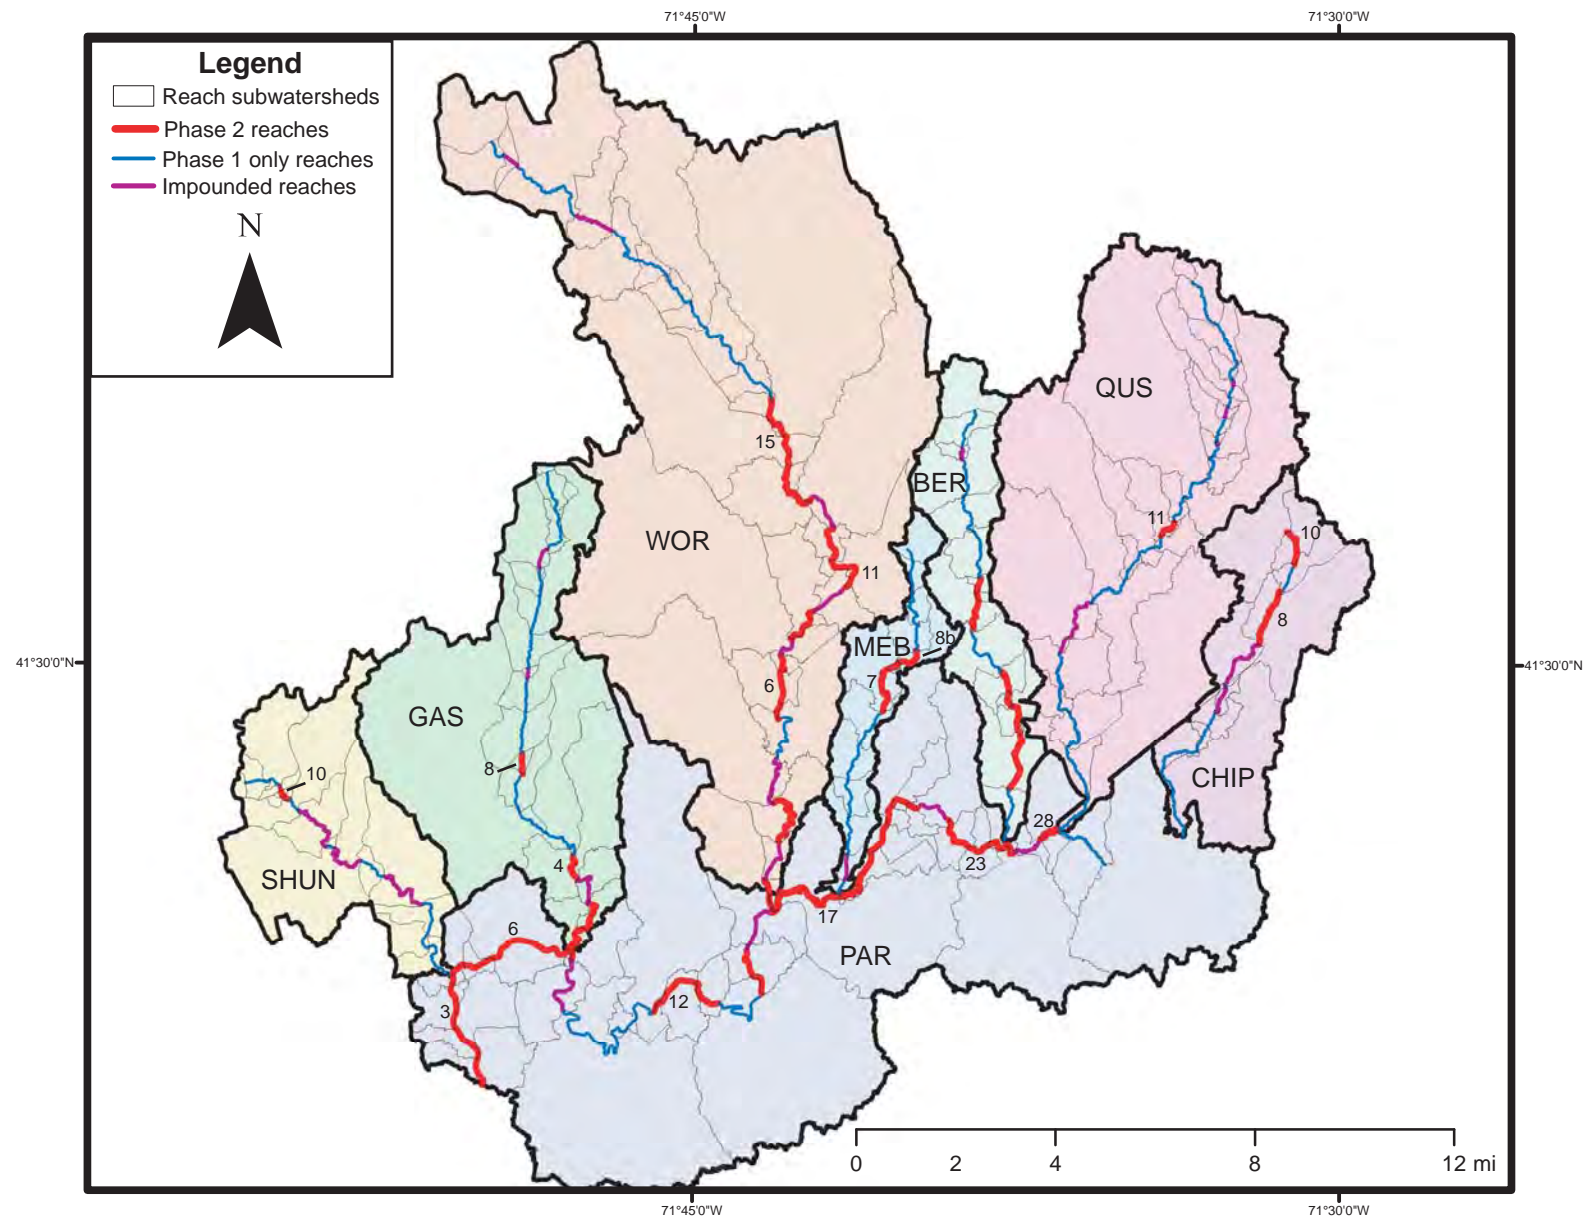
Figure 9. Watershed map showing reach subwatersheds, Phase 2 reaches assessed, and impounded reaches.

time-consuming Phase 2 study. The Phase 2 assessment encompassed only 44 reaches with a total channel length of approximately 38 mi (Figure 9). An effort was made to select contiguous reaches for the Phase 2 assessment because information on adjacent reaches is often useful for establishing the causal factors for why specific channel conditions have developed in a given reach. However, several factors resulted in many of the 44 assessed reaches being separated from others. Stakeholders were interested in sites of known and repeated flooding problems that were in some cases isolated from other reaches. In general, though, the numerous dams and associated impoundments partition the river into separate sections making an assessment of one long continuous length of river impossible. Given those limitations, reaches were also selected to: 1) include areas where development on the floodplain is potentially at risk to flooding and erosion, 2) investigate the potential downstream impacts of possible watershed stressors (i.e., dams), and 3) provide additional information on reaches where in-stream management work is proposed (i.e., dam removals).
