SHANNOCK FISH PASSAGE FEASIBILITY STUDY

**PAWCATUCK RIVER
RICHMOND AND CHARLESTOWN, RHODE ISLAND**

August 10, 2007

MMI #2989-01

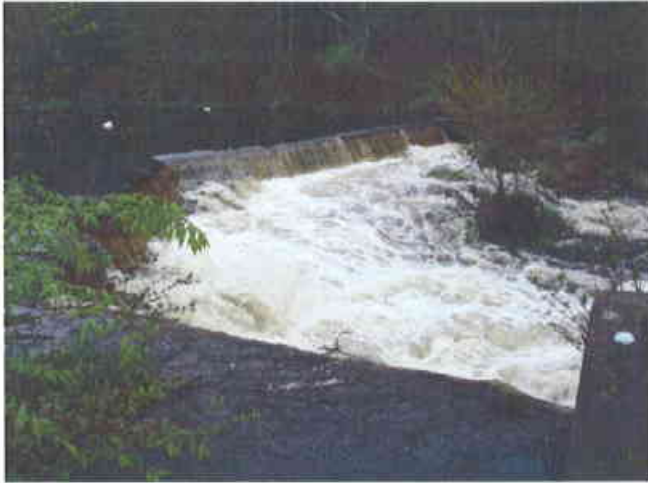
View of Lower Shannock Falls Dam from the right bank

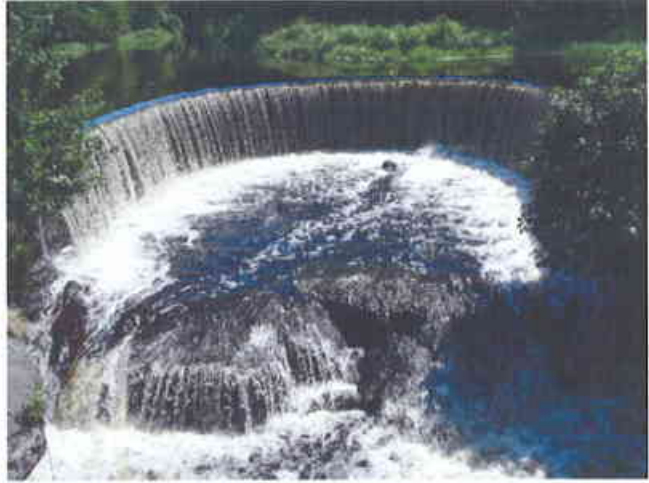
View of Upper Shannock Horseshoe Falls Dam looking upstream

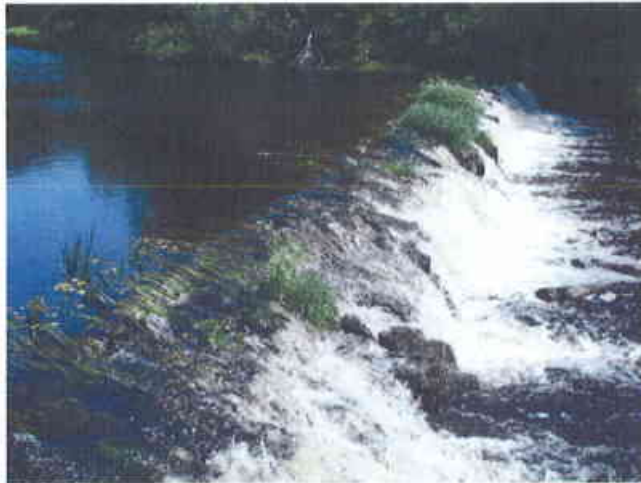
View of Kenyon Mill Dam from the right bank
