# **The RI River and Stream Continuity Project**

## **Follow Up Meeting**

**April 18, 2007**

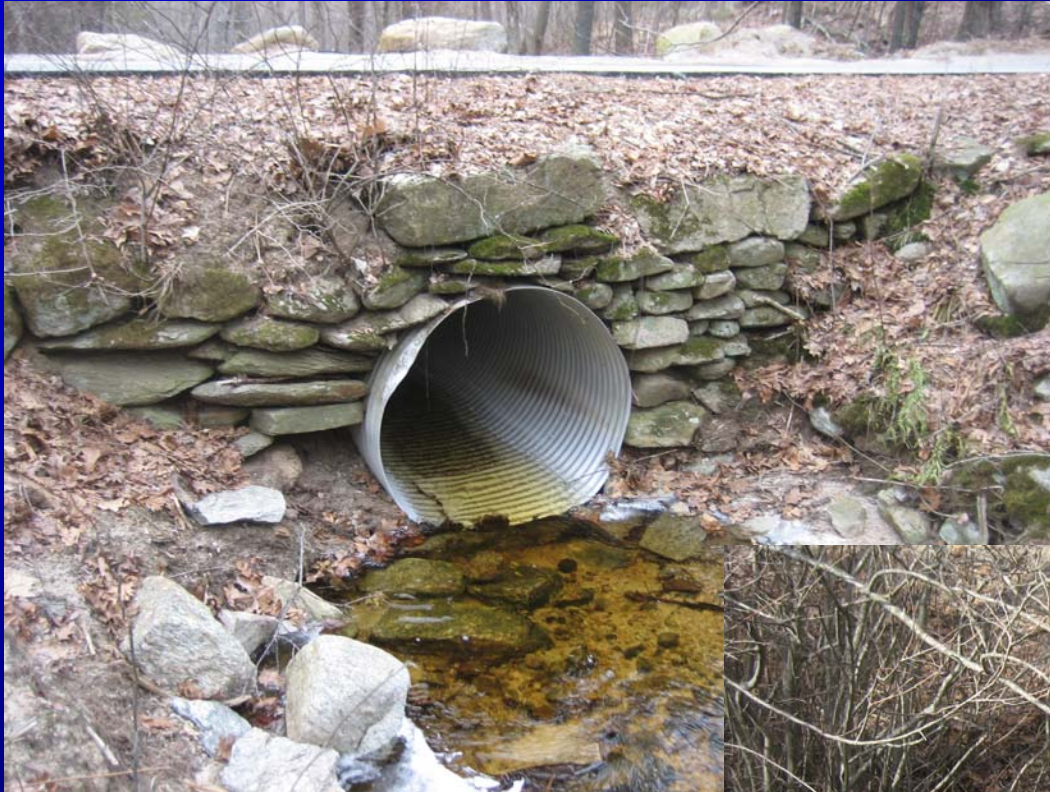
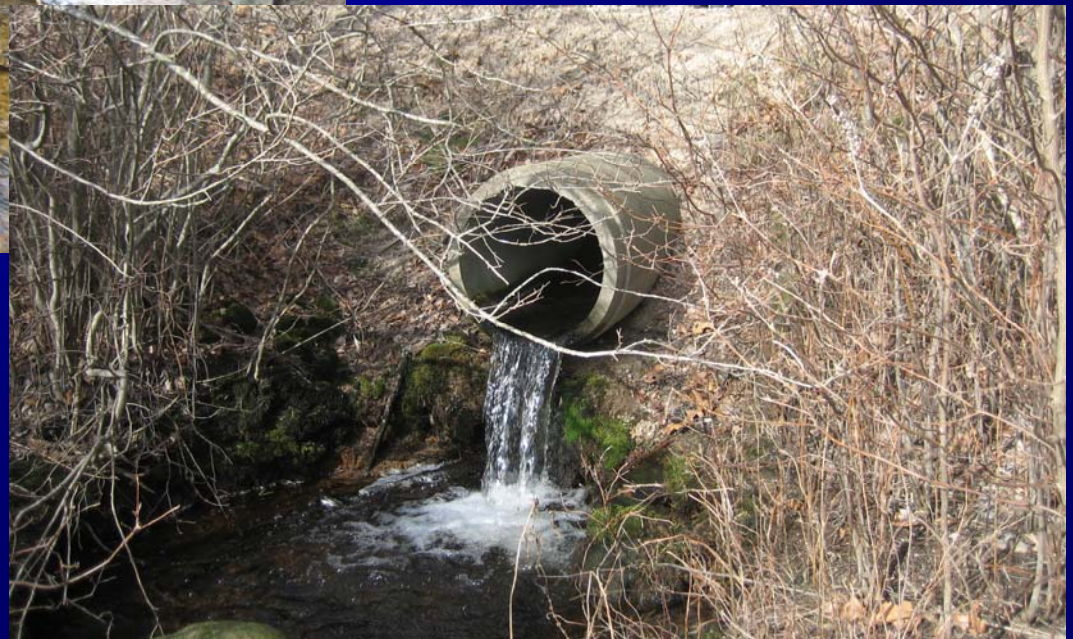
# Sub-standard Culverts

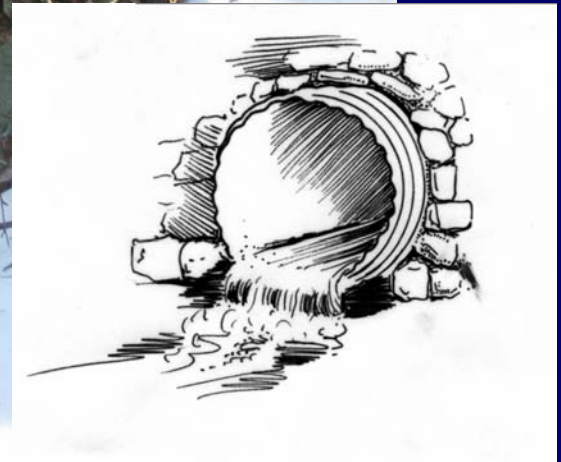
# Outlet Perch

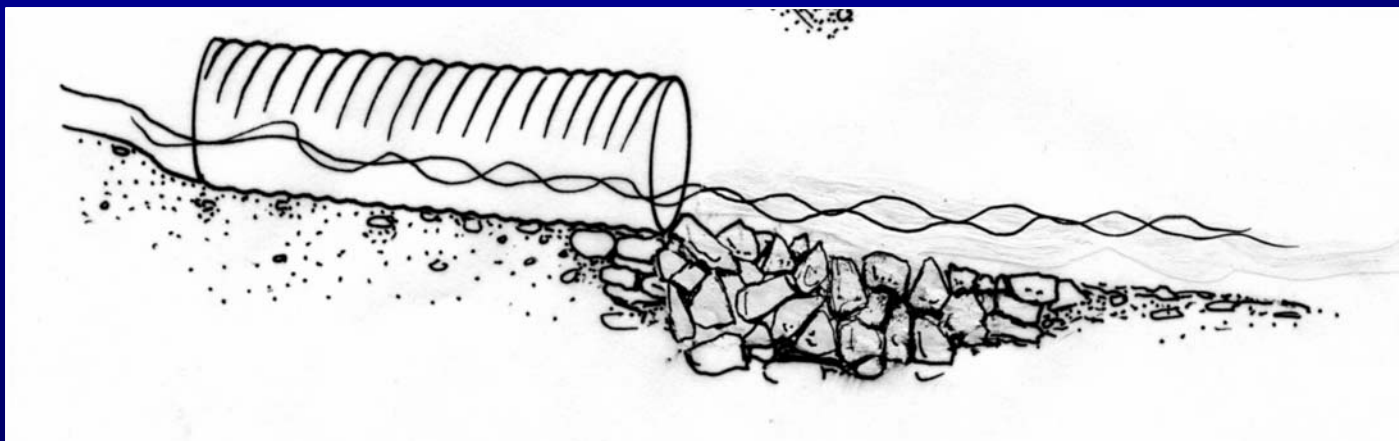
## Tailwater Armoring

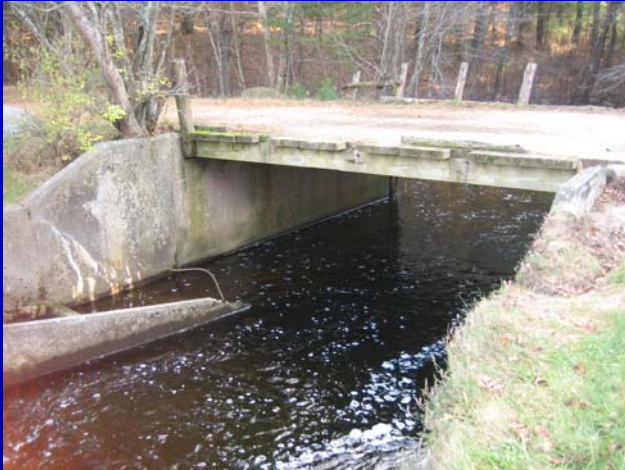
Breakheart Brook and Austin Farm Road

# Minor Barriers

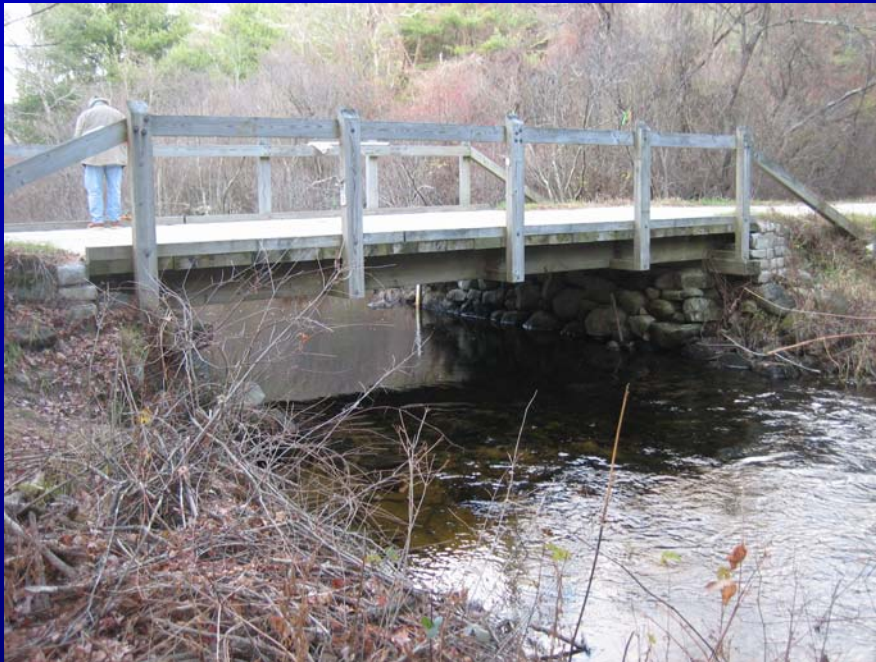
**Flat River and Austin Farm Road**

# Meets General Standards

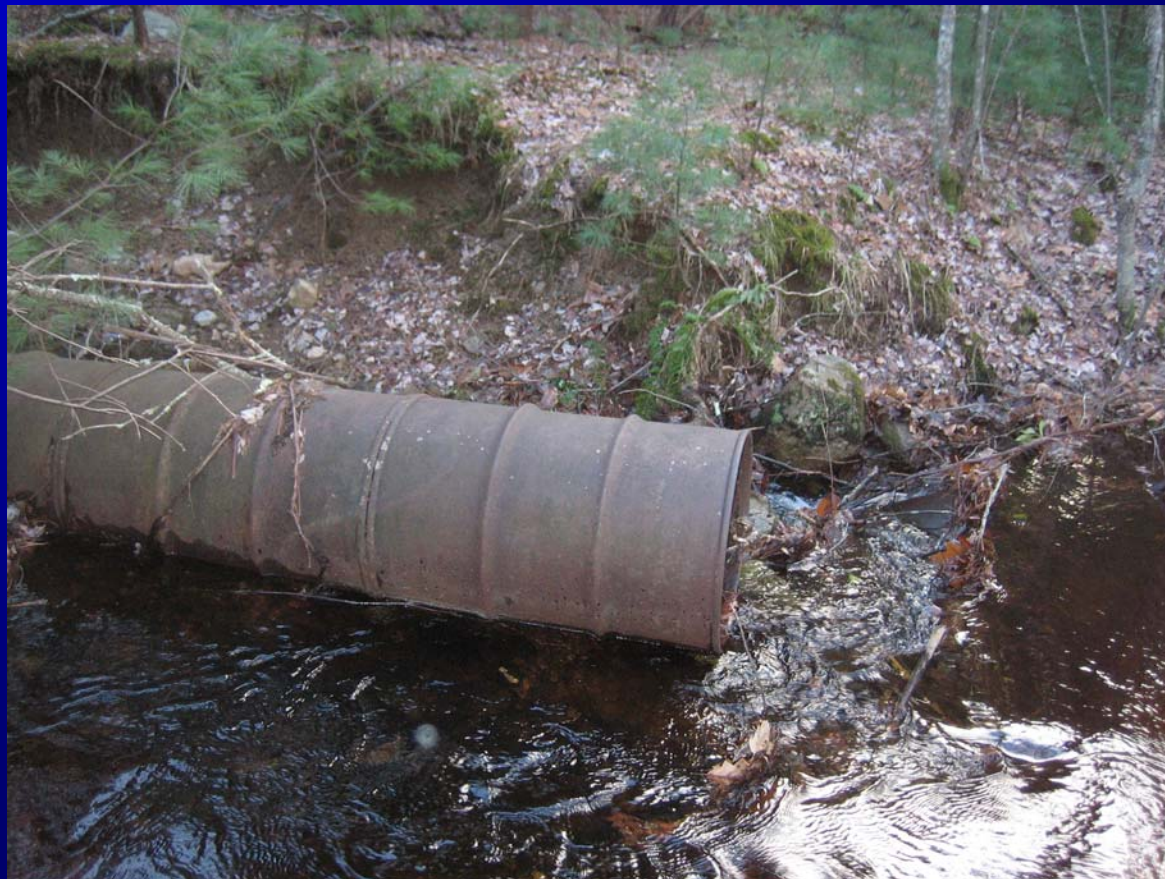
## Unnamed Brook and Matteson Road in the URI Alton Jones Campus

# Meets Optimum Standards
